Re: St. Lucie Unit 1
Docket No. 50-335
Reportable Event: 96-009
Date of Event: July 10, 1996
Operation Prohibited by Technical Specifications
Due to Procedural Inadequacy and Personnel Error

LICENSEE EVENT REPORT (LER)

TITLE (4)
Operation Prohibited by Technical Specifications due to Procedural Inadequacy and Personnel Error

FACILITY NAME (1)	DOCKET	LER NUMBER (6)			PAGE (3)
ST. LUCIE UNIT 1	05000335	YEAR	SEQUENTIAL	REVISION	2 OF 5
		96	-- 009	-- 00

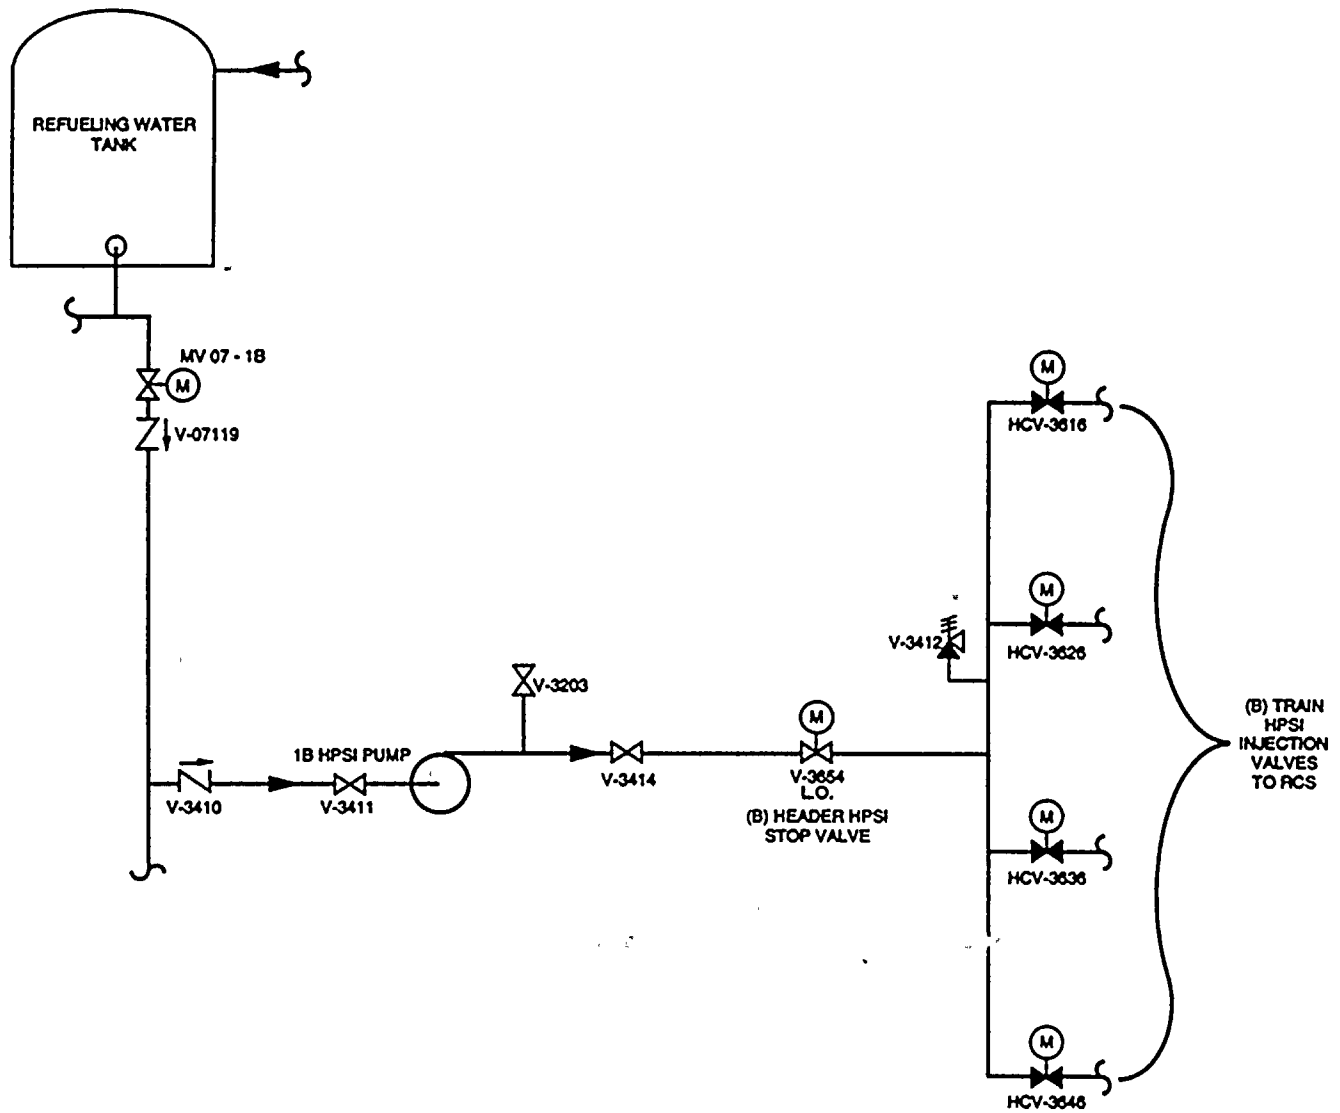
FIGURE 1
SIMPLIFIED HPSI FLOWPATH DIAGRAM

To facilitate the RCS fill evolution and prevent delays associated with boric acid batching operations, utility licensed operators changed the boration flow path at 2140 hours to use the refueling water tank (RWT) (EIS:BP) via the 1B high pressure safety injection (HPSI) pump (EIS:BQ). The 1B HPSI pump stop valve (V3654) (EIS:BQ) was opened to take credit for this boration flow path. The 1B HPSI pump control switch was maintained in the STOP position and the cold leg HPSI injection valves from the 1B HPSI pump were maintained closed (refer to Simplified Flow Diagram - Figure 1).

During the time that the 1B HPSI pump was aligned as the TS boration flowpath and the RCS pressure boundary was intact, the HPSI pump was not operated and the four HPSI header injection valves remained closed (refer to Figure 1). Additionally, the 1B HPSI pump control switch was maintained in the STOP position thereby preventing the potential for automatic actuation. There was no adverse effect on RCS pressure/temperature limits during this event and the Technical Specification requirement for rendering the HPSI pumps inoperable does not apply for plant operating Modes above 236 degrees.

Although the LCO requirements of TS 3.5.3 were not met during the time that the 1B HPSI pump was aligned as the boration flow path with its header stop valve (V3654) open, the four HPSI header to RCS injection valves remained closed, and the 1B HPSI pump control switch position was maintained so as to prevent the automatic start of the pump. The RCS was not challenged by any over pressure event, and the health and safety of the public were not affected.
