U.S. NUCLEAR REGULATORY COMMISSION

Report No: 50-335/96-16, 50-389/96-16

Facility: St. Lucie Nuclear Plant, Units 1 & 2

Date: August 23, 1996

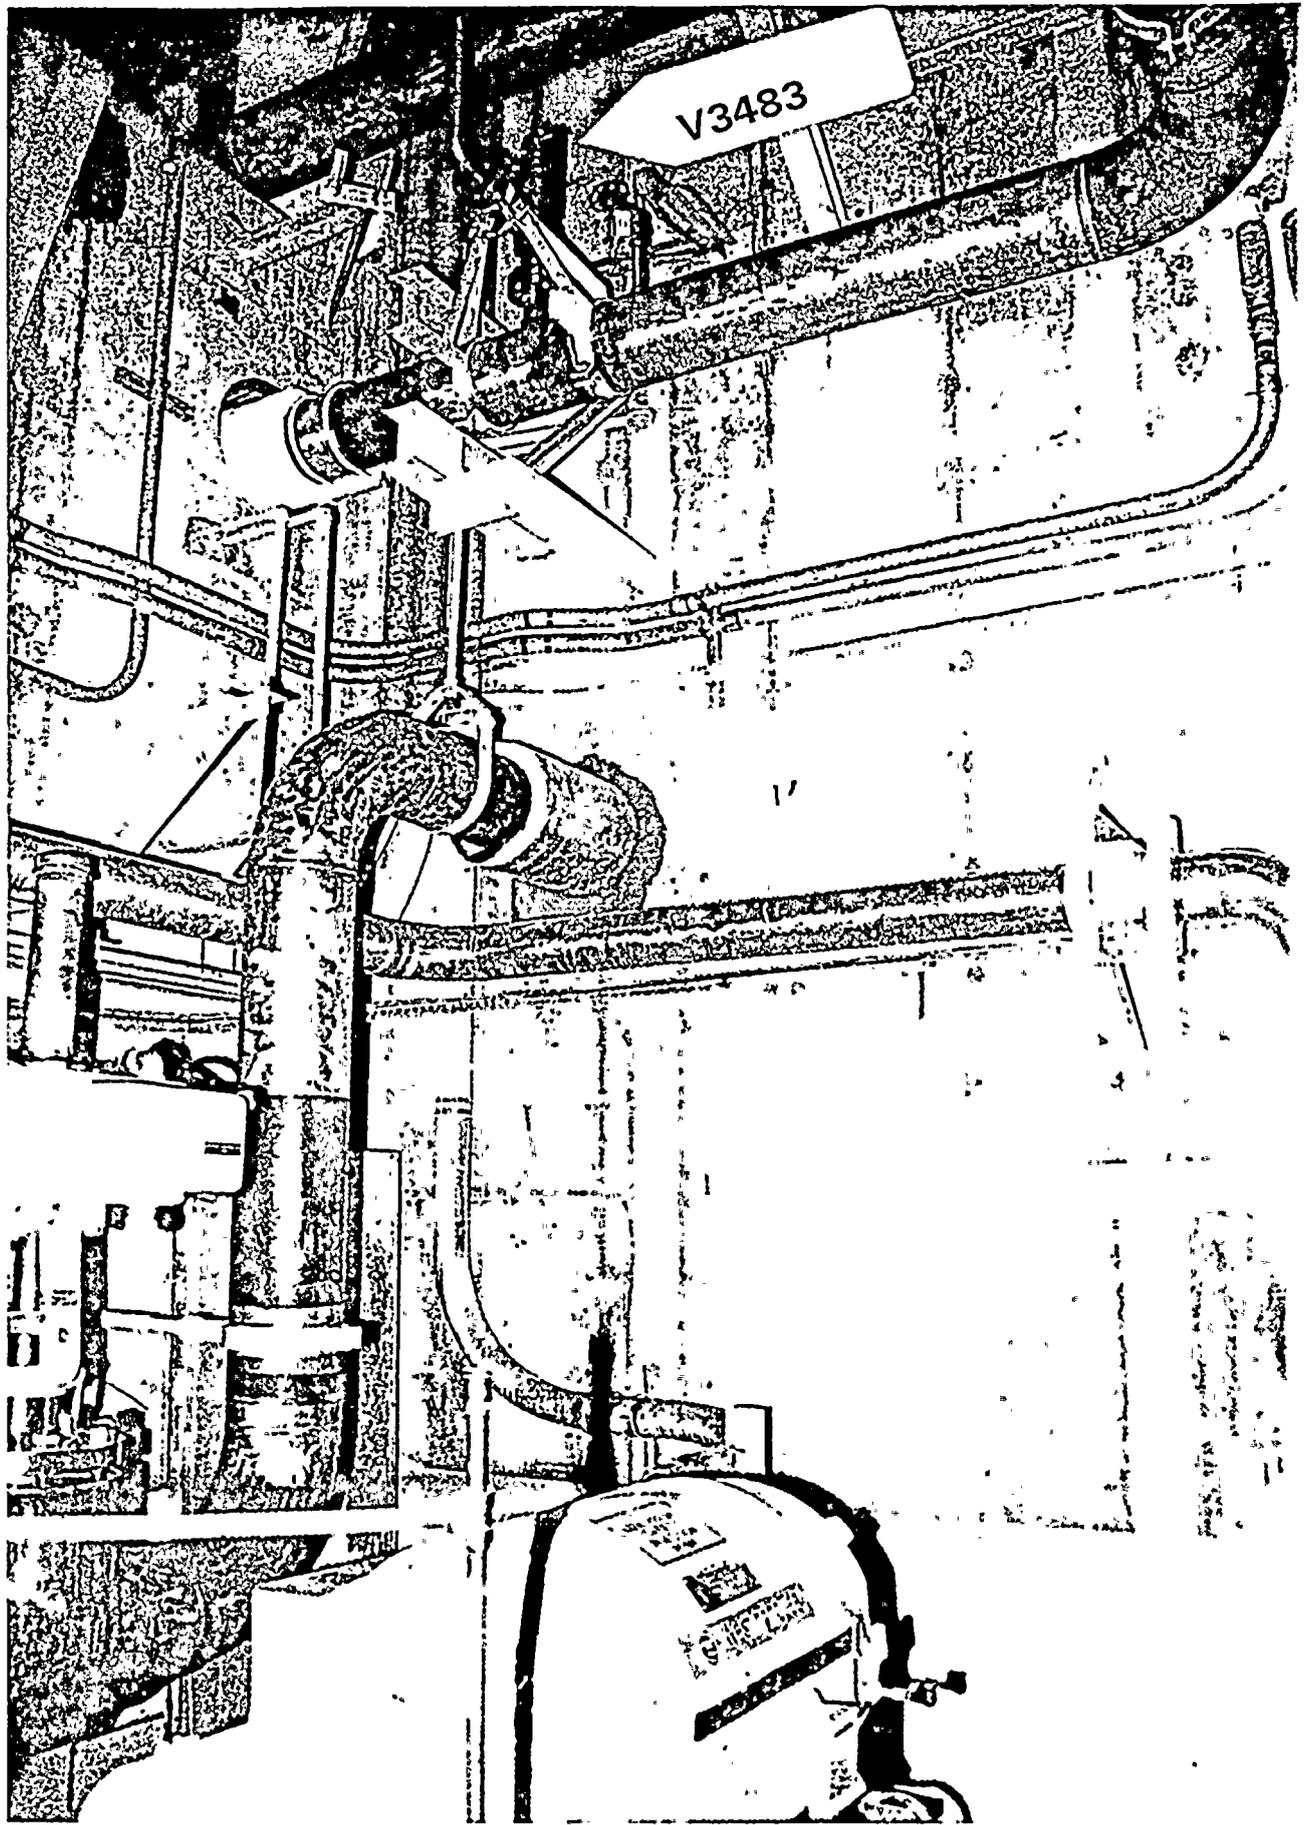
FIGURE 1

On May 13, 1996, relief valve V3483 was removed from the plant for a planned check of its pressure relief setpoint. This valve had been installed on the 1A Low Pressure Safety Injection (LPSI) pump return line. On May 15, 1996, the planned check of the valve setpoint was initiated. Testing determined the pressure setting to be approximately 55 percent above its design set point. This valve was found with its wire seal broken and wrapped around the valve cap. A broken wire seal could be an indicator that the valve internals experienced some tampering. As recorded in the licensee's CR documentation, the root cause of this failure was stated by the licensee to be "apparently due to tampering or misadjustment of the valve's set screw controlling spring tension by unauthorized individual(s)." Figures 1 - 3 show the installed configuration for valve V3483.

The inspectors reviewed CR 96-0890, which documented that the as-found lift setpoint of the 1A LPSI pump discharge relief valve V3483, was approximately 55 percent above its set pressure. This report stated that, after the valve was removed from the system it was placed in the drumming room to be tested. Prior to testing, an initial inspection identified that the adjustment cap screw seals were broken and the nozzle forging was not properly seated in the valve body and was loose. In the past it had been a common maintenance practice to install wire seals as a method to quickly and easily identify if tampering had occurred. However, the lack of a seal did not provide conclusive evidence that tampering had occurred. Seal wires could be broken during installation, maintenance of pipe insulation or other maintenance activities occurring in the same area. Subsequent testing was performed with the valve in this condition and the aforementioned results were obtained.

Through discussion with the licensee and documentation reviews, the inspector determined that, once the valve was installed, tampering adjustments to the V3483 setpoint required the removal of four 2.5" X 0.5" cap bolts tightened to a torque value of 45 Ft-lbs. in order to gain access to the adjusting nut. The cap bolts were not reported as having been found loose when the valve was removed from the system. The inspector observed the valve installed in the system and noted that it was located approximately twenty-five feet above the floor, making it accessible only with the use of a long ladder, scaffolding or crawling along the associated pipe. Figures 1 - 3 show the location of the valve. Although the report concluded that the root cause of the failure was apparently due to tampering or misadjustment of the valve's set screw controlling the spring tension, site management assessed the events to most likely be due to poor work practices. Documentation review indicated the valve was subsequently replaced with a pretested spare.

Based on independent review of documentation, observations of the installed valve configurations, and the effort required to access the valve spring tension mechanisms, the inspectors concluded that tampering, although it could not be conclusively ruled out, was not likely to have occurred in this specific case. The more likely cause for this misadjusted valve was poor maintenance practices.

The inspectors verified through documentation review that the two valves were either replaced or repaired.

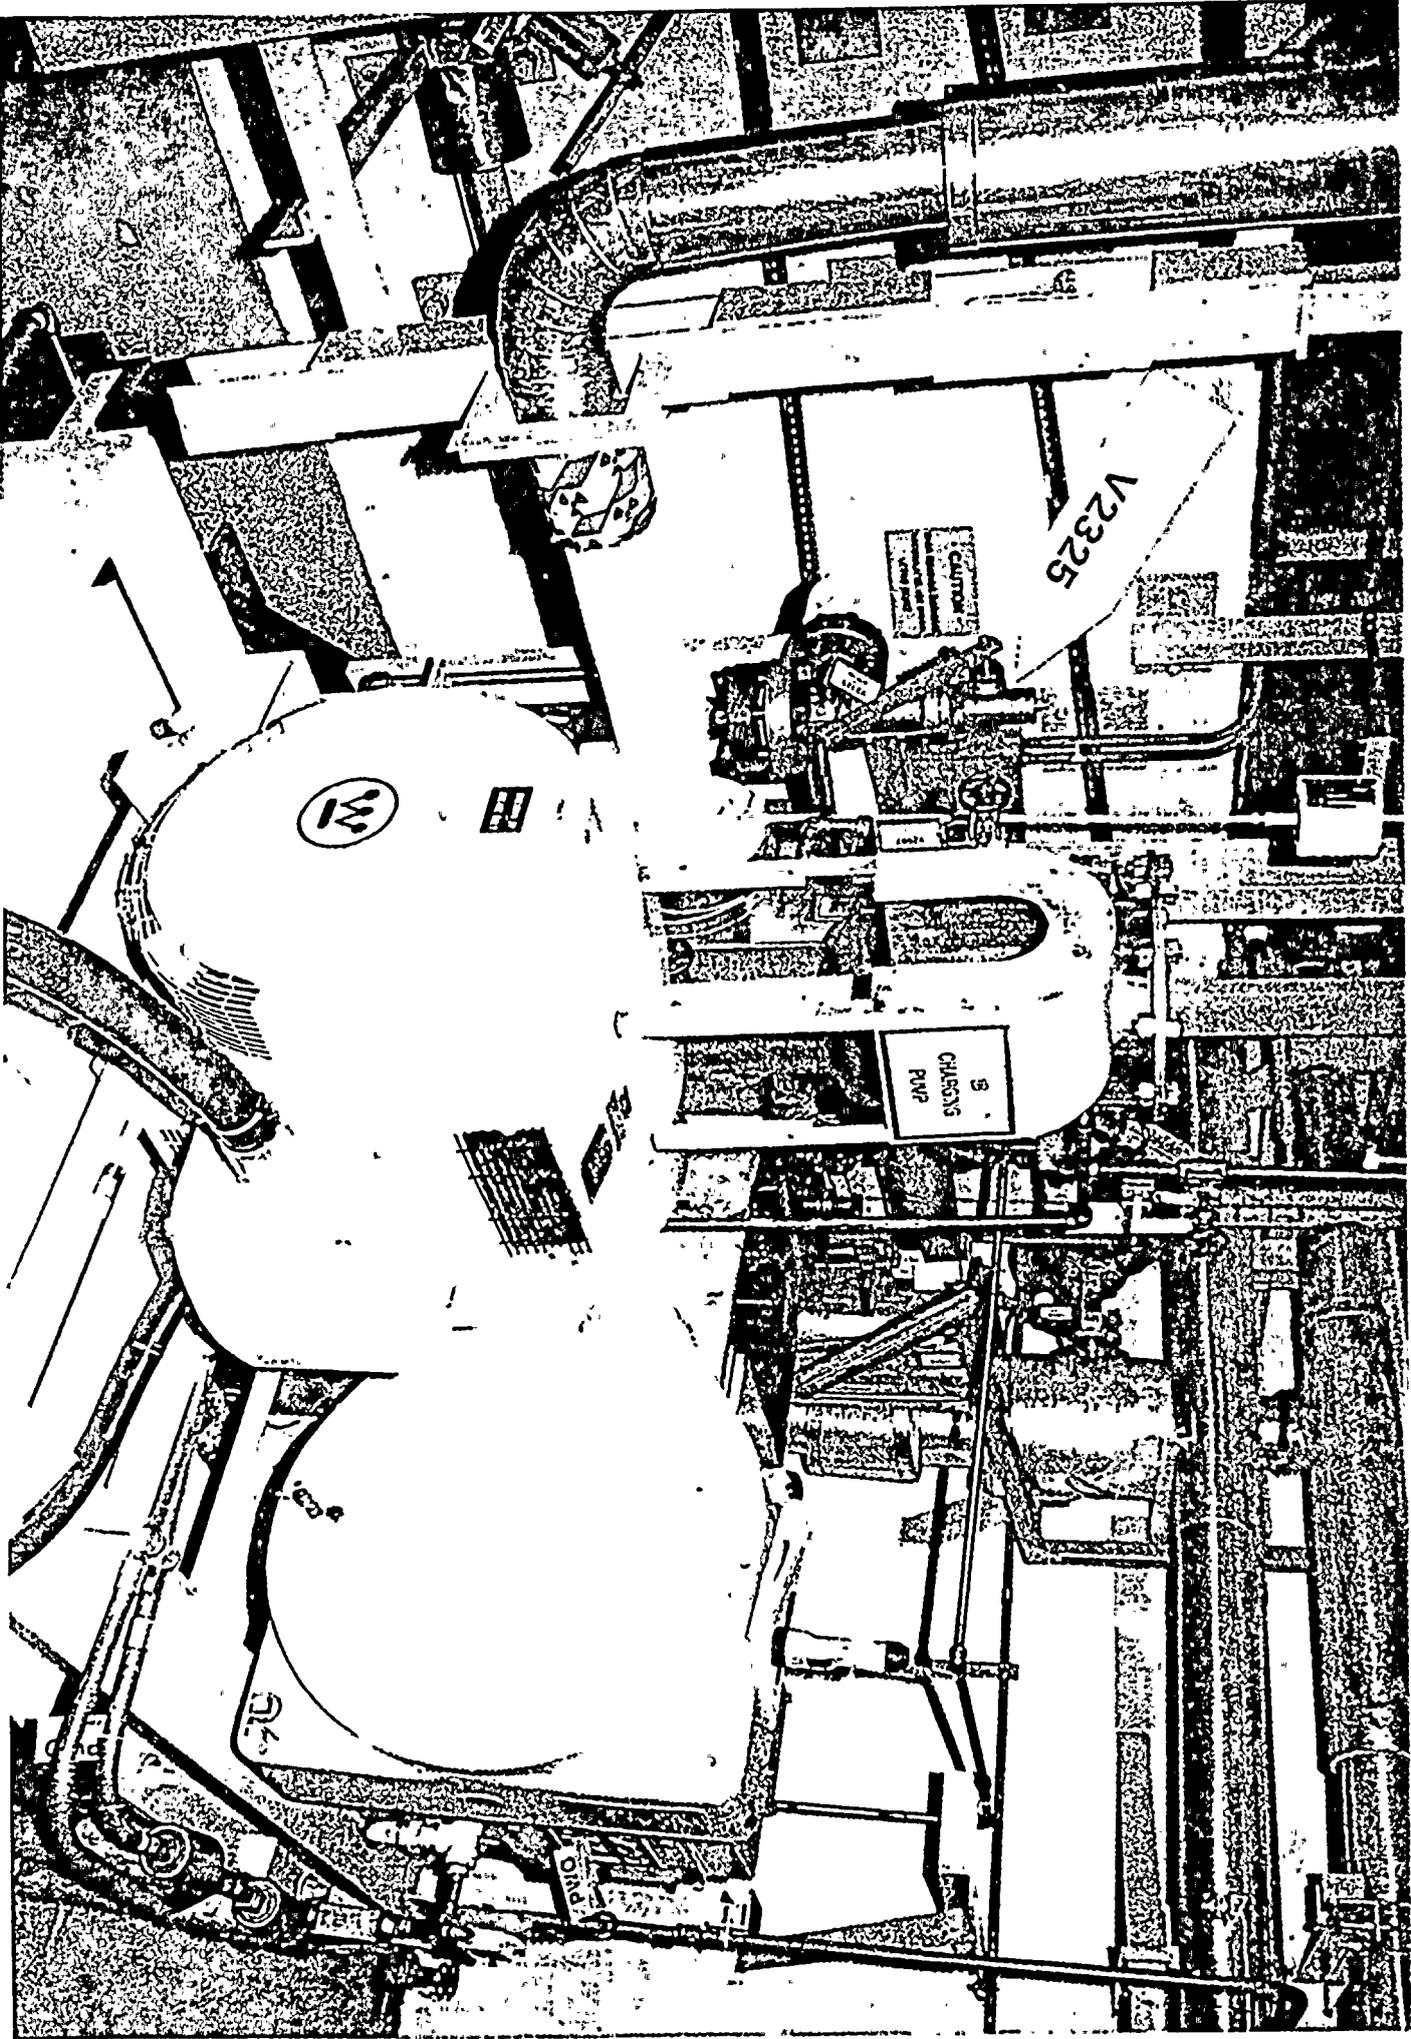
FIGURE 4

In response to the high as-found pressure setpoint of the V3483 and the broken wire seal on the valve, the licensee performed an inspection of wire seals on an additional 150 safety related valves. This effort was documented in CR 96-1247. After a review of both units, a total of 10 Unit 1 valves were identified with damaged or missing seals. Three of these valves had the seal intact but damaged. Five of the valves had proper lift setting visually verified by the position of the adjustment bolt. One of the valves had proper lift setting verified by bench test. One of the valves, 1B charging pump discharge relief valve, V2325, was tested and found to have its lift setting approximately 9 percent high. The licensee initiated CR 96-1469 to identify the root cause of the high setpoint on this valve. The valve was subsequently disassembled in accordance with Work Order 96015293 and no abnormalities were identified. Following adjustment of the setpoint, the valve was reinstalled in the system. The conclusion for the high setpoint was stated in the CR to be "unauthorized setpoint adjustment by personnel outside of the scope of work controls." This was based on the fact that no hardware problems were found, cap and lever seals were missing, and the previous setpoint adjustment was witnessed by Quality Control (QC). The inspector reviewed the work order and the CR, and inspected the valve installed in the system. Numerous discussions were held with Maintenance personnel on the process of adjusting the setpoint. Conversations with knowledgeable licensee personnel indicated that, on occasion in the past, the V2325 valve had been observed to "weep" or slightly leak past its seat.

Based on independent review of the documentation and the fact that the valve spring tension was not adjusted to its highest setting, the inspectors concluded that tampering, although it could not be conclusively ruled out, was not likely to have occurred in this specific case either. The more likely cause for the misadjusted valve was due to unauthorized maintenance performed to stop the valve from weeping.

CR 96-1469 documents the plant evaluation performed on valve V2325 once the valve was determined to be about 9% greater than its design setting on June 14, 1996. The analysis concluded that setpoint drift was an unlikely cause for the increased setpoint and that a potential and most likely cause was "unauthorized setpoint adjustment by personnel outside the scope of work controls." The CR analysis also states that the plant's discipline policy and management's expectation for verbatim procedure compliance were recently articulated and should eliminate future concerns about unauthorized work.

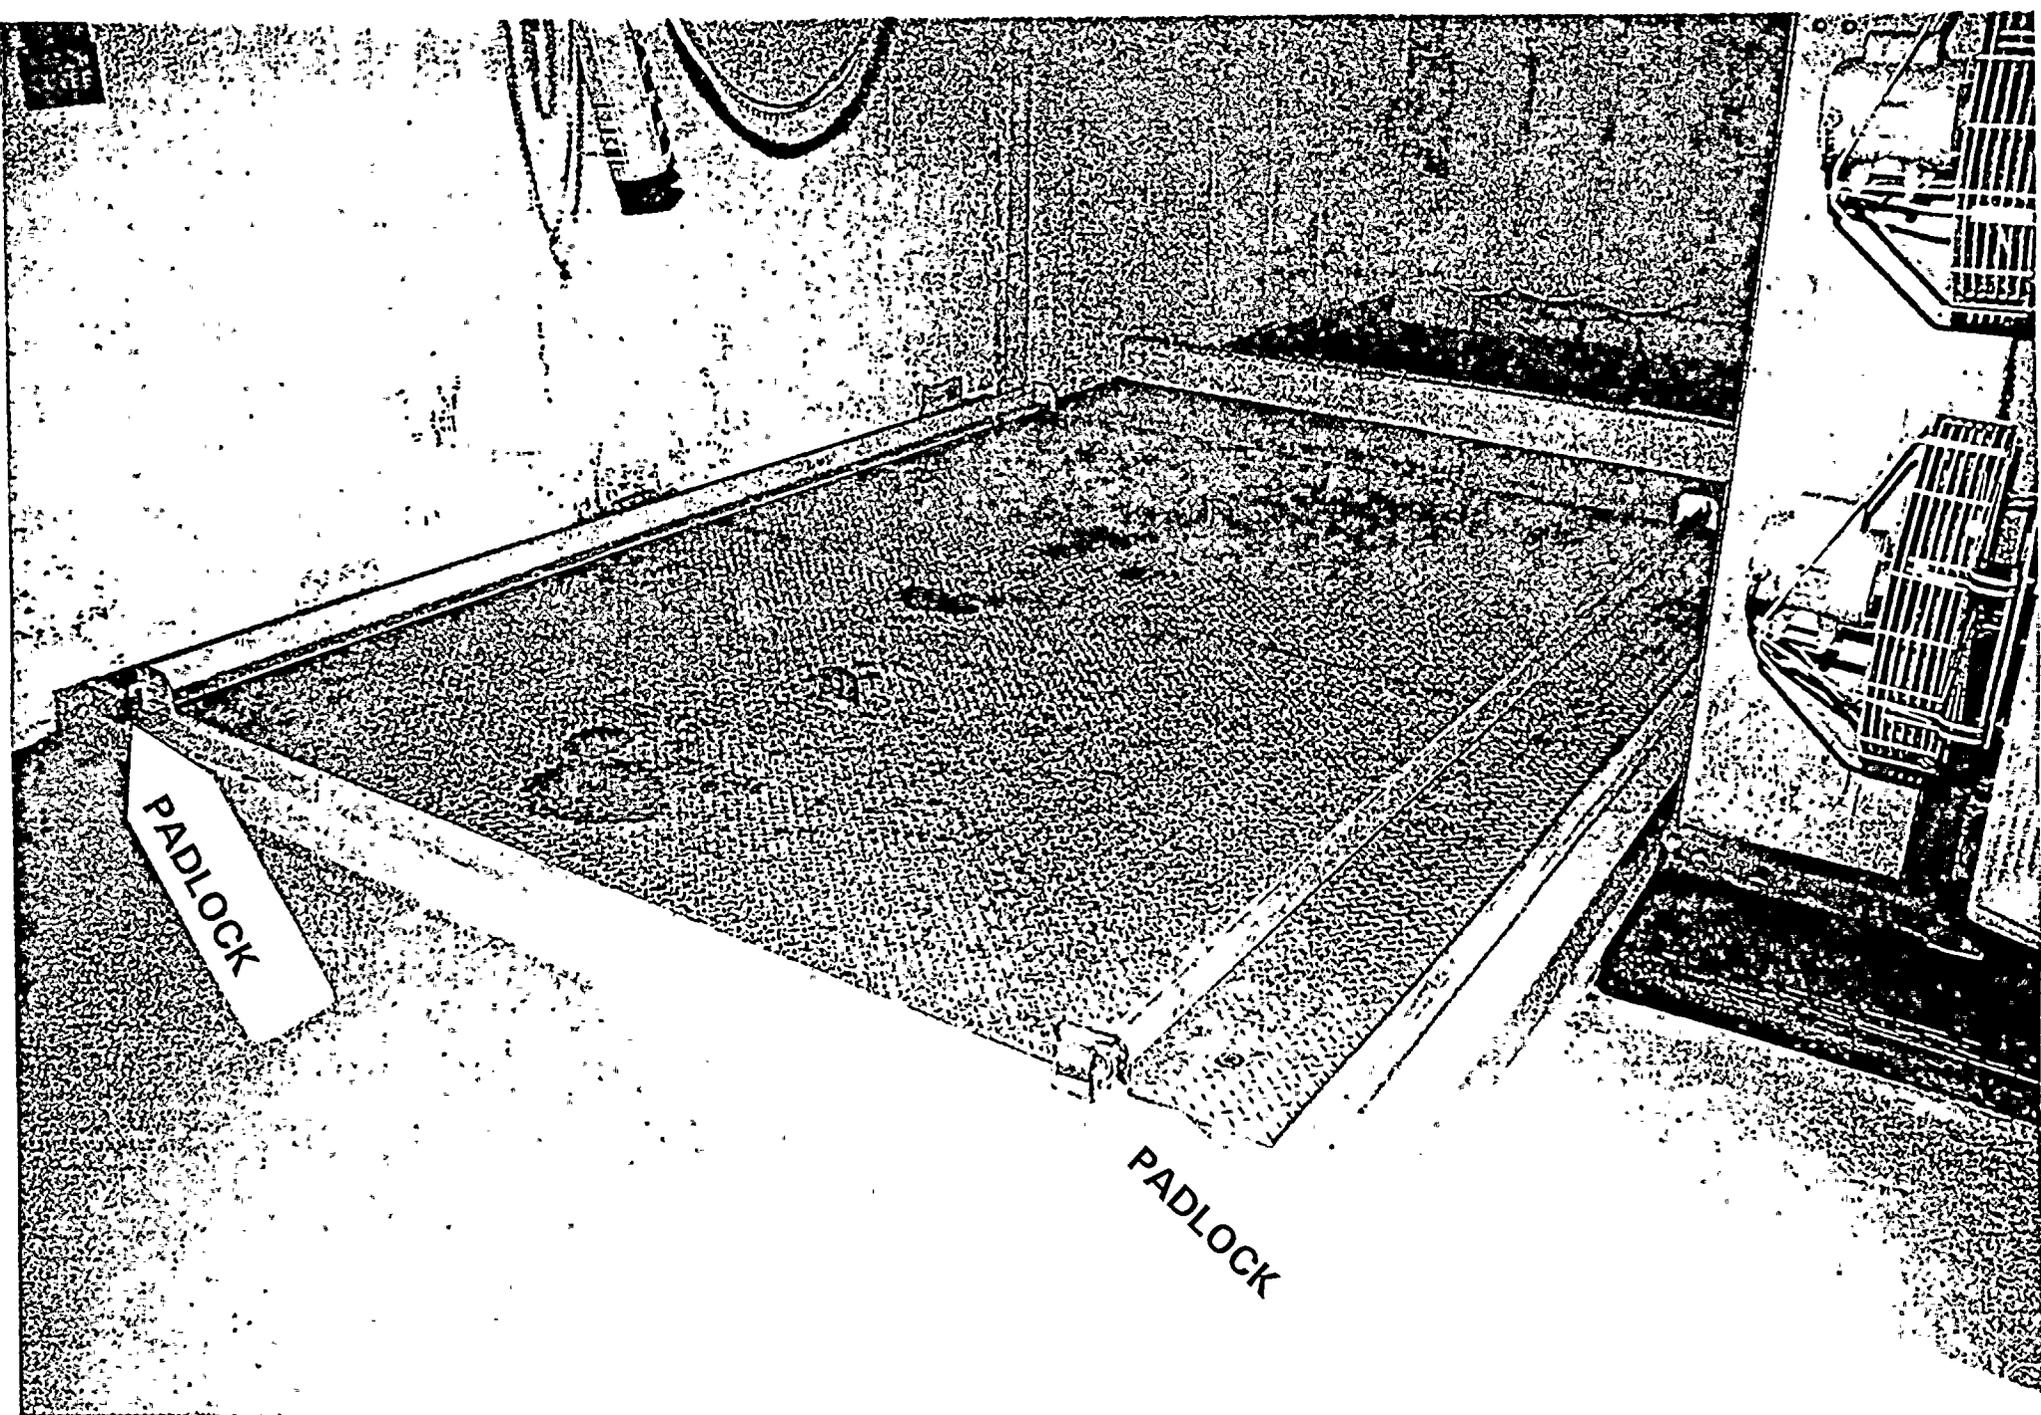
FIGURE 6

On July 26, 1996, at about 8:30 a.m., an entry door to the Unit 2 Control Element Drive Mechanism Control System (CEDMCS) room could not be opened due to some foreign material in the lock. Subsequent evaluation identified additional examples of padlocks and door locks damaged by the insertion of foreign material into the lock cores.

A total of nine padlocks and two door locks were found to be damaged by foreign material in the lock cores. The damaged locks were for the following areas and equipment:

The damaged locks were repaired and verified operational.

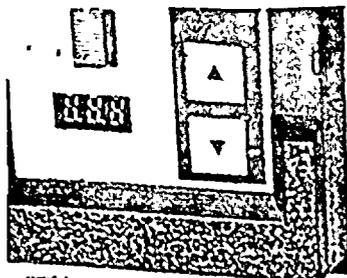
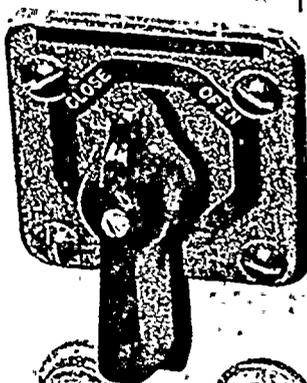
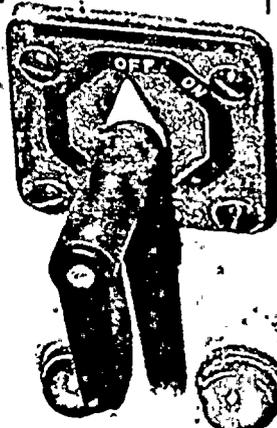
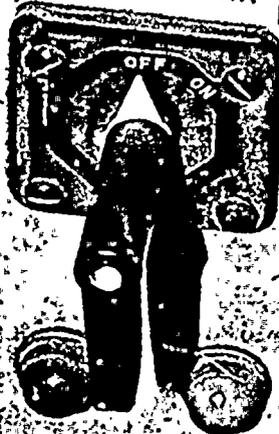
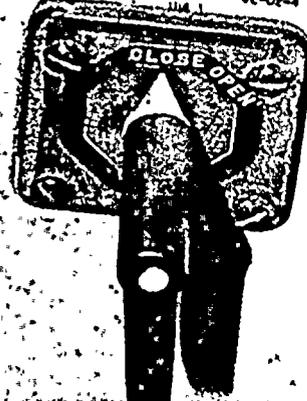
Upon identification of the damaged Unit 2 key lock switches, a check of the HSDP for Unit 1 was conducted. The Unit 1 HSDP contained only one key switch on the panel. Similar to Unit 2, that key lock switch could not be operated because of foreign material in the lock mechanism. The damaged key lock switch operated the pressurizer PORV which provides a backup means to control primary system pressure if auxiliary pressurizer spray becomes unavailable while bringing the unit to a controlled shutdown condition.

CR 96-1994 documented that PORV 1404 keylock control switch, CS 117, located on the Unit 1 Hot Shutdown Control Panel (HSDCP) and SIAS Bypass Switches channels "A" and "B," CS 246-3 and CS 248-3 respectively, were found to be inoperable due to foreign material in the lock core which prevented key insertion. An inspector observed the damaged switches while still installed on the HSDCP and noted that a foreign substance was not visible.

The inspectors reviewed Work Order 96020830 which documented the replacement of the inoperable Unit 1 PORV switch. Prior to installation the new switch was tested for continuity. During installation, the two wires attached to the old switch were lifted and relanded on the same terminal connections and independently verified to be correct. Following installation of the switch, an inspector verified the wires were landed on the appropriate terminals. An inspector reviewed Work Order 96020826 which documented the replacement of the inoperable Unit 2 "A" and "B" channel SIAS bypass switches. Following installation of the new switches, portions of I & C Procedure 2-1400052, Engineered Safeguards Actuation System - Channel Functional Test, Revision 23, were performed as a post maintenance test to verify operability. This test operated each switch and verified the appropriate response was obtained. An inspector witnessed the performance of this test and verified it was satisfactorily completed.
