SUBJECT: LER 96-012-00: on 960831, manual reactor trip caused by increased gas accumulation in 1B main transformer. Detailed insp of 1B main transformer cooling sys & affected oil cooler replaced, transformer 1B mods performed. W/960926 ltr.

Re: St. Lucie Unit 1
Docket No. 50-335
Reportable Event: 96-012
Date of Event: August 31, 1996
Manual Reactor Trip due to Increasing Gas
Accumulation Indicated on the 1B Main Transformer

TITLE (4)
Manual Reactor Trip due to Increasing Gas Accumulation Indicated on the 1B Main Transformer

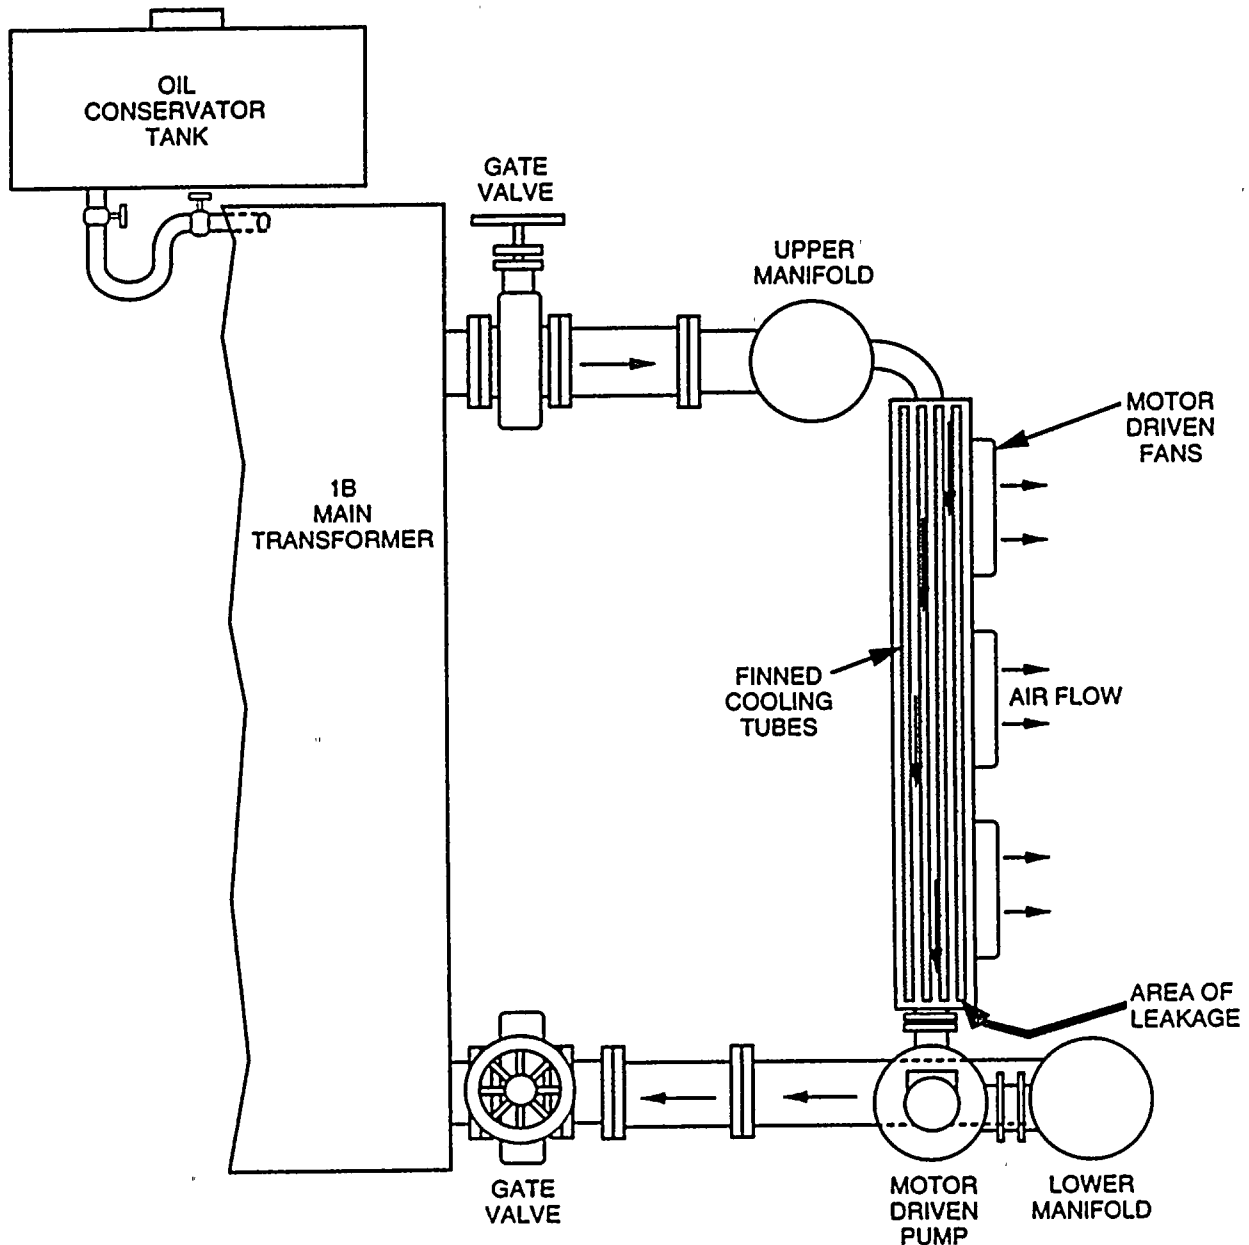
FIGURE 1
1B MAIN TRANSFORMER COOLING SYSTEM
(SIMPLIFIED)

The increase in gas for the 1B main transformer was determined to be caused by outside air leakage into the main transformer forced oil cooling system. Analysis of the transformer oil confirmed that, with the exception of air, no other abnormal gas levels were present in the system. An extensive inspection of the 1B main transformer cooling system determined that the most probable source of air in-leakage into the cooling system was through a leak found in the number three oil cooler. Inspections confirmed that a leak, which was located in the number three oil cooler tube sheet, corresponded to an area in the cooling system where a negative pressure existed during normal system operation.

St. Lucie Unit 1 has two main transformers connecting the main generator to the system grid. Each main transformer is equipped with a forced oil and air cooling system that consists of six finned cooling tube oil coolers connected to an upper and lower manifold (see figure 1). The system functions to remove heat from the main transformer windings during operation by circulating oil through the transformer and back to the oil coolers via six centrifugal pumps while fans force air through the cooler fins. The main transformers are not required for the safe shutdown of the plant.

4. FPL implemented a modification which raised the level of the oil conservator tanks on the 1B main transformer in order to increase the operating pressure within the system and reduce the potential for negative pressure areas during system operation.
