SUBJECT: LER 96-013-00: on 960918, operation prohibited by TS occurred due to failure to bypass inoperable ESF channel within required action time. Self assessment performed by operating crew. W/961017 ltr.

Re: St. Lucie Unit 1  
Docket No. 50-335  
Reportable Event: 96-013  
Date of Event: September 18, 1996  
Operation Prohibited by Technical Specifications due to Failure to Bypass  
Inoperable Engineered Safety Feature Channel within the Required Action Time

Operation Prohibited by Technical Specifications due to Failure to Bypass an Inoperable Engineered Safety Feature Channel within the Required Action Time

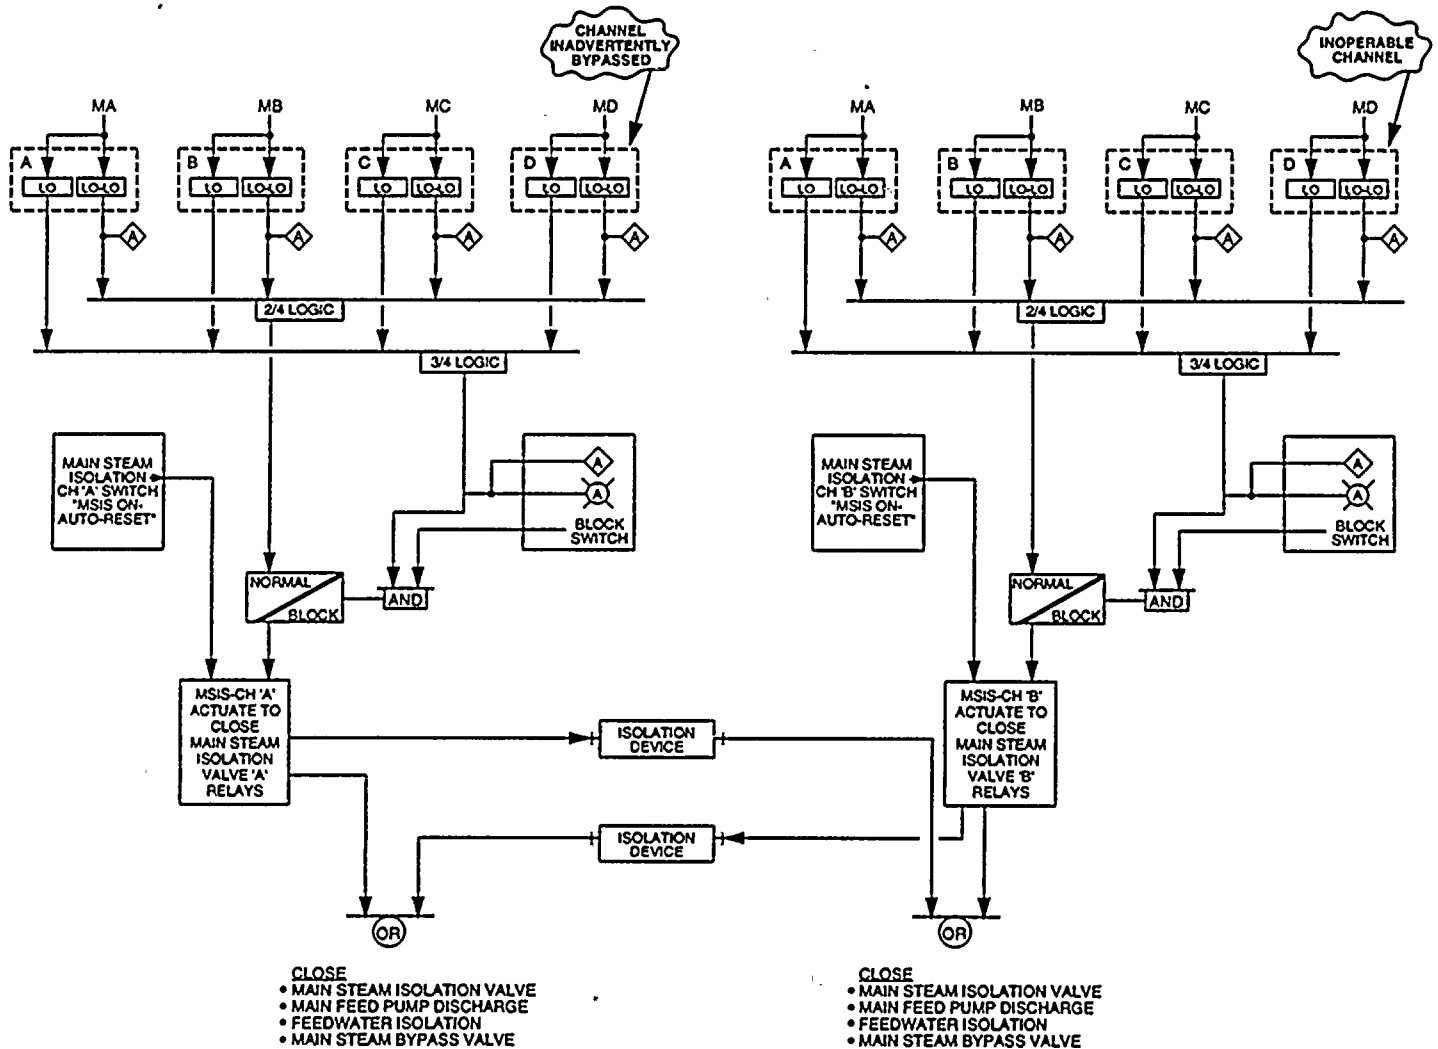
FIGURE 1  
SIMPLIFIED MSIS LOGIC DIAGRAM

For MSIS, there are four independent channels of SG pressure for each steam generator. During this event, operators failed to bypass an inoperable channel of 1B SG pressure for channel D MSIS within the one hour required by St. Lucie Unit 1 TS 3.3.2.1, Action 9.a. The channel was placed in bypass approximately eleven hours later upon discovery of the condition. The 1A SG pressure for MSIS on channel D of ESFAS was incorrectly bypassed during this period. Both of these pressure measurement inputs affect only the D channel of the ESFAS. The resulting configuration (refer to Figure 1 Logic Diagram) was such that the MSIS feature of ESFAS remained in a two-out-of-three logic condition for both the 1A and 1B SG MSIS, which is bounded by the assumptions described in the St. Lucie UFSAR Section 7.3.1.
