SUBJECT: LER 96-015-00: on 961029, operation prohibited by Tech Specs occurred. Caused by inadequate procedure for isolating DC grounds. DC power restored, failed relay replaced & testing performed to determine root cause. W/961127 ltr.

Re: St. Lucie Unit 1
Docket No. 50-335
Reportable Event: 96-015
Date of Event: October 29, 1996
Operation Prohibited by Technical Specifications
Due to Loss of Undervoltage Protection on Safety Related Electrical Bus

TITLE (4)
Operation Prohibited by Technical Specifications due to Loss of Undervoltage Protection on Safety Related Electrical Bus

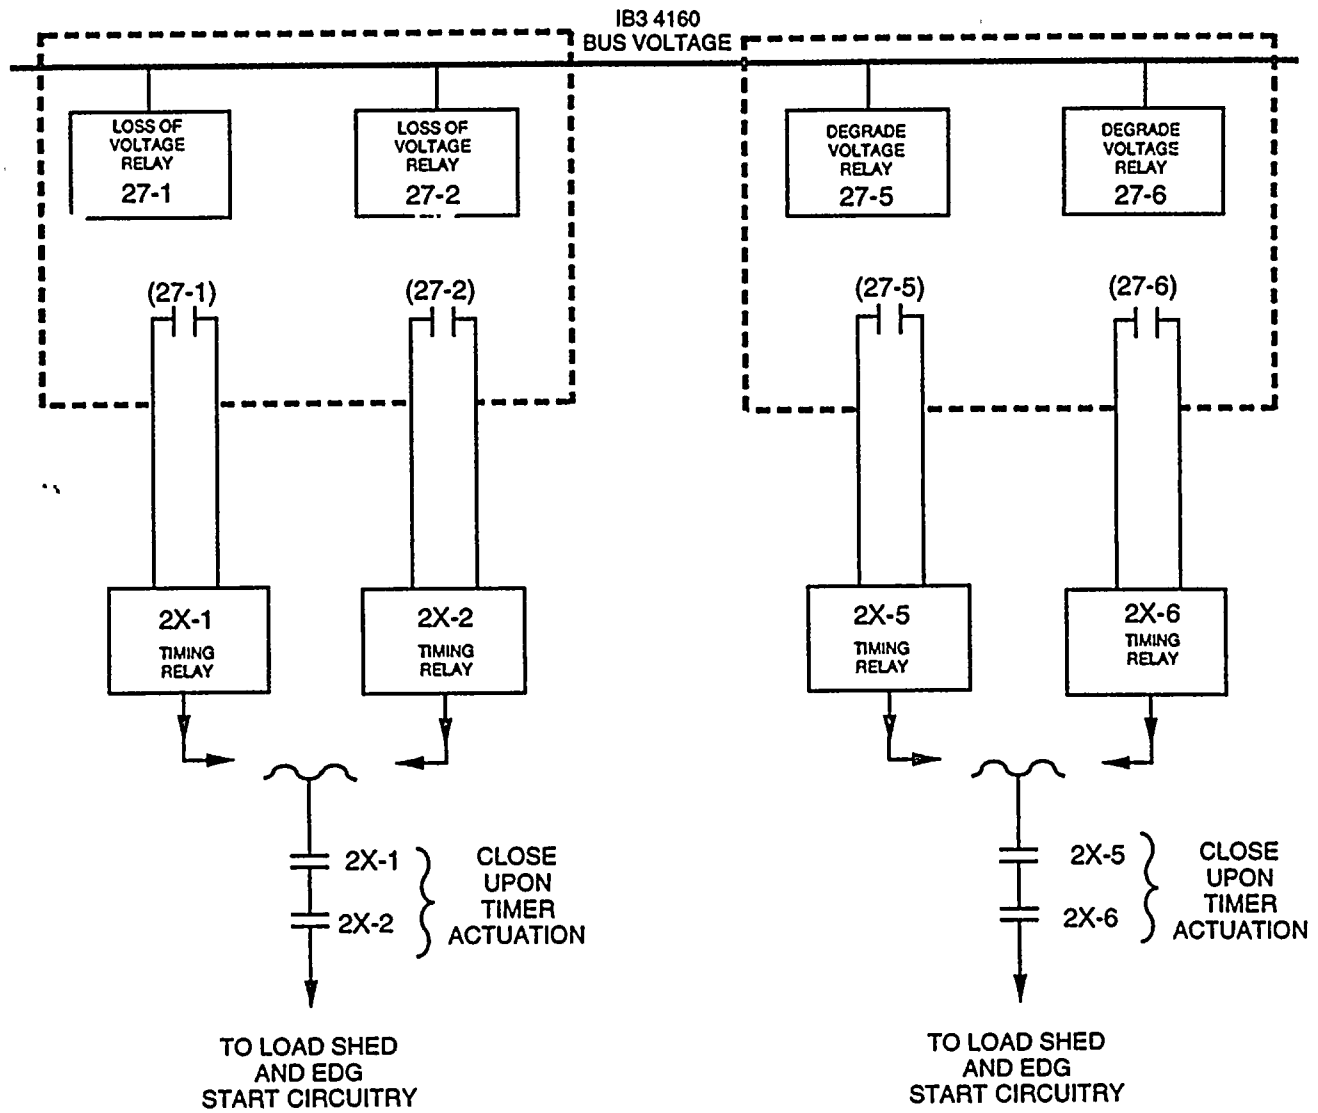
FIGURE 1
1B3 4160 BUS
UNDER VOLTAGE PROTECTION-SIMPLIFIED

- b) For second level protection, each emergency 4160V bus utilizes two sets of 2 undervoltage relays in a 2-out-of-2 coincident logic for degraded grid voltage detection (relays 27-5 and 27-6). The relays are set to actuate at no less than 3831 volts with a time delay of approximately 18 seconds. The function of these relays is the same as described in (a), above. Figure 1 shows a simplified drawing of the UV arrangement for the 1B3 4160V bus.
