SUBJECT: LER 96-016-00:on 961122,insufficient testing & maint were noted on 125 vdc bus cross-tie breakers.Caused by lack of effective maint & testing.All four 125 vdc cross-tie breakers will be refurbished.W/961220 ltr.

Re: St. Lucie Unit 1  
Docket No. 50-335  
Reportable Event: 96-016  
Date of Event: November 22, 1996  
Insufficient Testing and Maintenance on 125 VDC Cross-tie Breakers

**TITLE (4)**  
Insufficient Testing and Maintenance on 125 VDC Bus Cross-tie Breakers

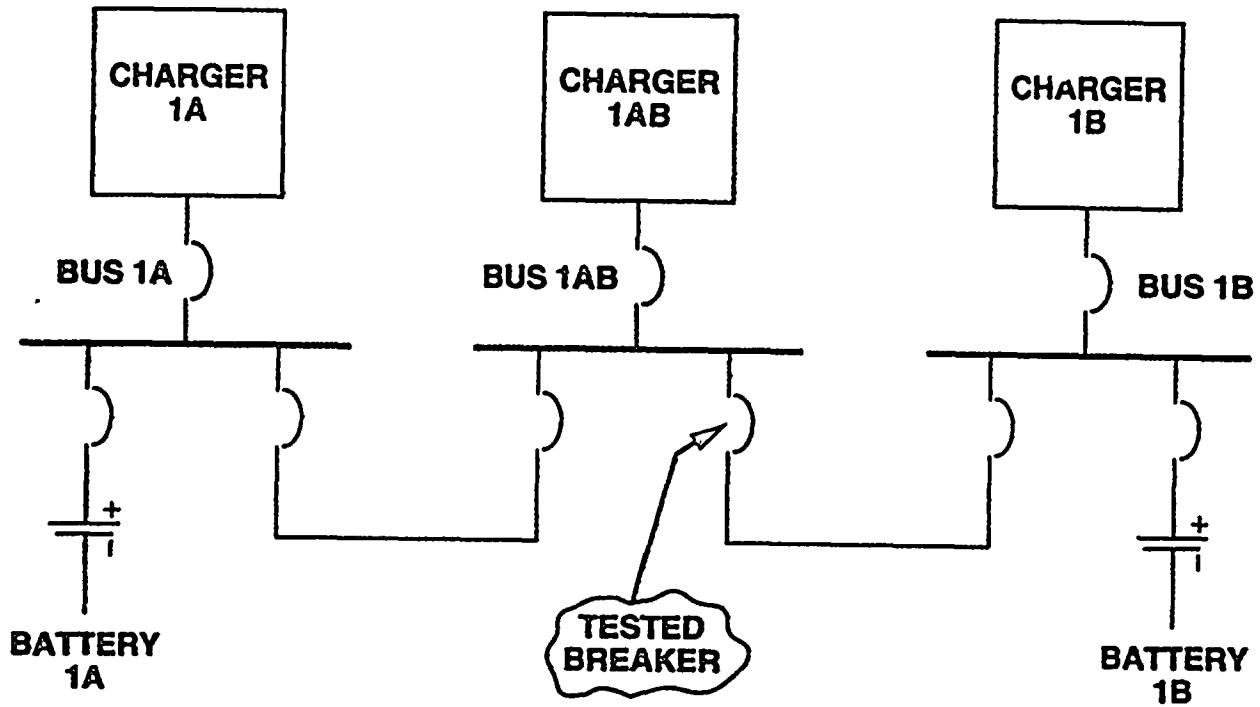
FIGURE 1

The AFW system consists of three trains. The "A" and "B" train consist of independent and redundant flow paths and 100% ac motor driven pumps. Electrical power is supplied from the respective "A" and "B" safety trains. The "C" AFW train utilizes redundant flow paths and a greater capacity steam turbine driven turbine pump. Control power for the turbine throttle valve and associated motor operated valves is supplied from the 1AB 125 vdc swing bus which can be powered from either the safety related 1A or 1B 125 vdc busses. Transfer of the 1AB bus is accomplished manually via switches in the control room when the swing bus is aligned to the bus that experienced the single failure.

DC POWER SUPPLIES
