SUBJECT: LER 96-006-00: on 961211, operation prohibited by TS identified due to inadequate surveillance of auxiliary feedwater components. Caused by inadequate procedures. Procedures revised & addl testing performed. W/970107 ltr.

Re: St. Lucie Unit 2
Docket No. 50-389
Reportable Event: 96-006
Date of Event: December 11, 1996
Operation Prohibited by Technical Specifications due to
Inadequate Surveillance of Auxiliary Feedwater Components

LICENSEE EVENT REPORT (LER)

Operation Prohibited by Technical Specifications due to Inadequate Surveillance of Auxiliary Feedwater Components

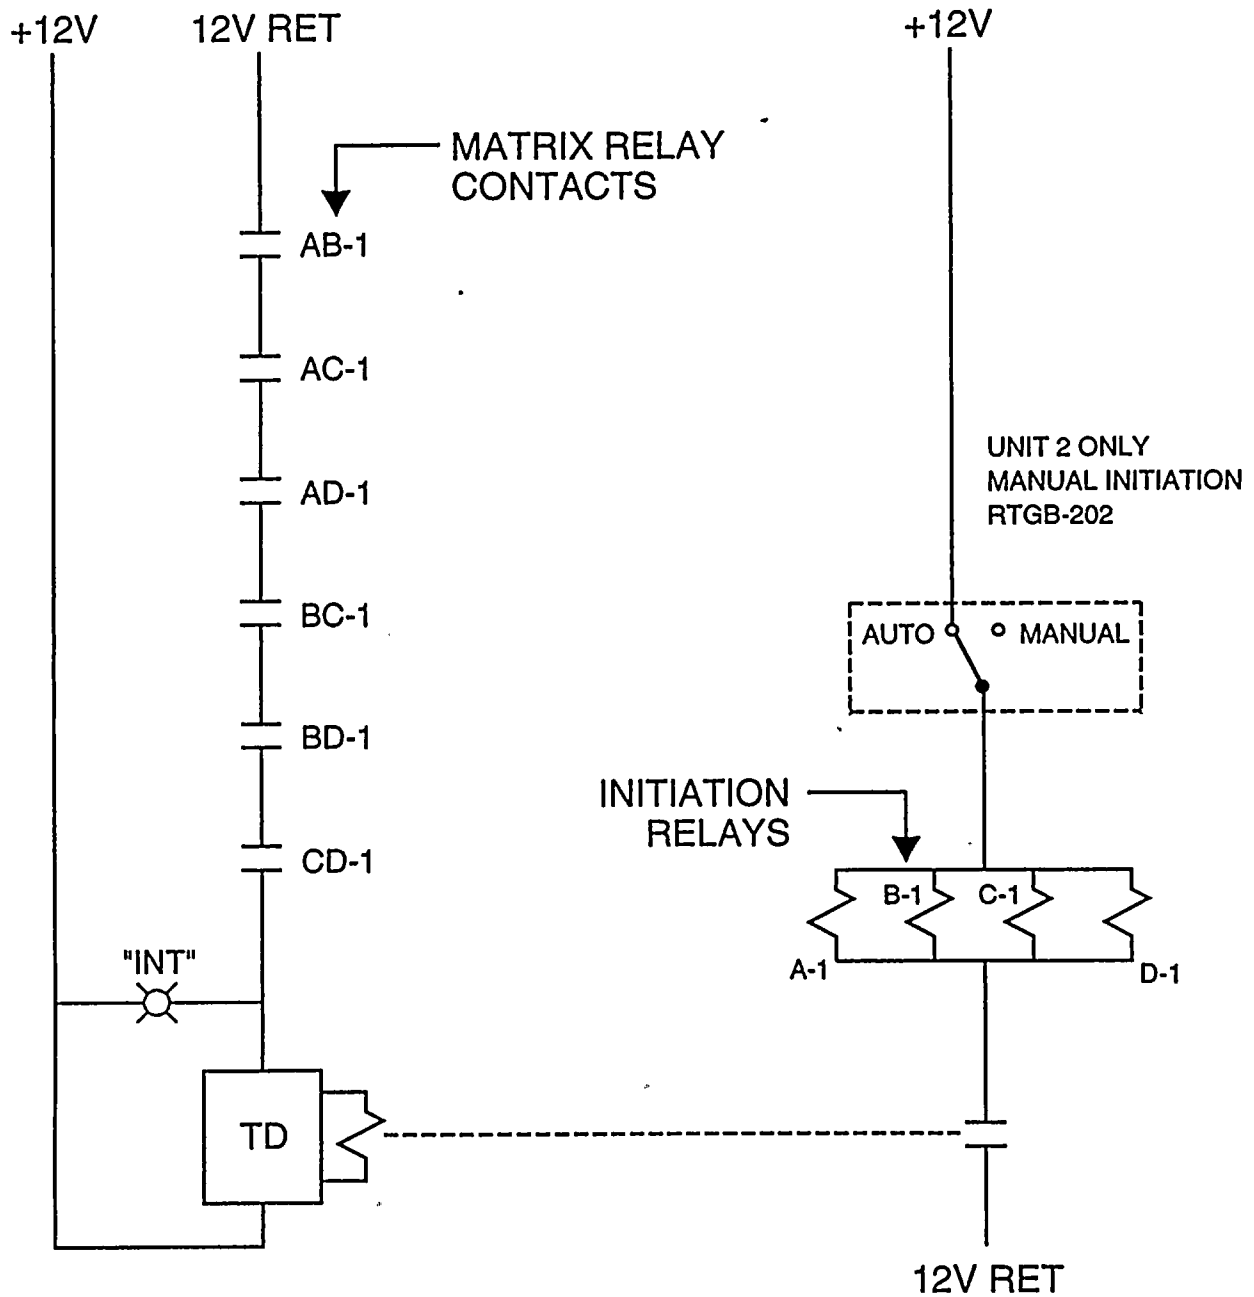
FIGURE 1
AFAS INITIATION CIRCUIT
(TYPICAL)

There are four AFAS manual initiation switches (channels) for each steam generator located on the main control board. The manual initiation switches are designed such that an individual contact from each switch is used in the AFAS actuation logic at the initiation relay stage. Placing a switch in the manual position will deenergize the four initiation relays in the channel associated with that switch (refer to Figure 1). The potential failure of an AFAS manual initiation switch to operate properly does not prevent the ability to manually initiate auxiliary feedwater, in that the inoperability of any one channel will result in a selective two out of three logic remaining for manual actuation. In addition, separate manual actuation switches are located on the front face of the AFAS cabinets in the control room. Contacts from these switches directly interrupt power to relays to actuate auxiliary feedwater and these switches are available as a backup to the manual initiation switches located on the control board (refer to Figure 2). At St. Lucie Unit 1, the Auxiliary Feedwater System uses manual actuation switches located on the AFAS cabinets and manual initiation is not available from the control board. The testing methodology differs for the Unit 1 system and therefore this condition is not applicable for Unit 1.
