SUBJECT: LER 97-005-00: on 970419, reactor was shutdown due to reactor coolant pressure boundary leakage. Repairs to RCPB was completed & 1a SDC train was restored to svc. W/970513 ltr.

Re: St. Lucie Unit 1
Docket No. 50-335
Reportable Event: 97-005
Date of Event: April 19, 1997
Reactor Shutdown Required by Technical Specifications
Due to Reactor Coolant Pressure Boundary Leakage

TITLE (4)
Reactor Shutdown Required by Technical Specifications due to Reactor Coolant Pressure Boundary Leakage

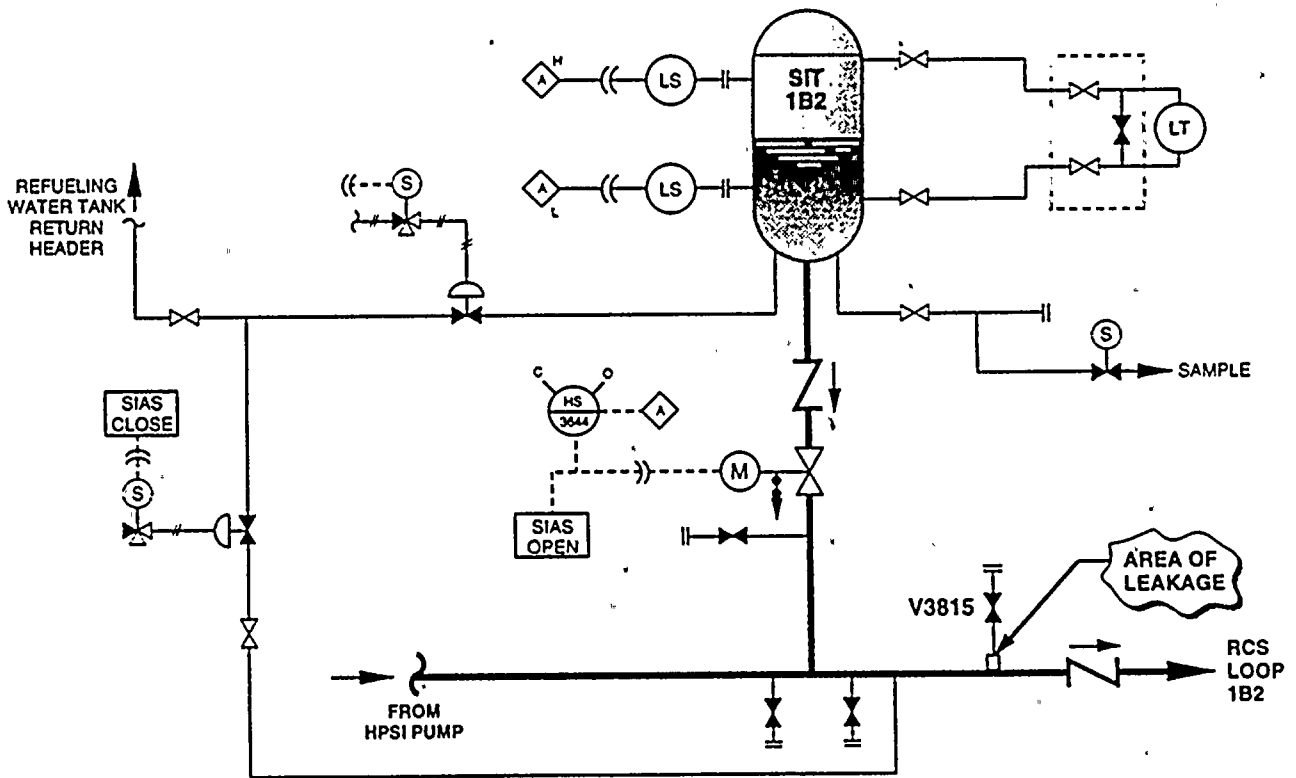
FIGURE 1

During this event, a small amount of inventory from the 1B2 SIT was observed leaking from a weld associated with a one inch vent, V-3815, located on the 1B2 safety injection pipe, upstream of the 1B2 safety injection loop check valve. Per the above definition, this vent is a part of the reactor coolant pressure boundary since it is located on a system connected to the RCS and is within the outermost containment isolation valve in system piping penetrating the primary reactor containment. Additionally, V-3815 is located in the Quality Group A portion of the safety injection system. This Quality Group is described by the St. Lucie Unit 1 Updated Final Safety Analysis Report (UFSAR), Section 3.2, as specifically applying to reactor coolant pressure boundary components.
