SUBJECT: LER 97-006-00: on 970501, operation was prohibited by TS due to inadequately tested degraded voltage sys. Revised Unit 1. ESFAS surveillance test procedure. W/970607 ltr.

Re: St. Lucie Units 1 and 2  
Docket No. 50-335  
Reportable Event: 97-006  
Date of Event: May 1, 1997  
Operation Prohibited by Technical Specifications  
Due to Inadequately Tested Degraded Voltage System

Operation Prohibited by Technical Specifications Due to Inadequately Tested Degraded Voltage System

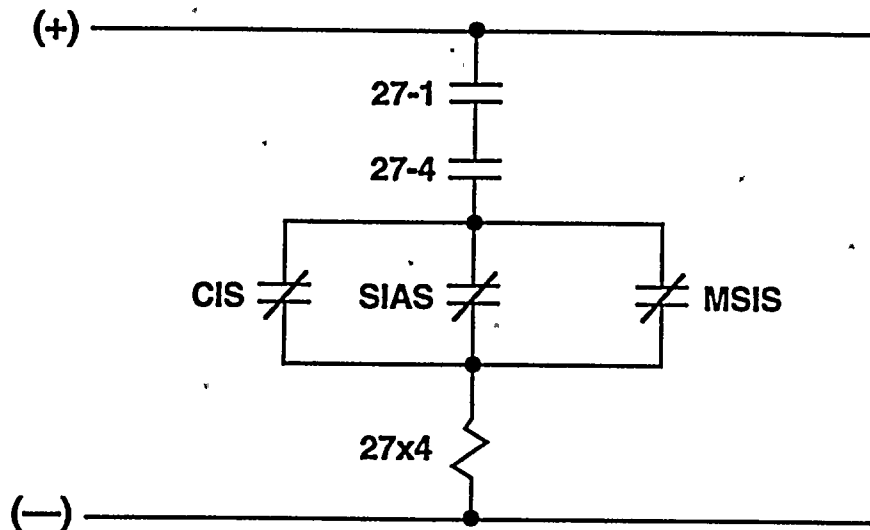
Figure 1  
Unit 1 Degraded Voltage Protection Scheme

The degraded voltage system for St. Lucie Unit 1 consists of 2 undervoltage relays (27-1 and 27-4), connected in a 2 out of 2 logic, with permissives for SIAS, Containment Isolation Actuation Signal (CIAS), and Main Steam Isolation Signal (MSIS). When both relays detect a degraded voltage condition with a coincident or subsequent SIAS, CIAS or MSIS, relay 27X4 is actuated, which initiates load shed and EDG starting. See Figure 1 for a simplified drawing:

Procedure 1-0970027 calibrates and tests the undervoltage relays. Both the degraded voltage relays are actuated together but the SIAS, CIAS, or MSIS permissive contacts are jumpered out and therefore not included in the testing. The Unit 1 ESFAS procedure 1-0400050 does not test the degraded voltage ESFAS permissives; during Loss Of Offsite Power (LOOP) and LOOP/ESFAS testing, a loss of voltage is initiated by opening the startup transformer circuit breakers, producing an immediate and total loss of voltage which is detected by other undervoltage relays.

1. Testing of the Unit 1 A train degraded voltage protective system ESFAS functions was successfully demonstrated on May 1, 1997.
2. The Unit 2 ESFAS Test Procedure (2-0400050) was revised to incorporate testing of the SIAS interlock with degraded voltage protection. Testing of the degraded voltage protection SIAS interlock for both Unit 2 trains was completed on May 9, 1997.
3. The Unit 1 ESFAS Test Procedure (1-0400050) will be revised to incorporate testing of the SIAS degraded voltage protection permissive contacts.

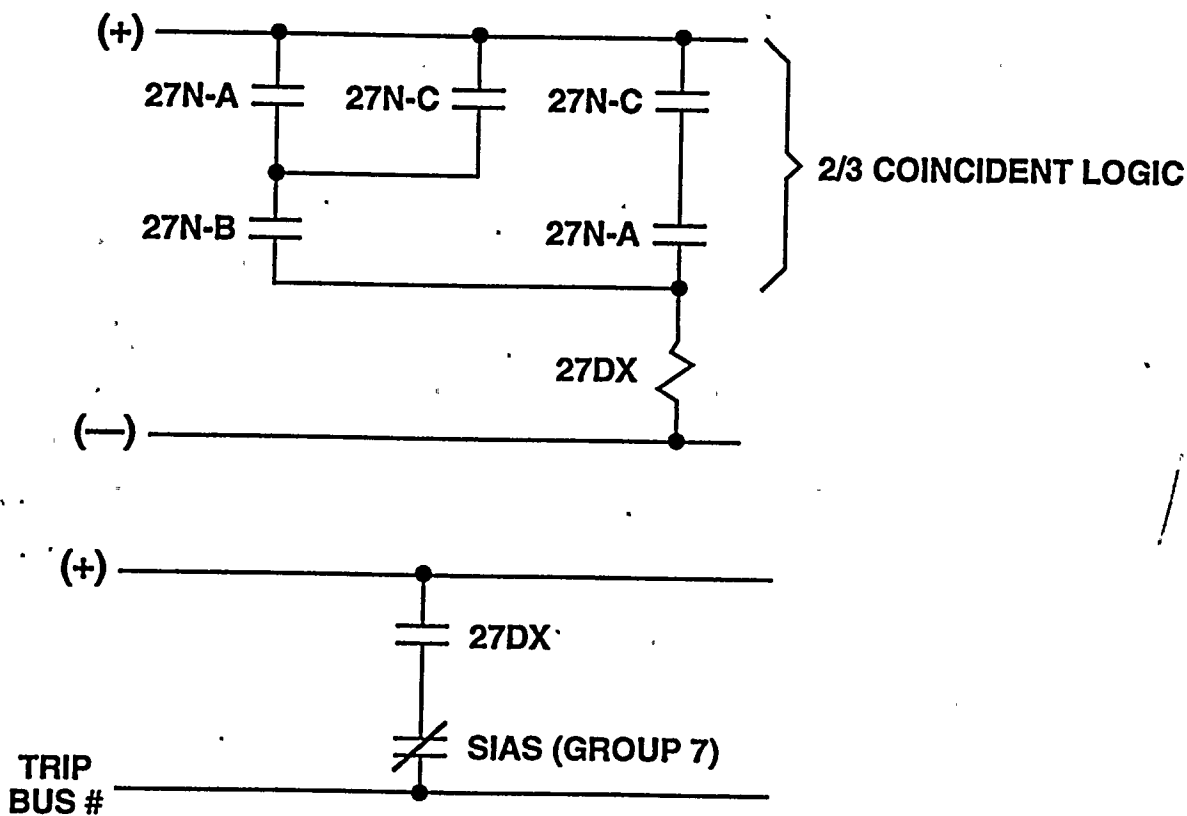
Figure 2  
Unit 2 Degraded Voltage Protection Scheme

The 4160V bus degraded voltage system for St. Lucie Unit 2 consists of 3 undervoltage relays (27N-A, 27N-B, and 27N-C), connected in a 2 out of 3 logic, with a SIAS permissive contact. When 2 of the 3 relays detect a degraded voltage condition and time out, without a coincident SIAS, an annunciator alarms in the control room to alert the operators to the degraded voltage condition. A subsequent SIAS will initiate an immediate load shed, EDG start, and load sequencing. See Figure 2 for a simplified drawing.

Procedure 2-0920020 calibrates and tests the undervoltage relays. This includes using the trip test pushbuttons for two relays at a time and observing a test light to indicate energization of the load shed bus, isolated during testing, to verify the logic. The SIAS contact is bypassed by a jumper and is not included in the testing. Procedure 2-0400053 tests the safeguards relays; however, the relays associated with the SIAS Group 7, which includes the degraded voltage permissive, are stated as being tested in accordance with OP 2-0400050, "Periodic Test of the Engineered Safety Features." Therefore, the interlock is not tested in this procedure. However, procedure 2-0400050, up to revision 22, did not test the degraded voltage interlock since during Loss Of Offsite Power (LOOP) and LOOP/ESFAS testing a loss of voltage is initiated by opening the startup transformer circuit breakers, producing an immediate and total loss of voltage which is detected by other undervoltage relays.
