SUBJECT: LER 97-006-00: on 970501, operation was prohibited by TS due to inadequately tested degraded voltage sys. Revised Unit 1. ESFAS surveillance test procedure. W/970607 ltr.

Re: St. Lucie Units 1 and 2  
Docket No. 50-335  
Reportable Event: 97-006  
Date of Event: May 1, 1997  
Operation Prohibited by Technical Specifications  
Due to Inadequately Tested Degraded Voltage System

Operation Prohibited by Technical Specifications Due to Inadequately Tested Degraded Voltage System

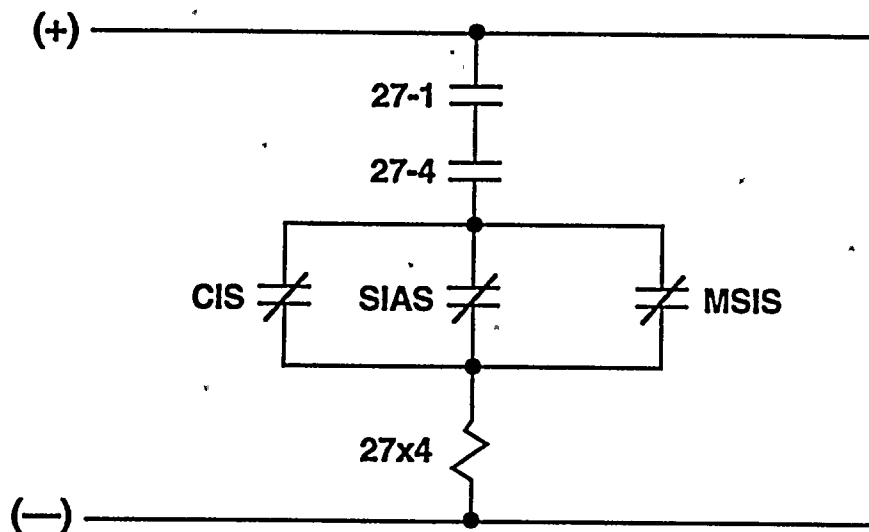
Figure 1  
Unit 1 Degraded Voltage Protection Scheme

The degraded voltage system for St. Lucie Unit 1 consists of 2 undervoltage relays (27-1 and 27-4), connected in a 2 out of 2 logic, with permissives for SIAS, Containment Isolation Actuation Signal (CIAS), and Main Steam Isolation Signal (MSIS). When both relays detect a degraded voltage condition with a coincident or subsequent SIAS, CIAS or MSIS, relay 27X4 is actuated, which initiates load shed and EDG starting. See Figure 1 for a simplified drawing:

Procedure 1-0970027 calibrates and tests the undervoltage relays. Both the degraded voltage relays are actuated together but the SIAS, CIAS, or MSIS permissive contacts are jumpered out and therefore not included in the testing. The Unit 1 ESFAS procedure 1-0400050 does not test the degraded voltage ESFAS permissives; during Loss Of Offsite Power (LOOP) and LOOP/ESFAS testing, a loss of voltage is initiated by opening the startup transformer circuit breakers, producing an immediate and total loss of voltage which is detected by other undervoltage relays.

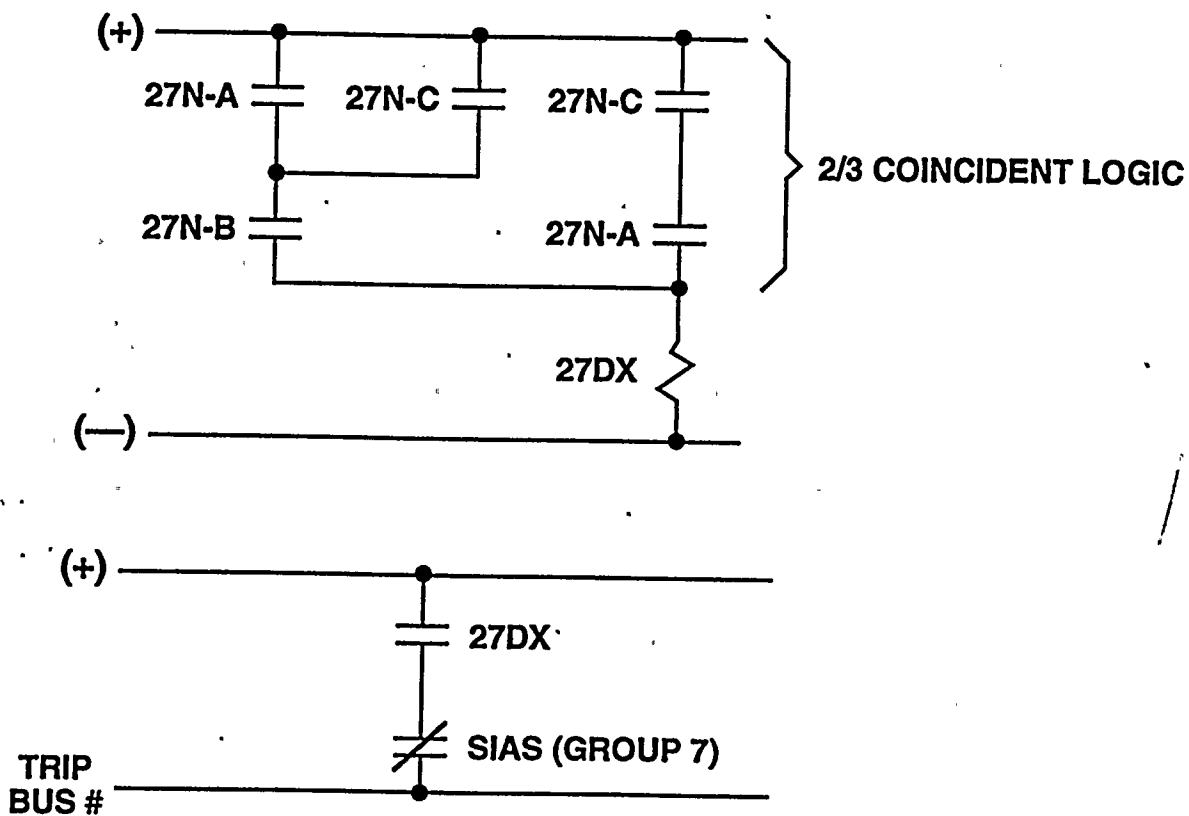
Figure 2  
Unit 2 Degraded Voltage Protection Scheme

The 4160V bus degraded voltage system for St. Lucie Unit 2 consists of 3 undervoltage relays (27N-A, 27N-B, and 27N-C), connected in a 2 out of 3 logic, with a SIAS permissive contact. When 2 of the 3 relays detect a degraded voltage condition and time out, without a coincident SIAS, an annunciator alarms in the control room to alert the operators to the degraded voltage condition. A subsequent SIAS will initiate an immediate load shed, EDG start, and load sequencing. See Figure 2 for a simplified drawing.

Procedure 2-0920020 calibrates and tests the undervoltage relays. This includes using the trip test pushbuttons for two relays at a time and observing a test light to indicate energization of the load shed bus, isolated during testing, to verify the logic. The SIAS contact is bypassed by a jumper and is not included in the testing. Procedure 2-0400053 tests the safeguards relays; however, the relays associated with the SIAS Group 7, which includes the degraded voltage permissive, are stated as being tested in accordance with OP 2-0400050, "Periodic Test of the Engineered Safety Features." Therefore, the interlock is not tested in this procedure. However, procedure 2-0400050, up to revision 22, did not test the degraded voltage interlock since during Loss Of Offsite Power (LOOP) and LOOP/ESFAS testing a loss of voltage is initiated by opening the startup transformer circuit breakers, producing an immediate and total loss of voltage which is detected by other undervoltage relays.
