SUBJECT: LER 97-004-00: on 970611, discovered incorrect original cable tray fire stop assembly installation outside App R design basis. Caused personnel error. Posted hourly fire watch patrols. W/970711 ltr.

Re: St. Lucie Unit 2
Docket No. 50-389
Reportable Event: 97-004
Date of Event: June 11, 1997
Incorrect Original Cable Tray Fire Stop
Assembly Outside Appendix R Design Bases

Incorrect Original Cable Tray Fire Stop Assembly Installation Outside Appendix R Design Bases

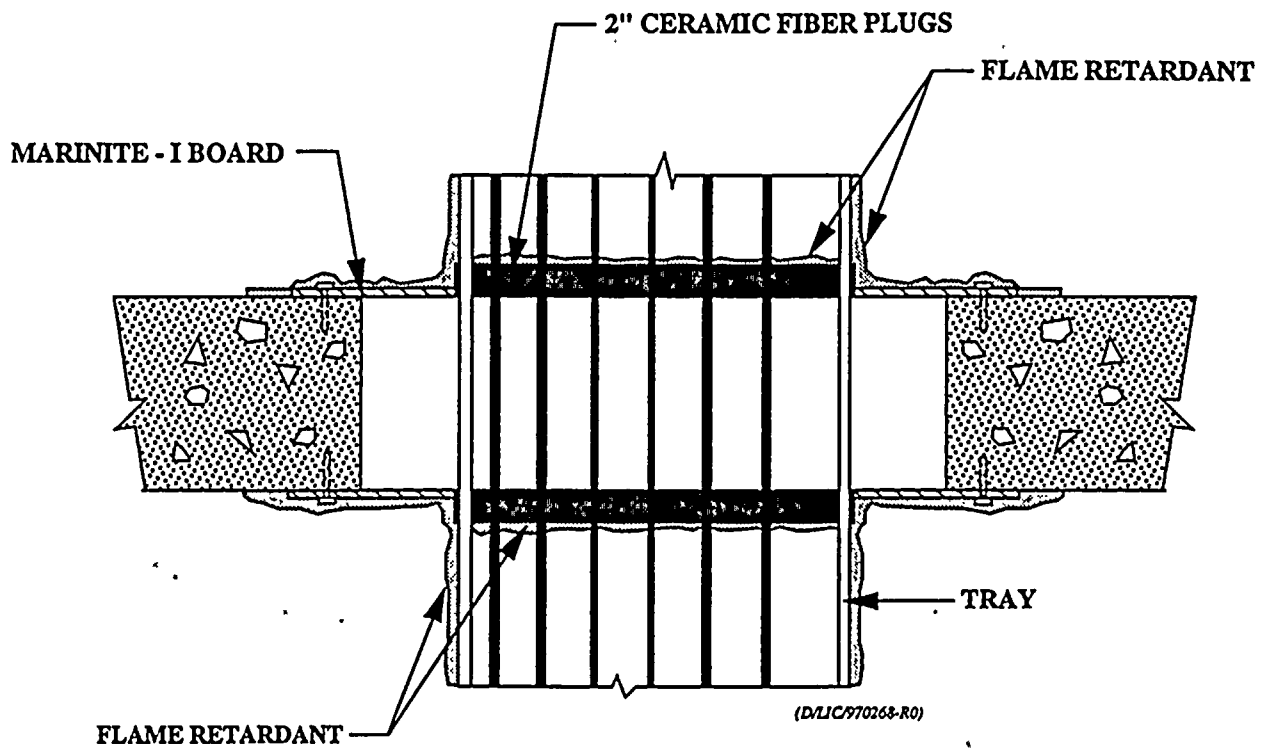
Figure 1
Typical Two Sided Cable Tray Fire Stop Assembly

On June 11, 1997, St. Lucie Unit 2 was in Mode 1 at 100 percent power. FPL was investigating discrepancies of two sided cable tray fire stop assemblies identified during previous field surveillances. Intrusive inspections of the remaining population of fire stop assemblies of this design were in progress to determine the extent of the issue. Preliminary inspection results indicated that, generically, the as-built configuration of two sided cable tray fire stop assemblies lacked the installation of ceramic fiber between cables within the fire barrier. The configuration did not conform to the design drawings and FPL ascertained that the identified field conditions were not previously evaluated during initial construction. Therefore, the two sided cable tray fire stop assemblies did not meet the tested configuration for a three hour fire rated assembly, as required by the plant 10 CFR 50 Appendix R commitments.

A review of the original installation and inspection documentation for the construction of the two sided cable tray fire stop assemblies suggests that the apparent cause of this event was due to personnel error during the implementation of design drawings or insufficient design guidance during initial installation. A contributing cause was that the installation drawings were not clear in specifying that ceramic fiber needed to be installed around each cable in the fire stop assembly.

The ceramic fiber between the cables is an extension of the Marinite board (ceramic fiber board) fire stop face. This ceramic fiber serves to resist heat, flame, and smoke propagation through the fire stop. In conjunction with the flame retardant this is an effective three hour fire rated assembly. (See Figure 1 for typical design details). However, without the ceramic fiber between the cables a path for heat and smoke propagation is provided. This is a small and tortuous path in that the space between the cables is typically small. The heat would still need to travel at least one foot down the tray where the flame retardant is applied, then would enter a large open space in the wall, and would then need to exit through another foot of confined space between cables on the non-fire side of the assembly. Localized hot spots would exist. The IEEE-383 cables will resist the effects of the increased temperatures and help to prevent the ignition of cable in the non-fire side of the assembly.

1. The hourly fire watch patrols were established to compensate for the inoperable two sided cable tray fire stop assemblies as required by plant administrative procedures.
2. FPL will either rework the associated fire stop assemblies to their original design or develop and implement a new design to restore the degraded barriers to a three hour fire barrier rating.
