SUBJECT: Requests approval of interim relief 17, main feed isolation valve bypass line repair for temporary non-code repair to install engineered mechanical clamp to encl steam leak.

RE: St. Lucie Unit 1  
Docket No. 50-335  
In-Service-Inspection Plan  
Third Ten-Year Interval  
Interim Relief Request 17

Relief Request No. 17  
Main Feed Bypass Line Repair

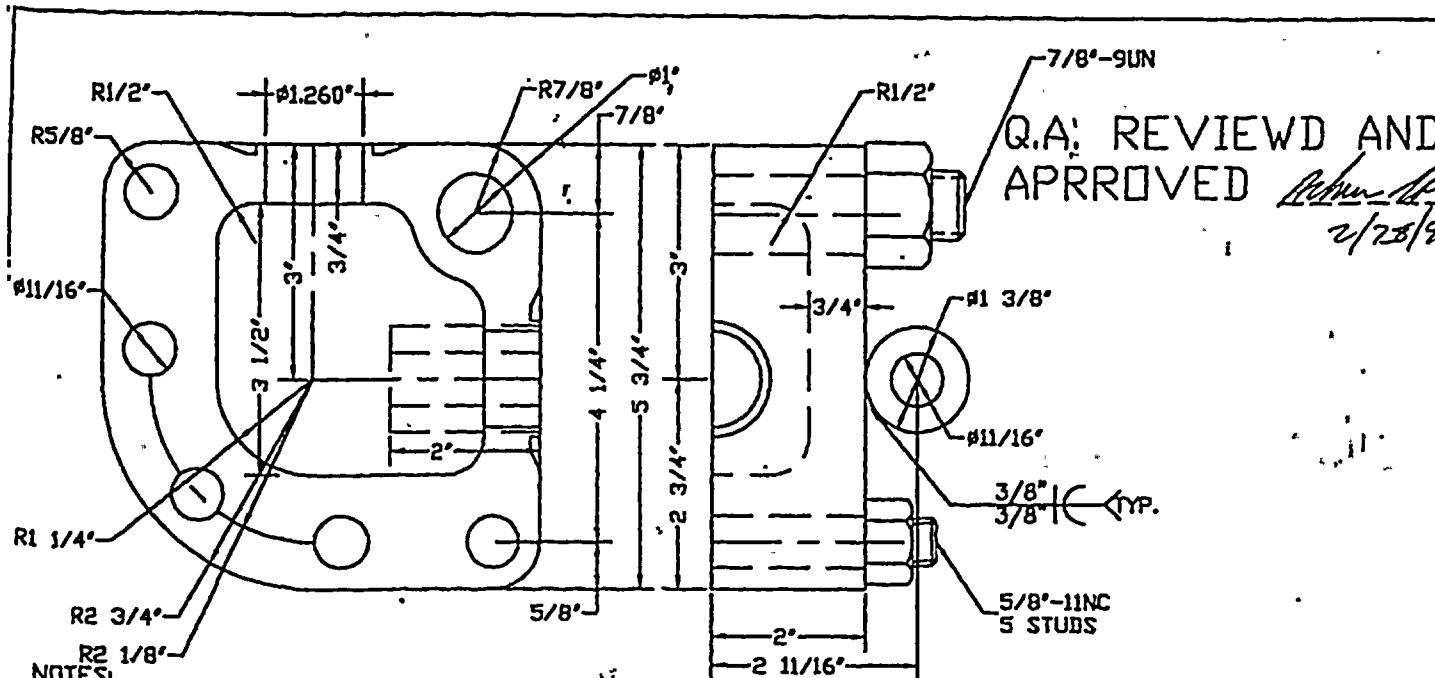
The leak repair enclosure and clamp is considered a non-code repair to stop the leakage to prevent further steam cutting of the MV-09-7 bypass line elbow weld. The leak is located in an oval pinhole in a socket weld near the fitting edge. In accordance with GL 90-05, the overall design of the leak repair enclosure will assume a postulated full circumferential severance of the socket weld at the defect location.

Figure 1 provides the design details for the temporary leak repair enclosure and clamp. The enclosure is designed for the conditions specified above. The enclosure completely envelopes the elbow fitting and weld and therefore the clamping device size will accommodate any projected growth of the flaw.

of SA 516 Gr. 70 carbon steel with SA-193 Gr B7 studs and SA-194 Gr. 2H nuts. A friction clamp provides a means of absorbing the axial load in the extremely remote possibility that the flaw propagates circumferentially around the weld joint. The enclosure design is based on stress limits in Table NC-3321-1 and meets Level A Service Limits of Section III using normal system operating conditions, and assuming postulated full circumferential severance of the pipe at the defect location. The enclosure is mechanically clamped to the pipe with a friction factor not exceeding 0.3 and designed to produce a friction load five times the slippage load.
