SUBJECT: Submits suppl 1 of Interim Relief Request 17 re in-svc-insp plan for third 10-Yr interval.

RE: St. Lucie Unit 1  
Docket No. 50-335  
In-Service-Inspection Plan  
Third Ten-Year Interval  
Supplement 1 of  
Interim Relief Request 17

Relief Request No. 17  
Main Feed Bypass Line Repair

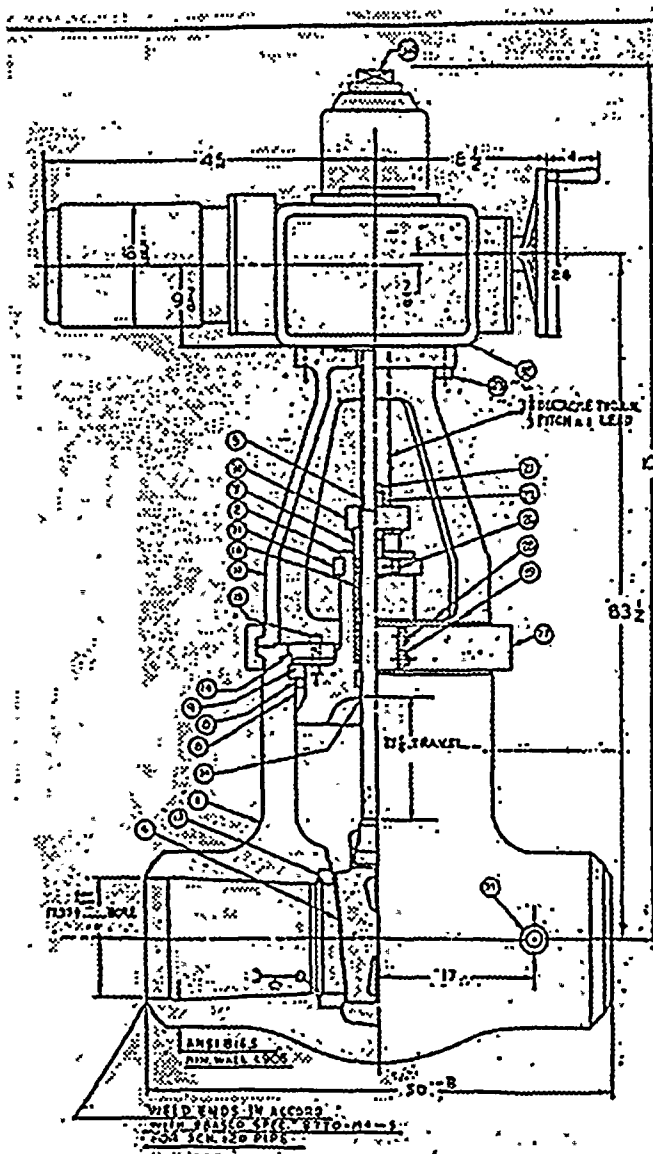
Figure 1

The leak repair enclosure and clamp is considered a non-code repair to stop the leakage to prevent further steam cutting of the MV-09-7 (Figure 1) bypass line elbow weld. The leak is located in an oval pinhole in a socket weld near the fitting edge. In accordance with GL 90-05, the overall design of the leak repair enclosure will assume a postulated full circumferential severance of the socket weld at the defect location.

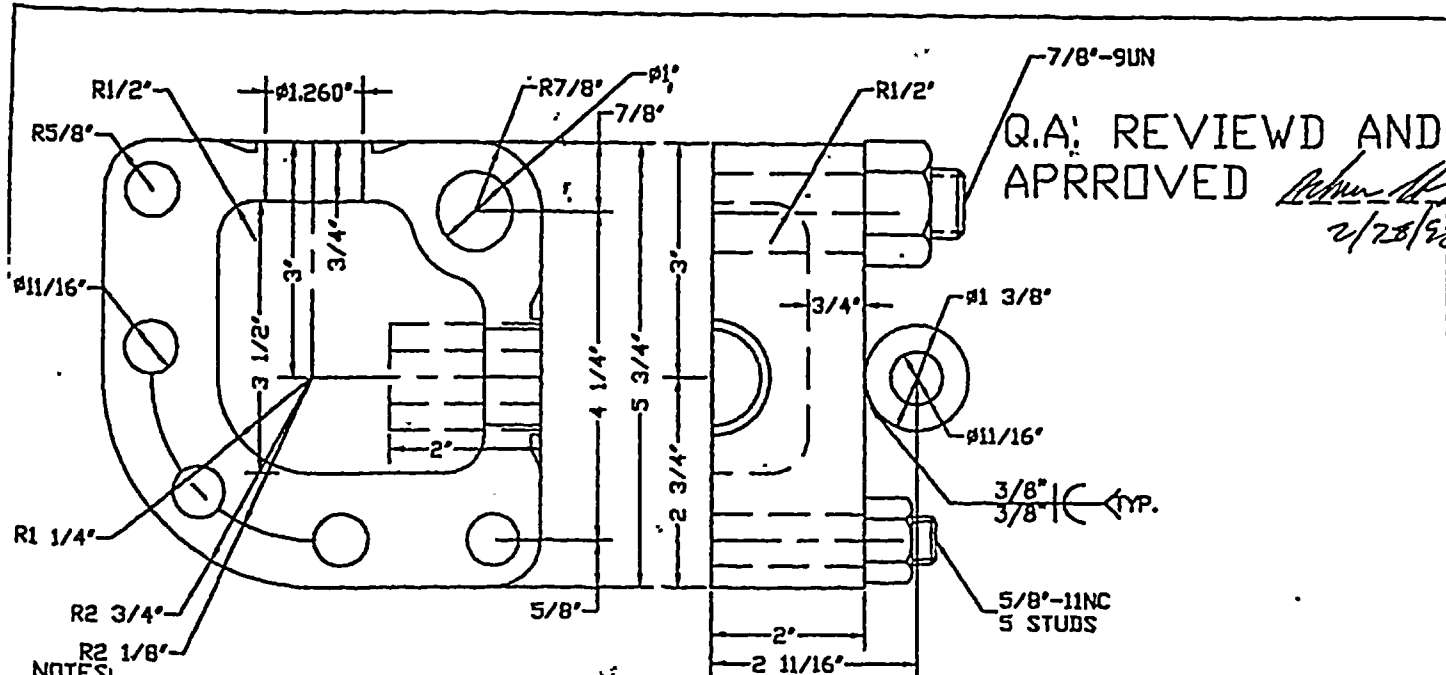
Figure 2 and Figure 3 provide the design details for the temporary leak repair enclosure and clamp. The enclosure is designed for the conditions specified above. The enclosure (Figure 2) completely envelopes the elbow fitting and weld and therefore the clamping device size will accommodate any projected growth of the flaw.

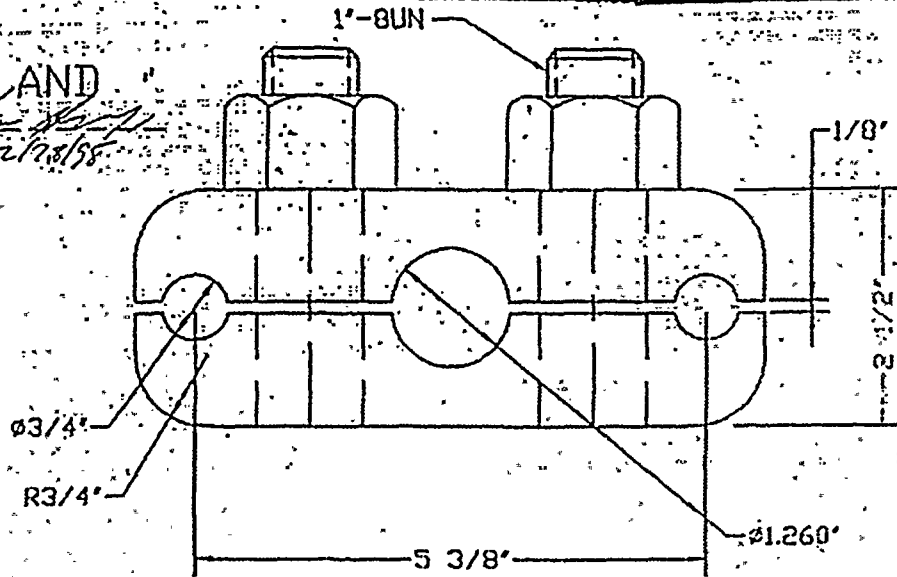
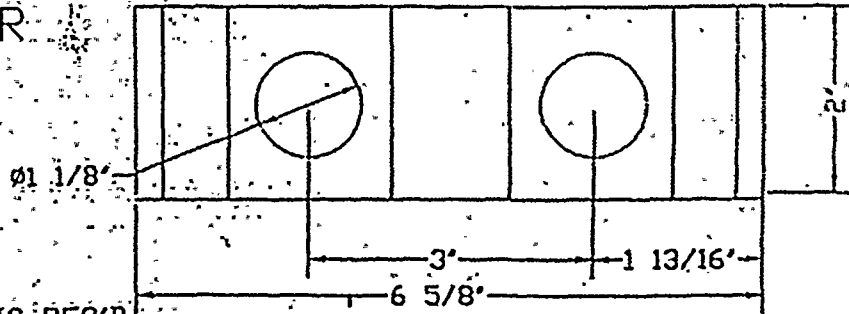
Figure 3

The materials of construction are acceptable for the application. The enclosure is made of SA 516 Gr. 70 carbon steel with SA-193 Gr B7 studs and SA-194 Gr. 2H nuts. A friction clamp (Figure 3) provides a means of absorbing the axial load in the extremely remote possibility that the flaw propagates circumferentially around the weld joint. The enclosure design is based on stress limits in Table NC-3321-1, and meets Level A Service Limits of Section III using normal system operating conditions, and assuming postulated full circumferential severance of the pipe at the defect location. The enclosure is mechanically clamped to the pipe with a friction factor not exceeding 0.3 and designed to produce a friction load five times the slippage load. Figure 4 and Figure 5 show plan and elevation views of the installed engineered clamp.

- ONE FRICTION CALMP IS REQ'D.
- (2) 5/8"-11NC X 12" LONG
- Torque clamping studs to 184 ft-lbs.
