RE: St. Lucie Unit 2  
Docket No. 50-389  
In-Service-Inspection Plan  
Second Ten-Year Interval  
Relief Requests 23 and 24

St. Lucie Unit 2  
SECOND INSPECTION INTERVAL  
RELIEF REQUEST NUMBER 23

St. Lucie Unit 2  
SECOND INSPECTION INTERVAL  
RELIEF REQUEST NUMBER 24

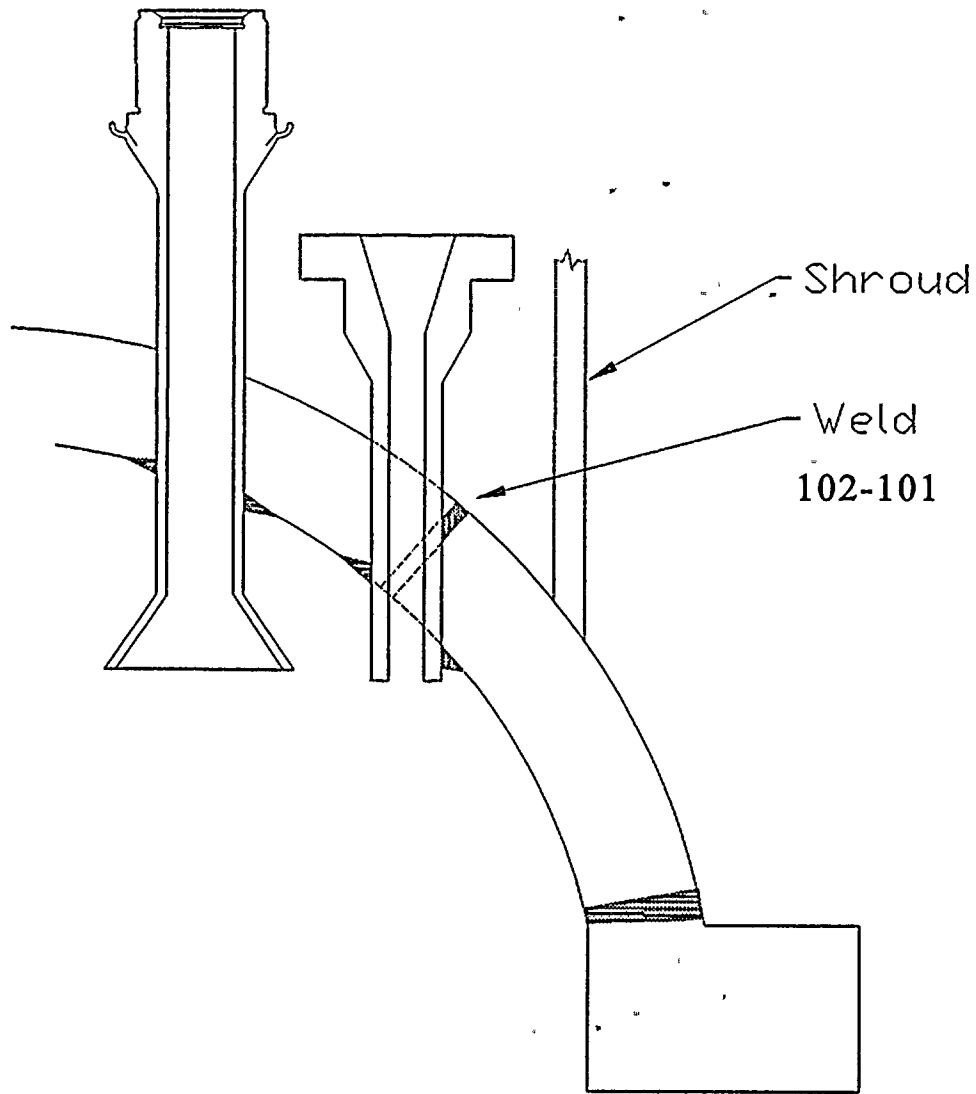
RPV Head General Arrangement

Weld 102-101 is located under the RPV head shroud, has permanent obstructions due to the control element drive mechanisms (CEDM) penetrating it, and is generally inaccessible from the outside and inside surfaces of the RPV head. The shroud is welded and bolted to the RPV head in several areas. Removal and replacement of the shroud would be time consuming, involve high radiation exposure, could create an airborne contamination hazard, and potentially cause harm to the RPV head. Alternative surface examinations can not be utilized for the same reasons.

The performance of a weld examination from the outside surface is impractical. The shroud, which is located below the weld (see attachment), would interfere with access for manual ultrasonic examinations and robotic equipment from the flange side. CEDMs that are located through and above the weld, limit access for manual examinations and robotic equipment from the other direction. Performing radiography is also impractical due to the high radiation levels and limited access. The CEDMs that penetrate the weld further limit the amount of weld that could be radiographed. Performance of an ultrasonic examination from the inside surface is also impractical due to the interference of the CEDMs and the high radiation levels.

Periodic system pressure tests per Category B-P, Table IWB-2500-1
