FirstEnergy Nuclear Operating Company

SUBJECT:
Perry Nuclear Power Plant
Docket No. 50-440, License No. NPF-58
Proposed Alternative to Use ASME Code Case N-513-4

10 CFR 50.55a Request to Use ASME Code Case N-513-4

Sketch of Location of Leak
(One Page Follows)

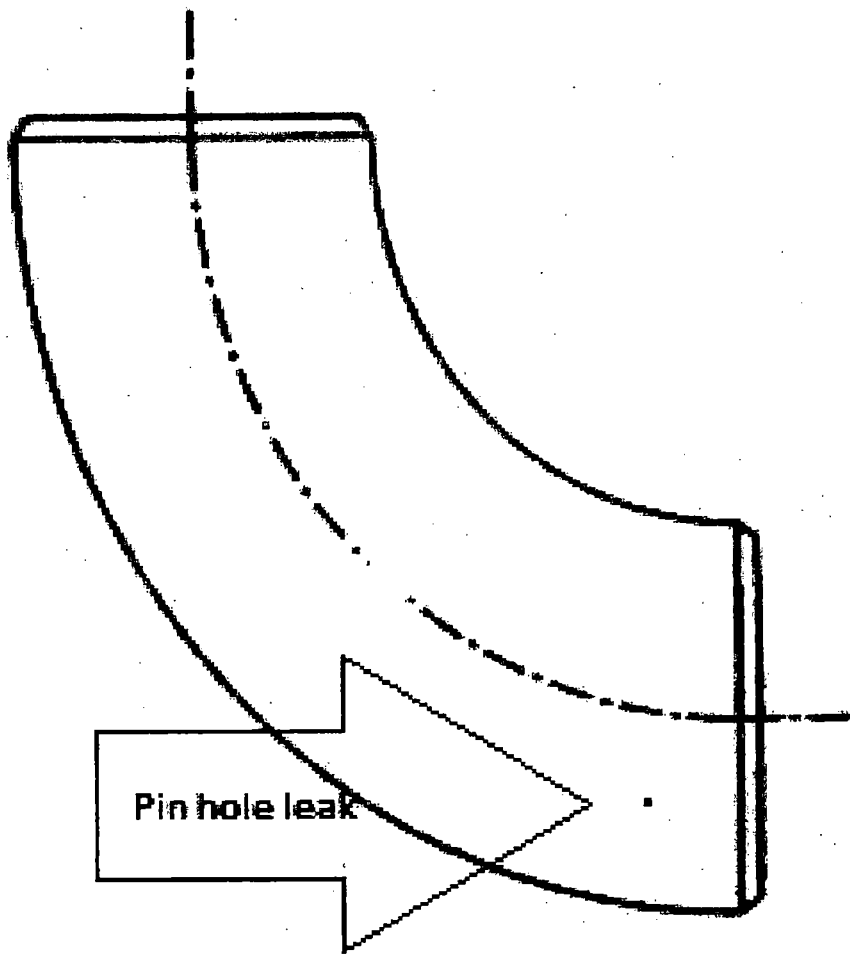
A pinhole leak was identified on a 14-inch elbow on B emergency service water (ESW) piping. The elbow is on the outlet of the B emergency closed cooling (ECC) heat exchanger, immediately downstream of valve 1P45F0541B, "ECC HX B ESW OUTLET."

The leak is located on the 574'-10" elevation of the control complex (east side), lowest elevation of the building. This level of the control complex has numerous floor drains, which are routed to the floor drain sump. The leak location on the 14-inch ESW line is on the south side of the pipe, and 50 inches off the floor. A 4-inch floor drain is located approximately 3-feet from where water would drip off the 14-inch pipe, if leakage were to increase. This floor drain will route water to the control complex floor drain sump where two-50 gpm pumps are located, which auto start. However, based on the analysis presented in the Structural Integrity Section there is reasonable assurance that the leakage will not significantly increase such that flooding would be a concern. This leak is bounded by a flooding analysis calculation, which postulates a pipe rupture in a 14-inch pipe.

There currently is no effect of water spray, because leakage is approximately 0.02 gpm, and is oriented in the downward direction (approximately in the 4 o'clock position of the piping when viewed axially). If leakage were to increase (that is, when the ESW B loop is in operation) water would exit the piping and spray downward and to the south. An 8-inch thick wall constructed of drywall (that goes to the ceiling) is located 6 1/2-feet to the west of the leak location.

Consistent with the flaw characterization described in ASME Section XI, IWA-3300, and by way of straight beam and angled beam ultrasonic testing (UT) NDE examination methods, the flaw in the 14-inch diameter ESW piping was characterized as a non-planar flaw (pinhole leak indicative of pitting corrosion). For the purposes of this evaluation, a conservative bounding flaw with a diameter of 0.125 inches will be used. This flaw is not crack like and thus it is not expected to be subject to further propagation, since only planar type flaws experience crack growth.

Thickness measurements were taken on the piping directly surrounding the leak. No pitting was observed. Additionally, circumferential readings were taken in three axial planes 0.5 inches apart, with readings taken every 1 inch around the entire circumference of the pipe. The minimum reading was 0.280 inches near the origin of the pinhole leak.

The maximum allowable flaw size is 0.58 inches in the axial direction and 1.35 inches in the circumferential direction to maintain structural integrity. As discussed above, the leak is a pinhole leak. Conservatively characterizing the through-wall extent as a circle with a diameter of 0.125 inches, the leak meets the acceptance criteria for structural integrity utilizing Code Case N-513-4, as it is bounded by the allowable flaw dimensions.

Pin hole leak

FENOC intends to repair or replace the elbow during the next scheduled refueling outage utilizing an ASME code approved method.
