Rancho Seco

Site-Specific ISFSI License Renewal (SNM-2510) Docket 72-11

Second Pre-Application Meeting with the NRC
August 4, 2017

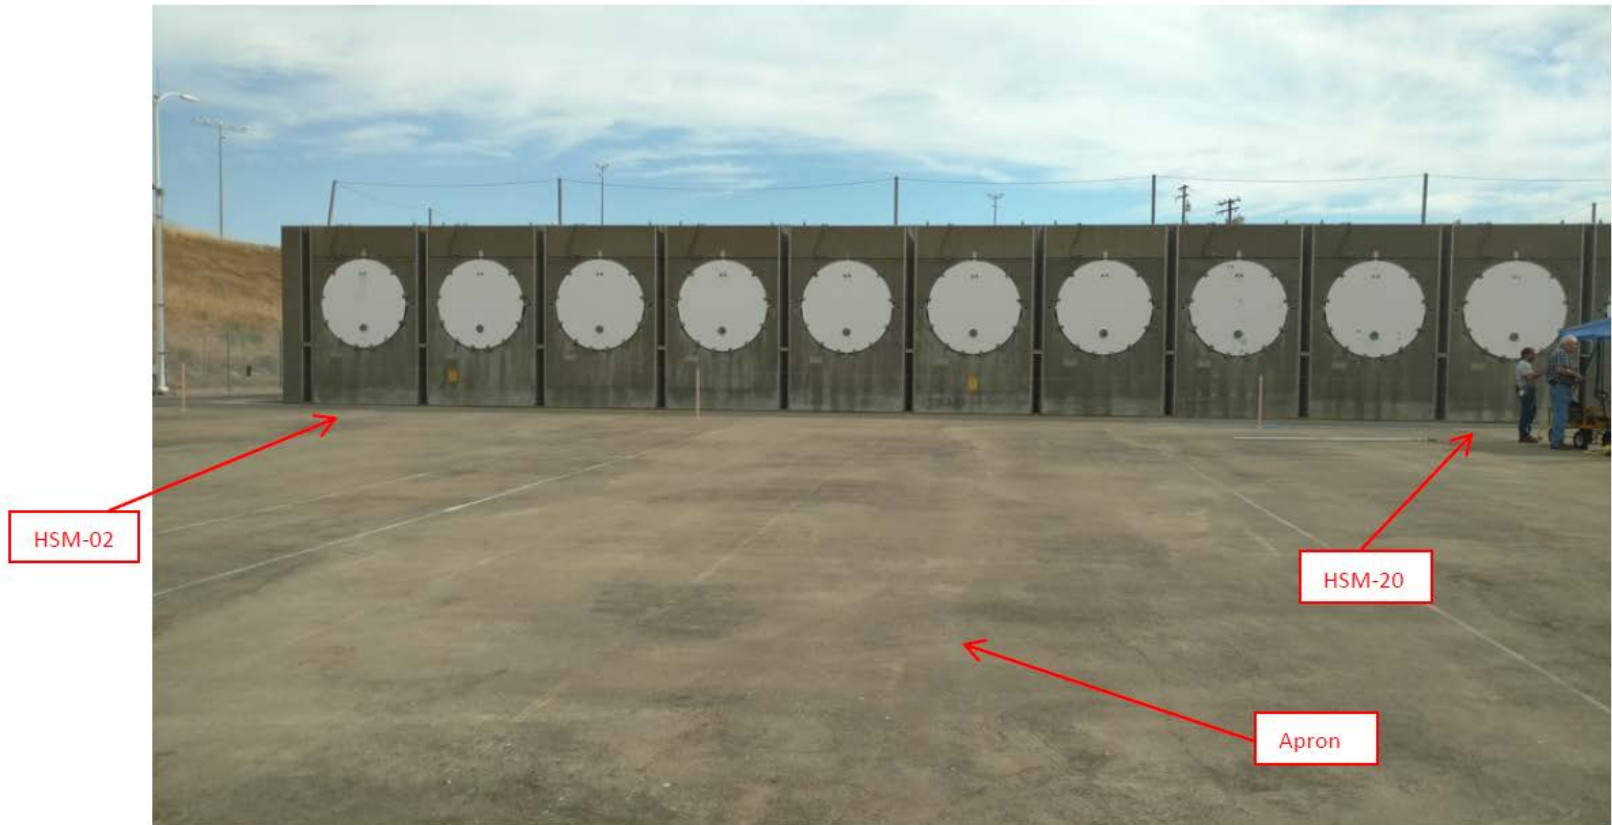
Figure 23

Picture: HSM Array South Elevation (HSM-02 far left)

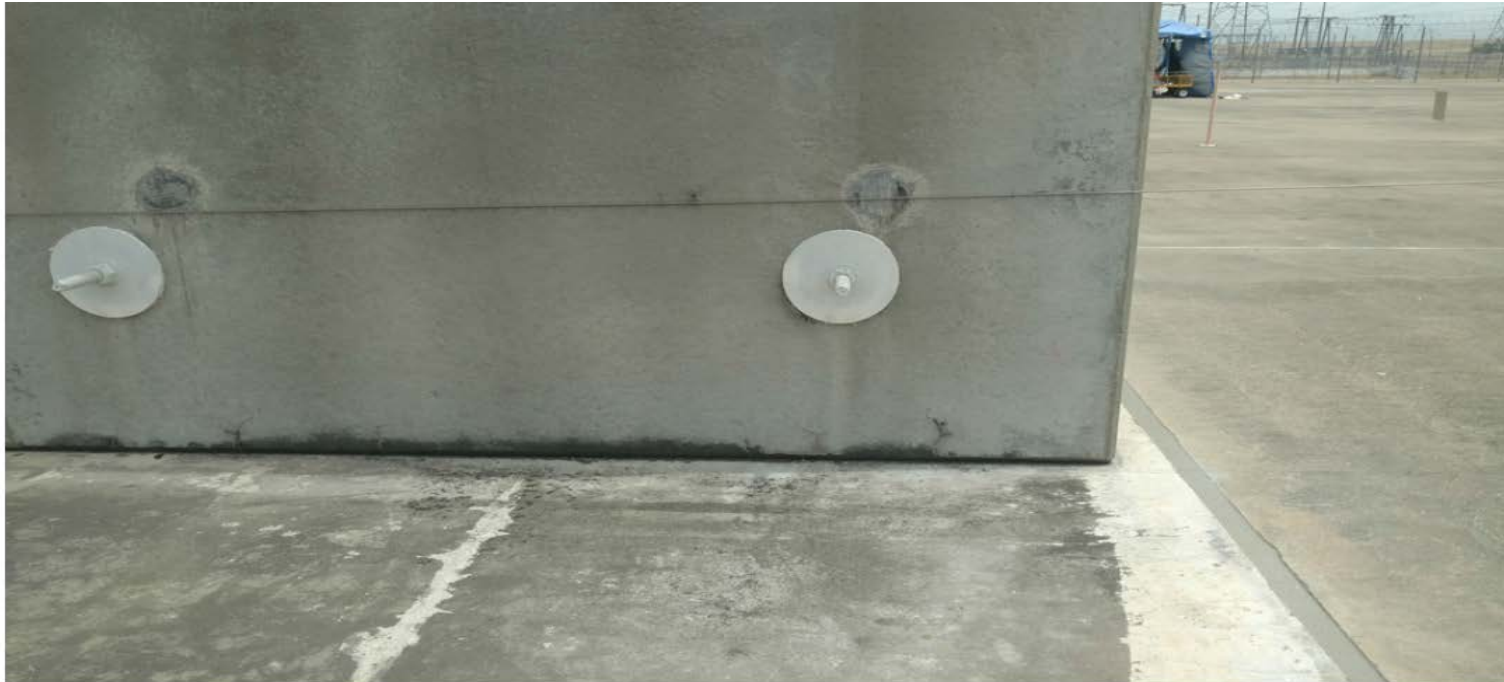
Figure 24

Picture: West End Shield Wall South Panel

The end shield walls consist of four vertical slabs attached to the end modules with through studs at the bottom and metal straps at the top. The concrete surface has minor superficial map cracking that is not deleterious. There are no spalls. The grout patches for filling the lifting embeds are sound. The light discolorations are superficial and appear to be part of the original construction.

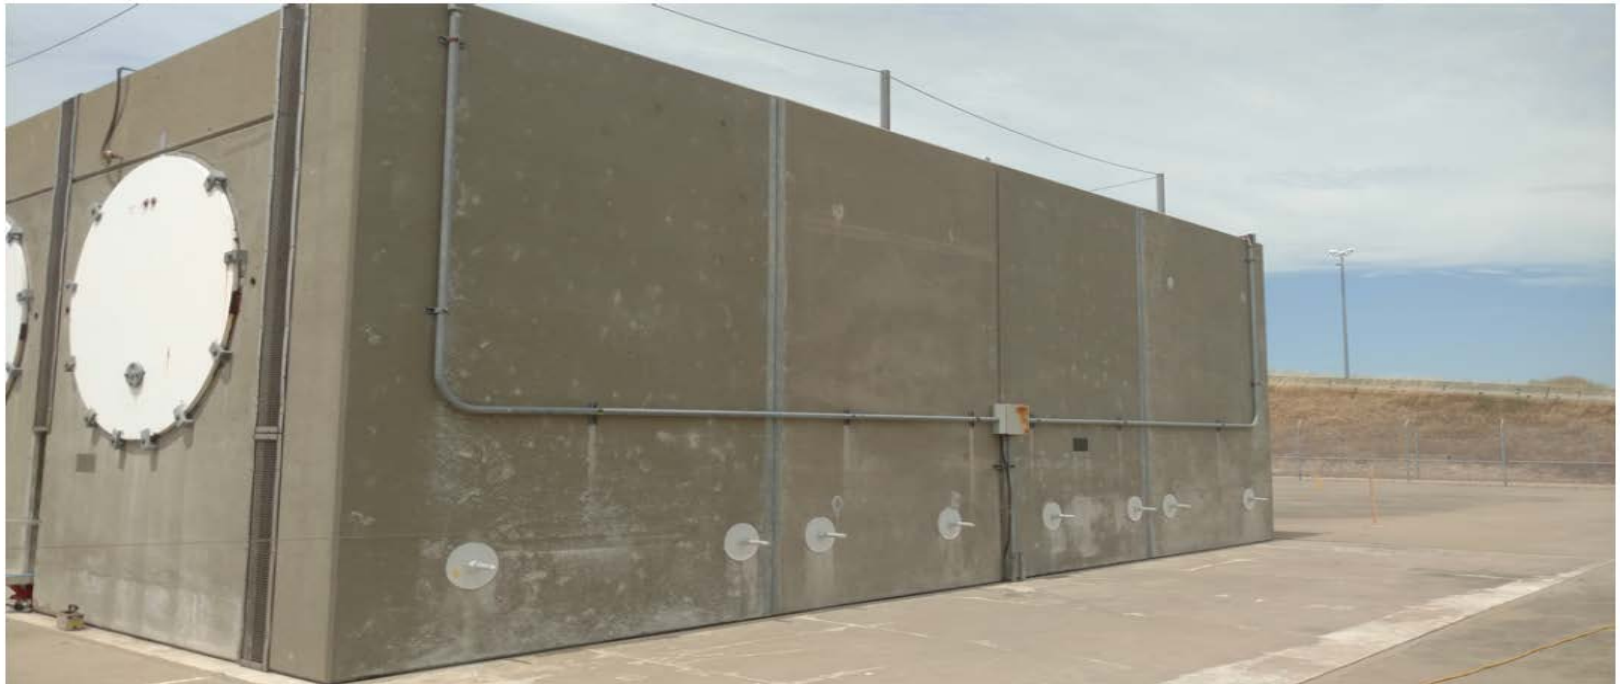
Figure 26

Picture: End Shield Walls East Side

The east shield walls are identical to the west panels. There are two shear keys reinforced with galvanized angles at the corners. The shear keys are intact. There are no spalls and the visible cracks are typical and minor. The grout patches for filling the lifting embeds are sound. The light discolorations are superficial and appear to be part of the original construction.

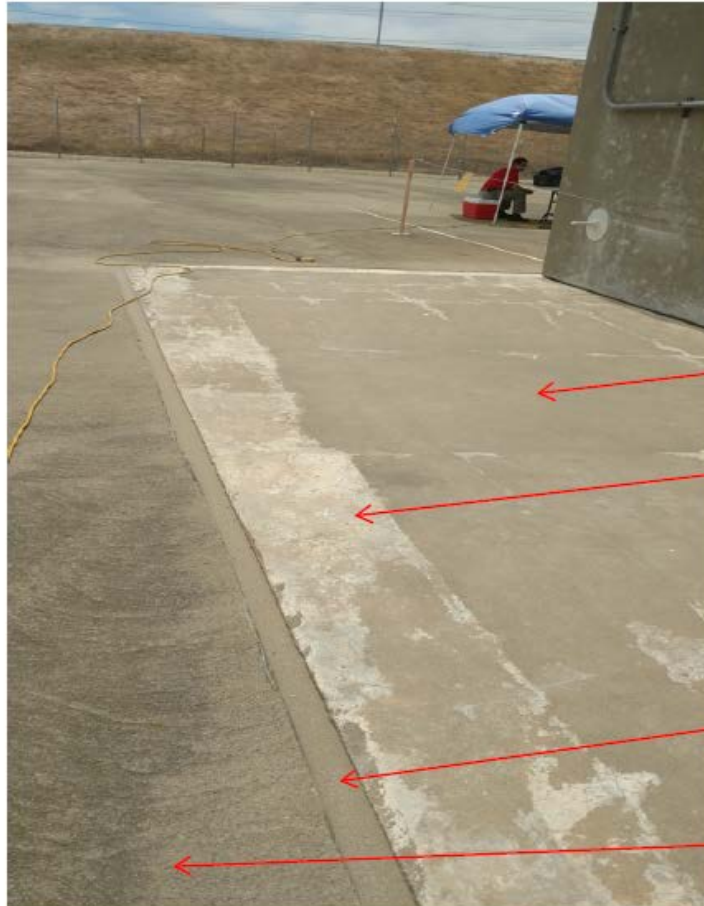
Figure 27

Superficial discoloration

Picture: Base mat East Side facing south

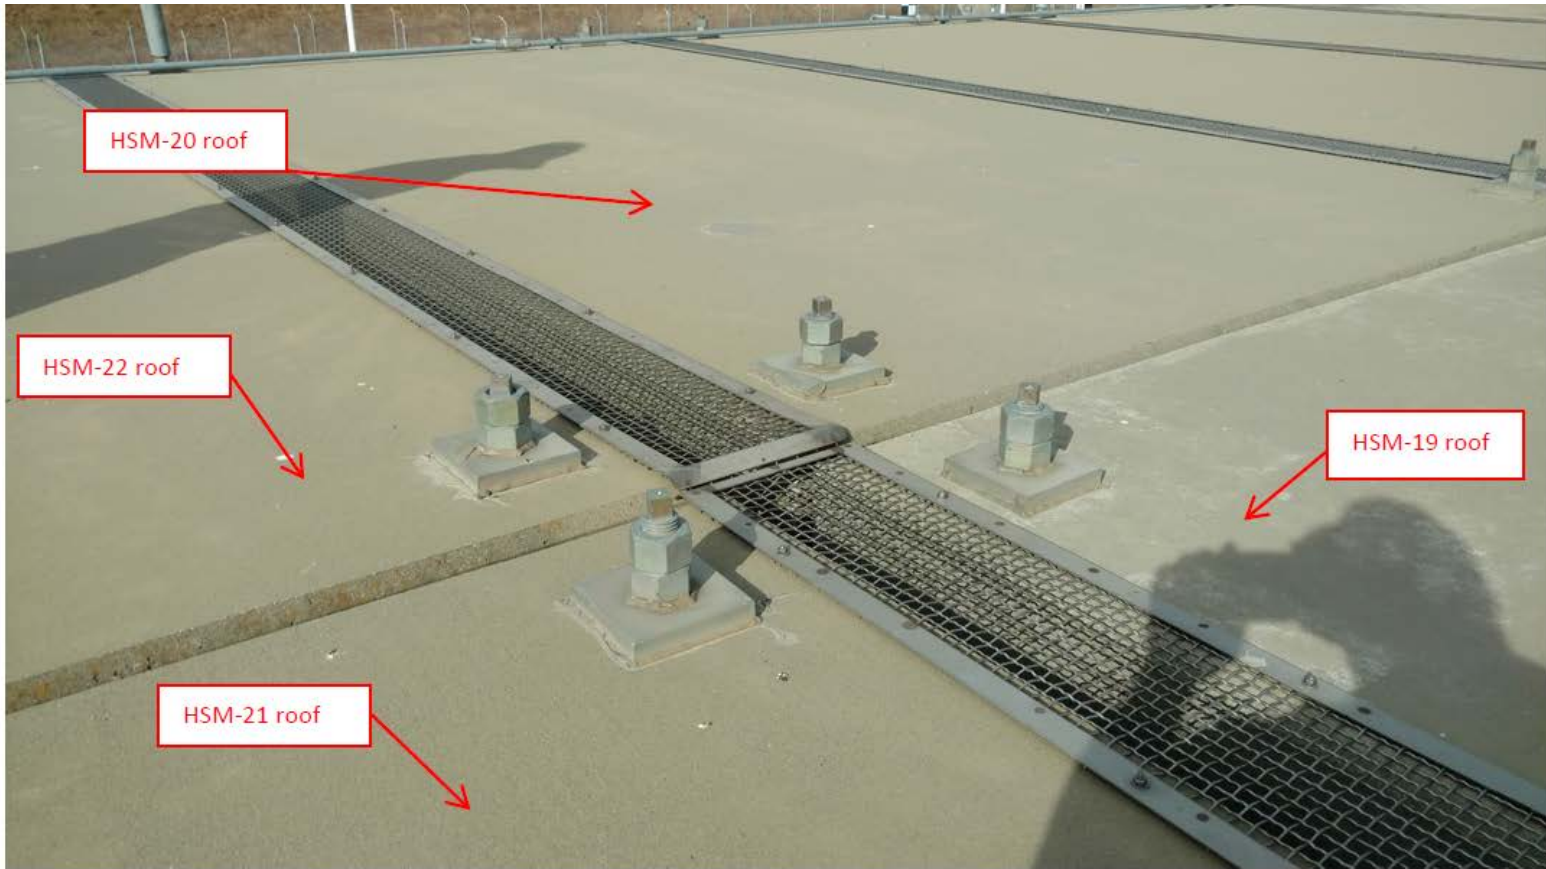
Figure 22

Picture: HSM-20 Roof

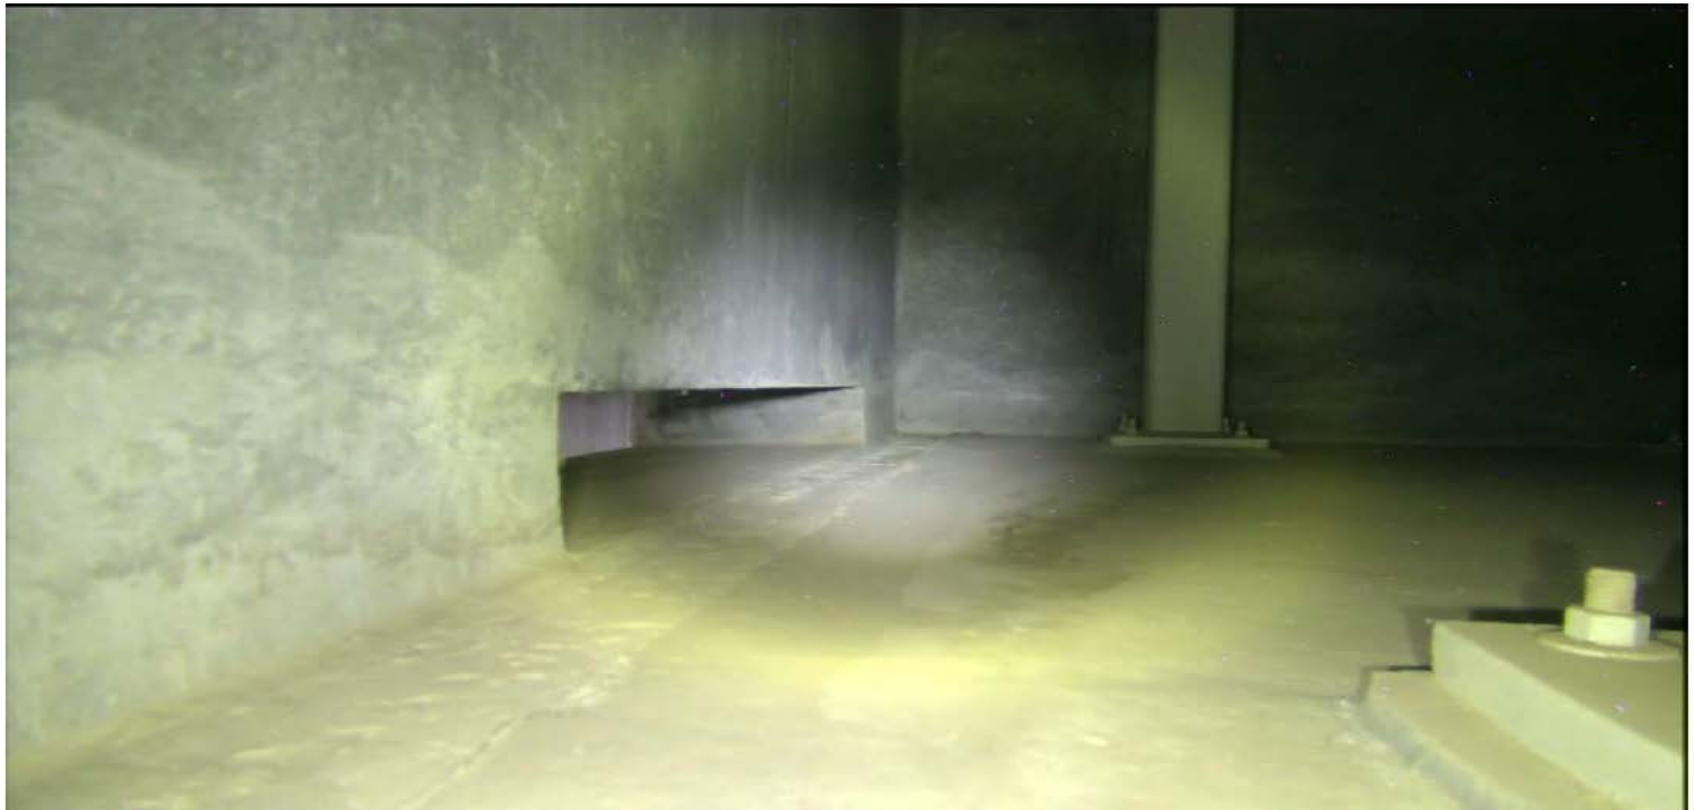
Figure 6

Picture: Floor at HSM Interior Northwest Corner, looking north.

No anomalies noted.

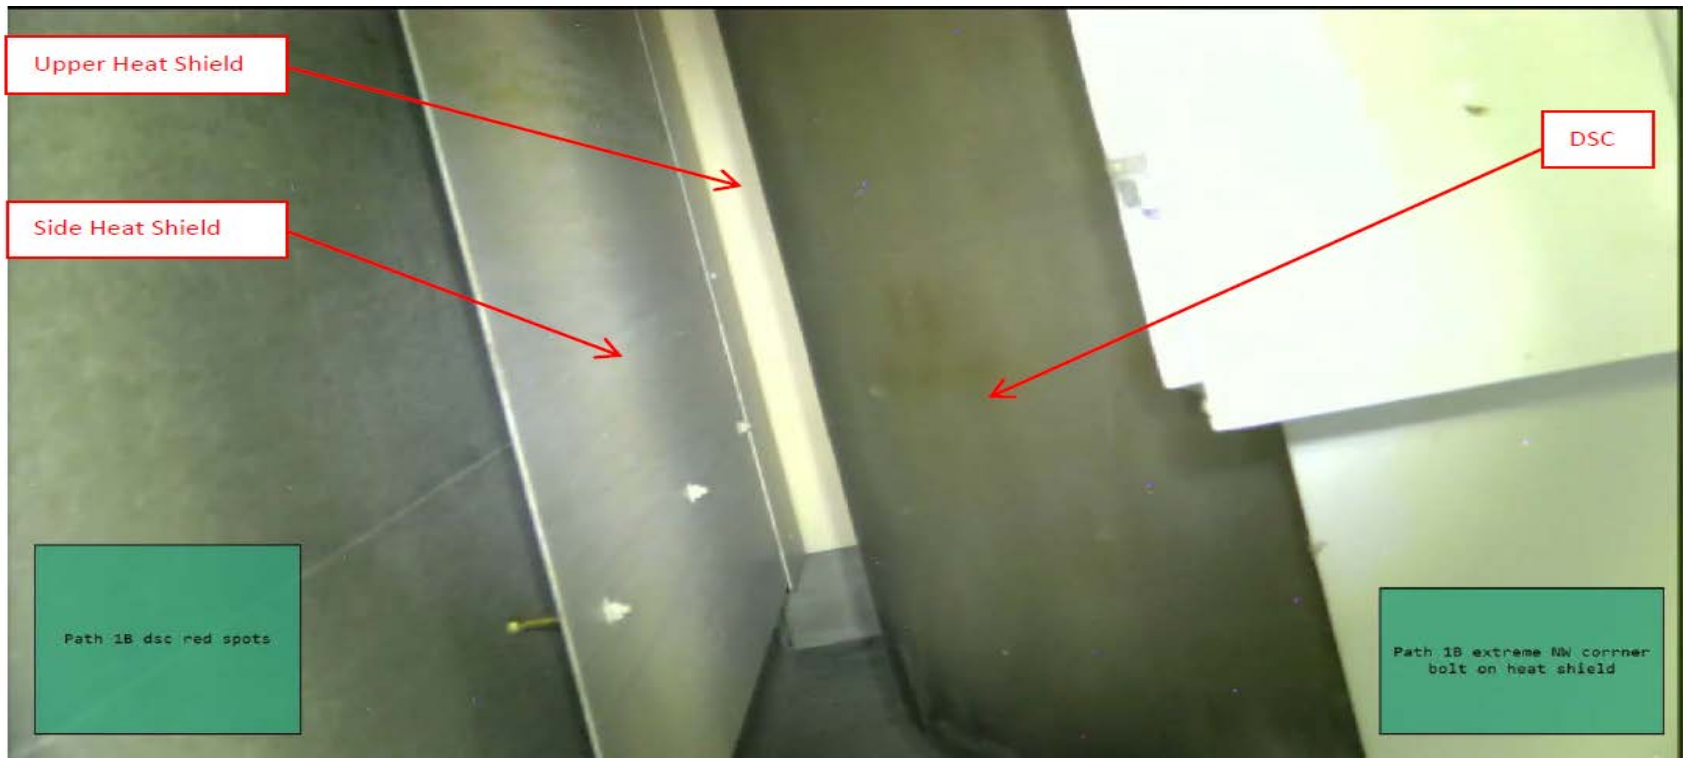
Figure 11

Picture: Northwest corner. Items visible in the picture are the side and upper heat shields mounted on the side wall and ceiling, respectively. The DSC is at right (dark gray).

The DSC support rail is at the far right. No anomalies noted.

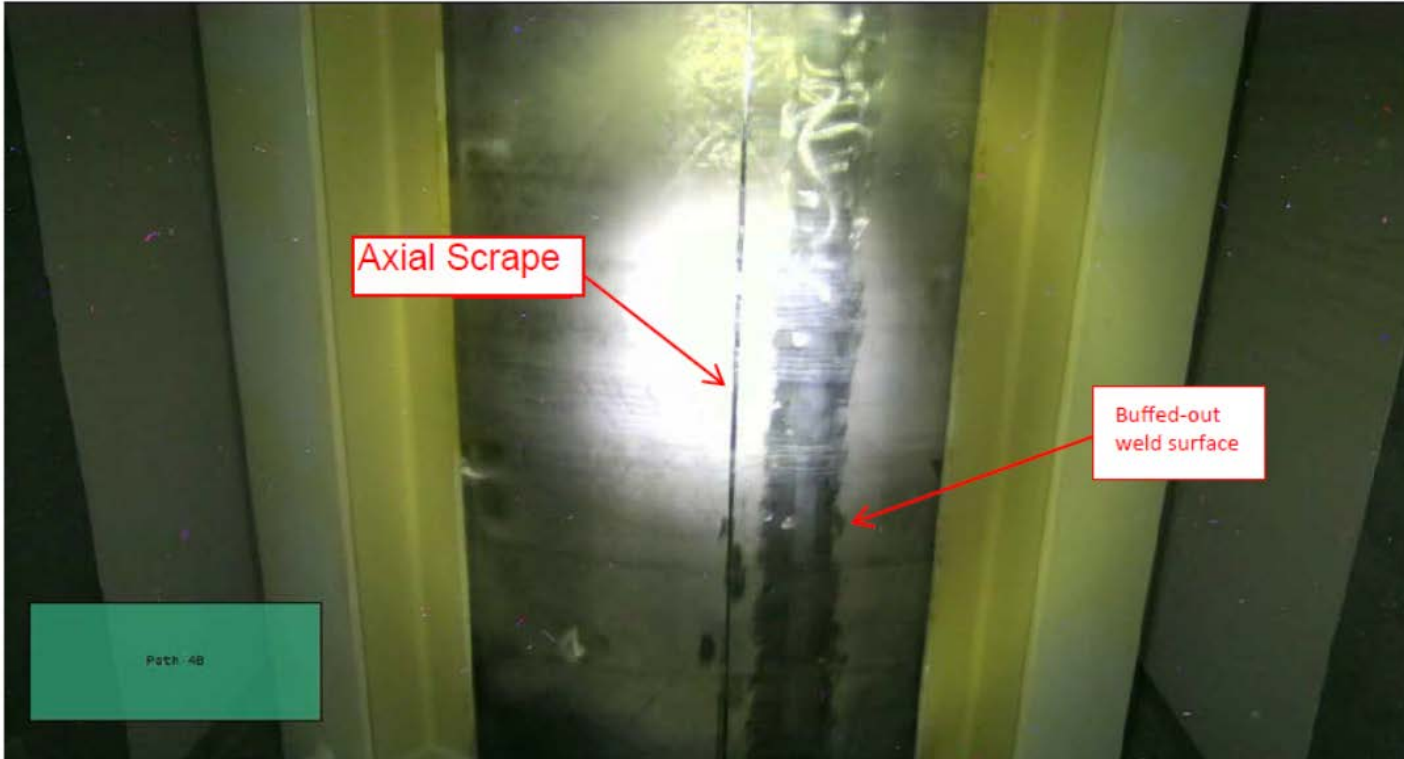
Figure 17

Scrape on bottom of DSC extends from approximately 4" from south DSC Door to the middle of the DSC along axial line. Also, buffed-out weld surface can be seen to the right of the scrape. No indication of degradation was observed.

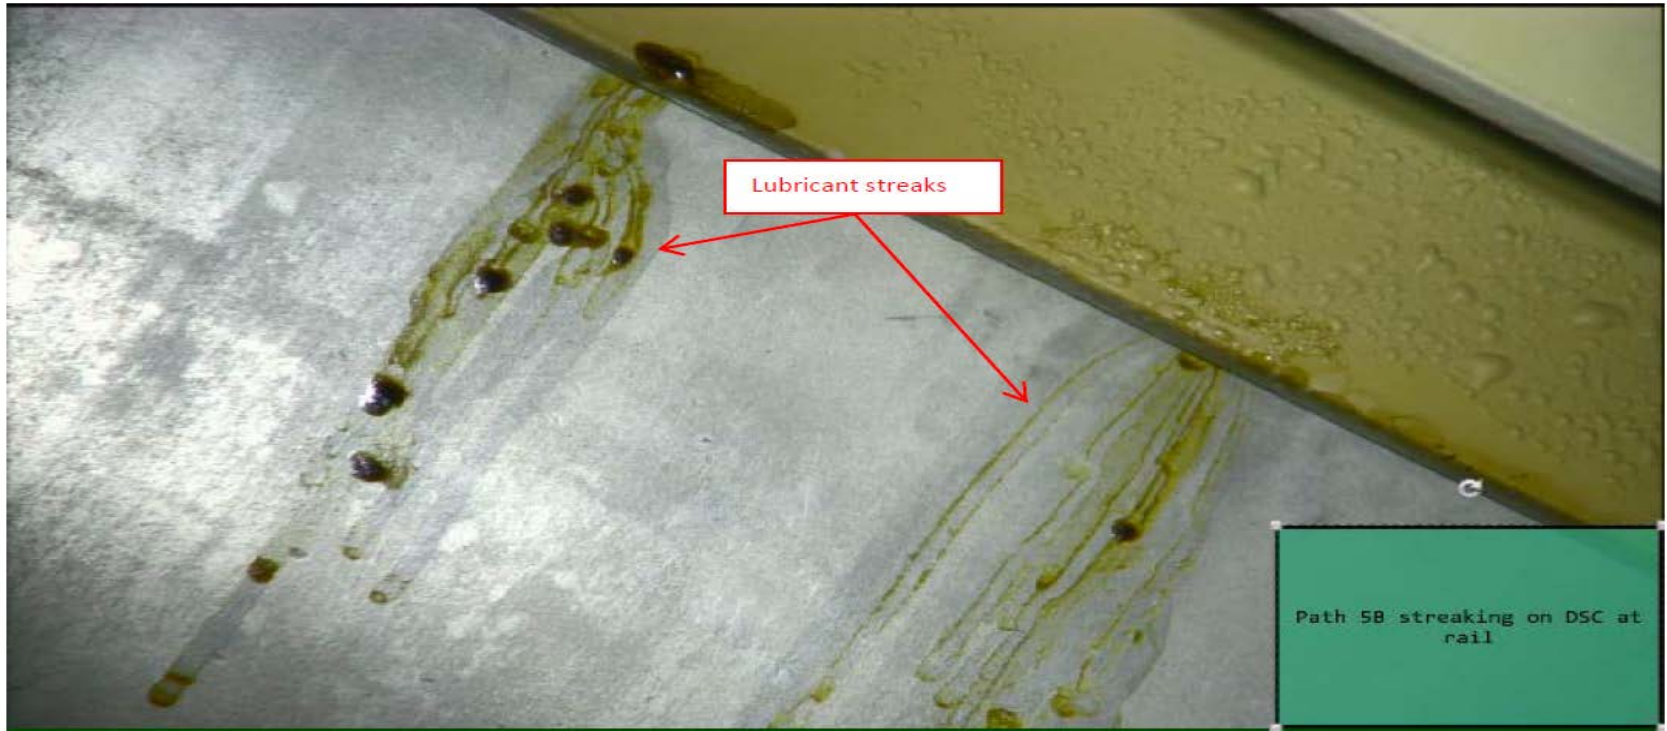
Figure 20

Picture: DSC Bottom and support rail, east side, between Support #2 and Support #3.

Note discoloration streaks can be seen on the DSC that appear to be rail lubricant carried by rainwater intrusion. The streaks appear to be dry with no indication of active water intrusion.

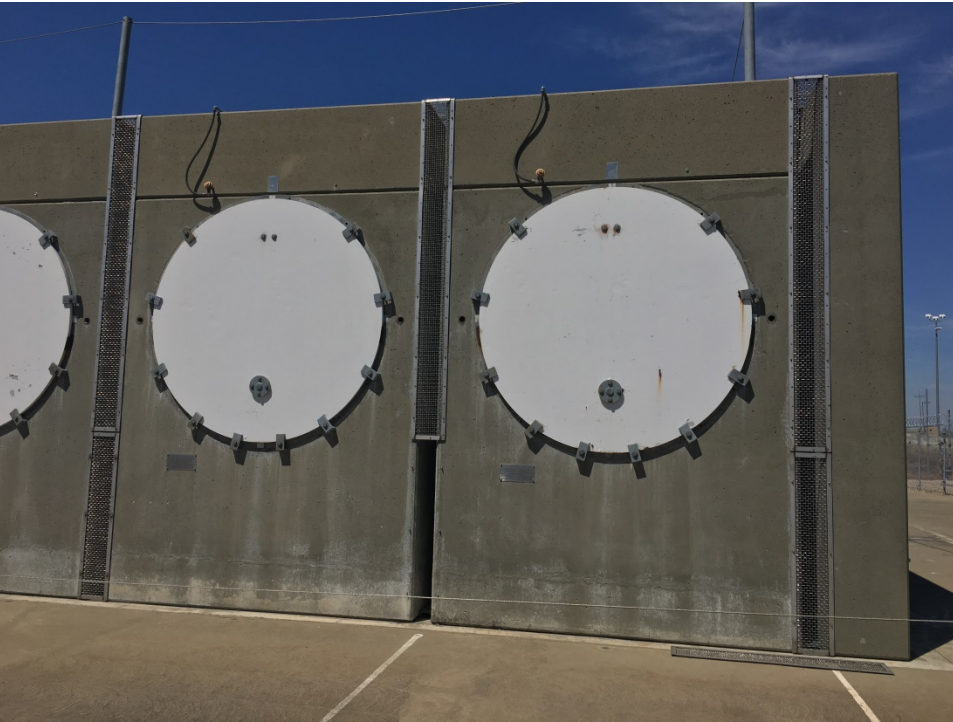
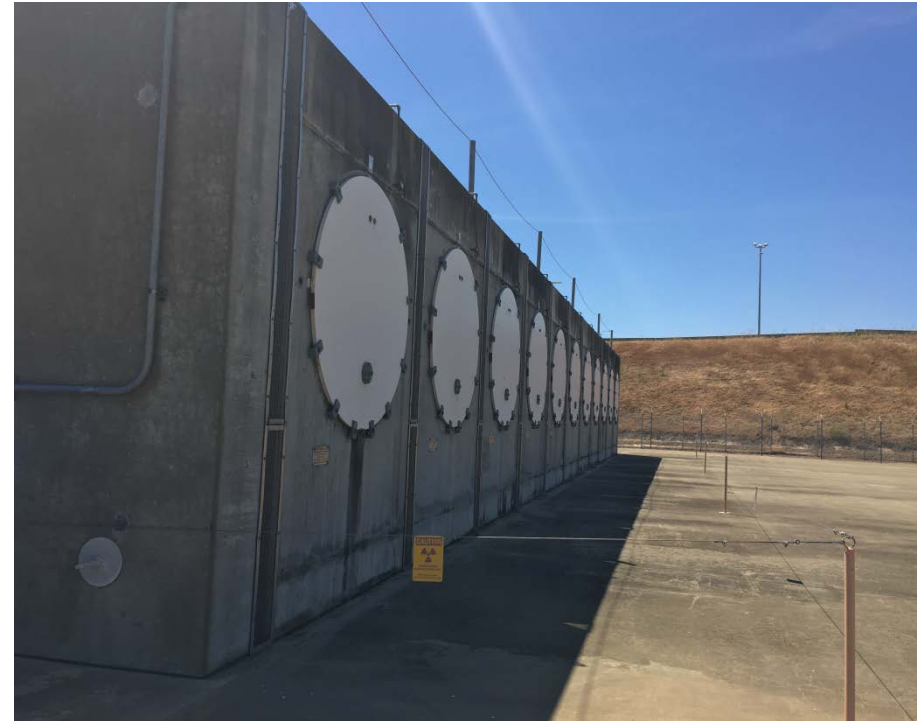
- External surface concrete inspection
- HSM top slab examination
