DRESDEN NUCLEAR POWER STATION UNIT 3

Special Report

JET PUMP FLOW BLOCKAGE

DRESDEN 3 REACTOR MARCH 15, 1971

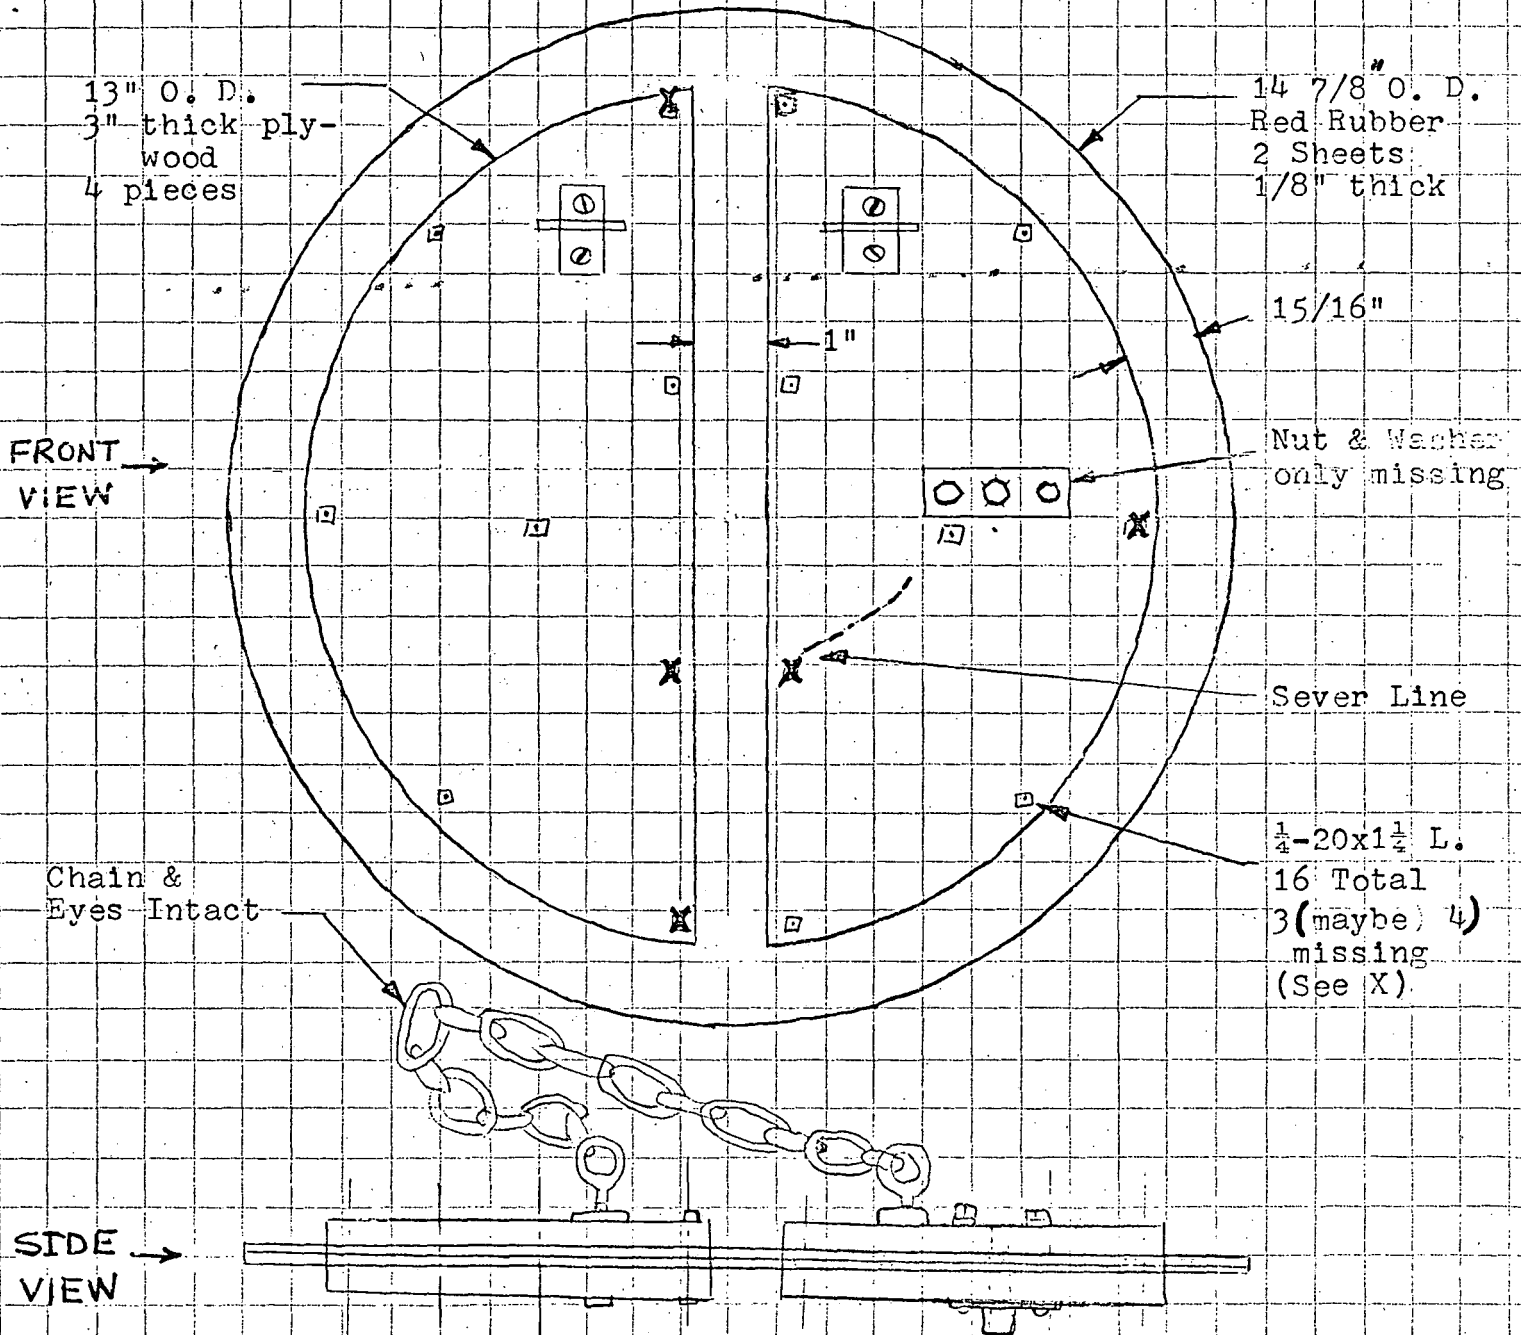
FIGURE 1

On March 23, the reactor head, dryer, separator and jet pump 11 ram's horn was removed. Work on the jet pump and subsequent removal of the dam was performed with the water level at approximately 2/3 core height. Radiation levels were approximately 35 mr/hour and the doses to personnel were low. The cause for the reduced flow in jet pump No. 11 was found to be a welding purge dam lodged in the transition casting of the jet pump at a point where the flow is divided from the riser inlet to two nozzles for jet pumps Nos. 11 and 12. The purge dam was lodged against the casting and blocked approximately three-fourths of the flow to jet pump No. 11. Upon removal, the purge dam revealed to be a standard plywood and rubber dam, approximately 16 inches in diameter, commonly used in construction heliarc welding operations. (See figure #1)

Due to the low exposure of the reactor core the radiation level was low and it was possible to lower the reactor level to approximately 2/3 core height for the removal of jet pumps 11 and 12. When the ram's head containing nozzles for jet pumps 11 and 12 was removed, an obstruction of wood, rubber and metal was revealed in the transition casting supplying the jet pumps. Approximately 75% of the available flow area to jet pump #11 was obstructed by the blockage. The transition casting was removed and the obstruction removed and identified as a welder's purge dam which is commonly used in construction for inert gas back purge of pipe closure root welds.

The purge dam consisted of a sandwich of four 3/8" thick plywood semi-circular segments and two circular 1/8" thick red rubber sheets held together by 1/4 - 20 x 1-1/4" stove bolts. Measurements indicated it was intended for use in 16" piping.

One half of the dam was broken in two, the other half was badly fouled, and the two halves were held together by a chain which was normally used as a handle for removal.

- (1) Rubber - total missing area 30 in.², 1/8" thick, small pieces
- (2) Wood - total approximate area 16 in.², mostly splinters
- (3) Hardware - 4 nut screw combinations 1/4" x 1-1/4", 1 washer 1/4",
1 nut 1/4"

**Standard Plywood and Rubber
Welder's Purge Dam**

(X) indicates location of missing nut/bolt combinations
note 1 combination recovered as a loose part
