Commonwealth Edison Company

Dresden Nuclear Power Station
R. R. #1
Morris, Illinois 60450
April 25, 1972

SUBJECT: LICENSE DPR-25, DRESDEN NUCLEAR POWER STATION, UNIT #3, SECTION 6.6.C.1 OF THE TECHNICAL SPECIFICATIONS, AND LICENSE DPR-19, DRESDEN NUCLEAR POWER STATION, UNIT #2, SECTION 6.6.C.1 OF THE TECHNICAL SPECIFICATIONS.

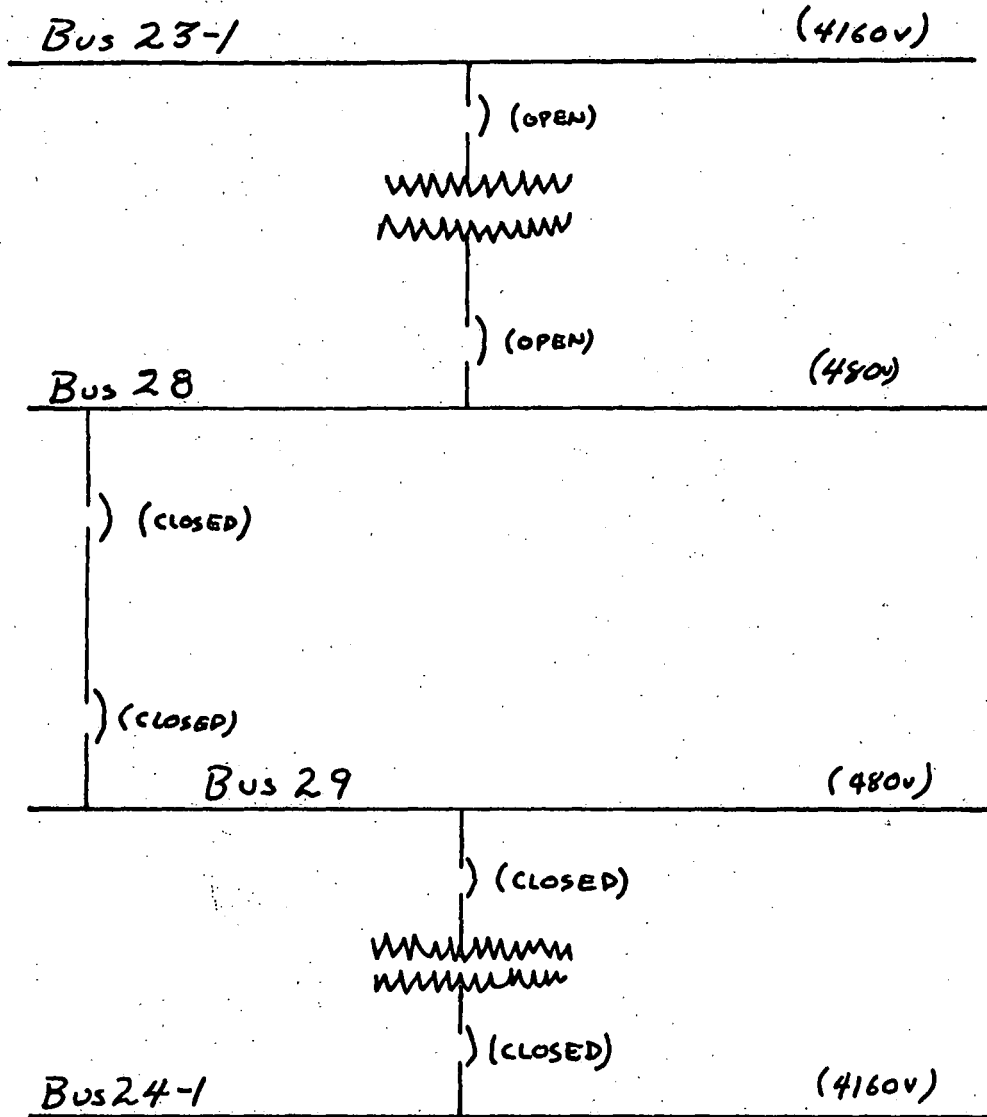
At 1130 hours on March 29, 1972, Unit #3 was at 800 MWe with the mode switch in "Run" and Unit #2 was in "Refuel" with all rods in and no fuel moves in progress. An electrical maintenance crew was overhauling the Transformer 28 high-side breaker at bus 23-1. Bus 28 was being supplied from bus 29 via the 28-29 bus tie breaker. (See figure 1)

The breaker auxiliary contacts in the breaker cubicle were exercised as part of the overhaul job. When these contacts were moved to a position corresponding to that of a closed breaker, an interlock circuit was satisfied that automatically tripped the 28-29 bus tie breaker at bus 29. This interlock circuit is designed to prevent tying bus 28 and 29 together when they are being fed from their parent 4160V buses.

When the bus tie breaker opened, power was lost to the motor control centers supplying "A" standby gas treatment system, "2A" standby liquid pump, and the "2A" core spray system valves, which rendered these systems inoperable.

The "B" standby gas treatment system was started immediately by the operator and verified to be operable. Normal electrical feed to bus 28 and its components was restored by 1330 hours the same day.

Maintenance procedural changes have been made to preclude a recurrence of this type of incident. In addition, caution signs have been placed in the Transformer 28 and 29 high-side breaker cubicles and in the corresponding breaker cubicles on Unit 3.
