# Commonwealth Edison Company

Dresden Nuclear Power Station  
R. R. #1  
Morris, Illinois 60450  
March 17, 1972

SUBJECT: LICENSE DPR-25, DRESDEN NUCLEAR POWER STATION UNIT #3,  
SECTION 6.6.B.2 OF THE TECHNICAL SPECIFICATIONS

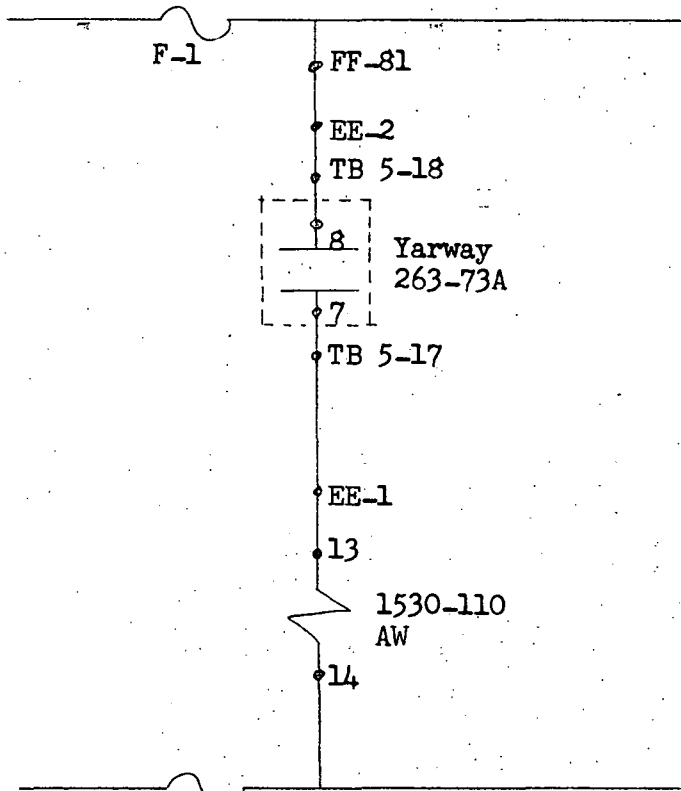
F-2  
 Correct Wiring  
 as shown on  
 print 12E3437

The wiring circuit for relay 1530-110AW was changed to correspond with that on the wiring diagram and the "LPCI System low flow" switch was recalibrated. The required surveillance test was repeated satisfactorily following the wiring change.

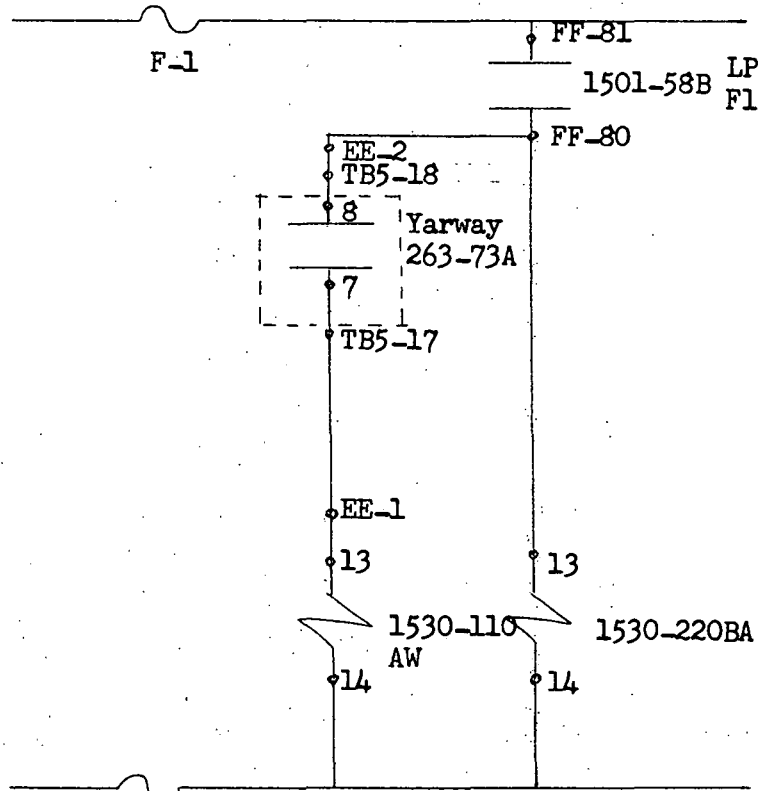
On March 7, 1972, at 1500 hours, while conducting monthly surveillance tests on the Low Pressure Coolant Injection System (LPCI), a containment spray interlock relay (1530-110AW) would not energize. This relay provides permissive to utilize containment spray if reactor water level is greater than 2/3 core height. Investigation revealed that one side of the relay was wired such that the "LPCI System low flow" switch, (3-1501-58B) was included in the relay circuit, contrary to the wiring diagram. (Refer to attached schematic.)

The "LPCI System low flow" switch contact is normally closed when the surveillance test is conducted. During this particular surveillance testing, however, the "low flow" switch calibration had drifted and the contact on this switch was open. This resulted in the de-energization of relay 1530-110AW. The drift in the calibration of the "low flow" switch was thus responsible for the events which led to the discovery of the wiring error and this also explains the fact that this wiring error was not detected during previous surveillance testing.

F-2  
 Wiring as found. Wire from EE-2  
 to FF-80 should be from EE-2 to FF-81
