MEETING ON CRACKS FOUND IN DRESDEN 3 CONTROL ROD DRIVE COLLET RETAINER TUBES

### SUMMARY OF MEETING ON CRACKS FOUND IN DRESDEN 3 CONTROL ROD DRIVE COLLET RETAINER TUBES

EXAMINATION OF CRACKS

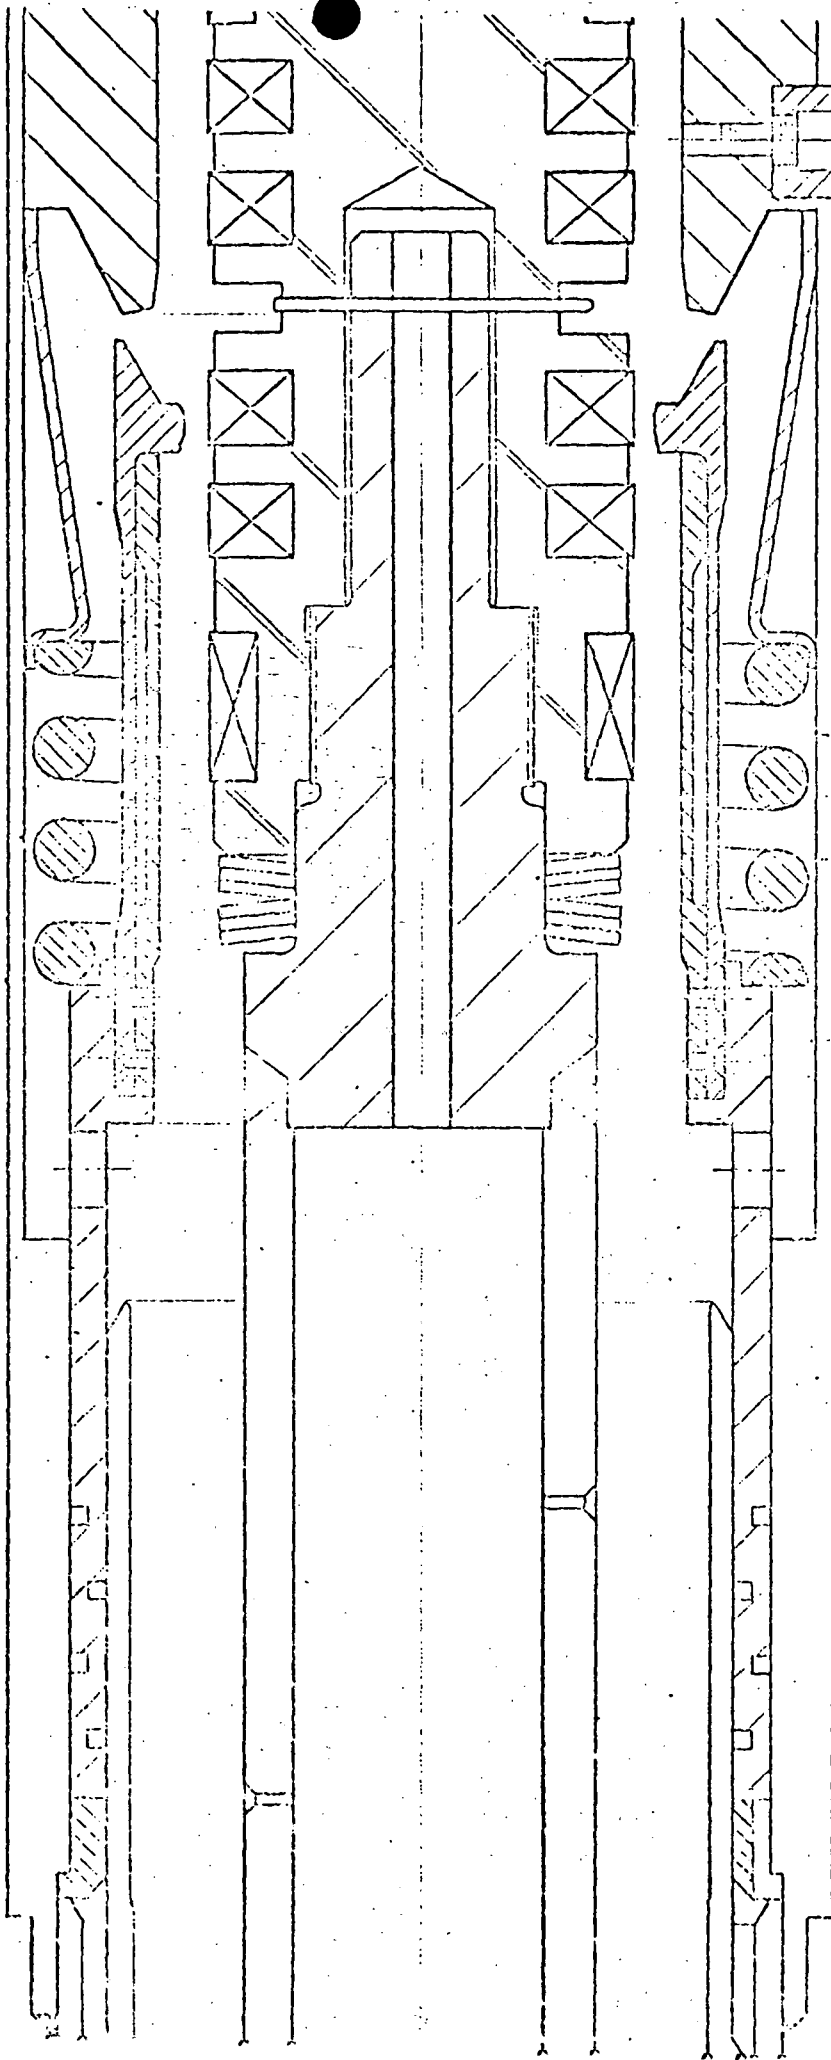
Slide #2

3. A cross-section of a drive at the position of interest is shown in Slide 2. A sketch of the cracks discovered in a Dresden 3 collet retainer tube is shown in Slide 3. The location (at the change in section midway between the flow holes) and orientation (circumferential) are typical. The cracking observed in a test drive retainer tube is shown in Slide 4. Metallographic sections also revealed cracking in the material between the "ram's horn" pattern.

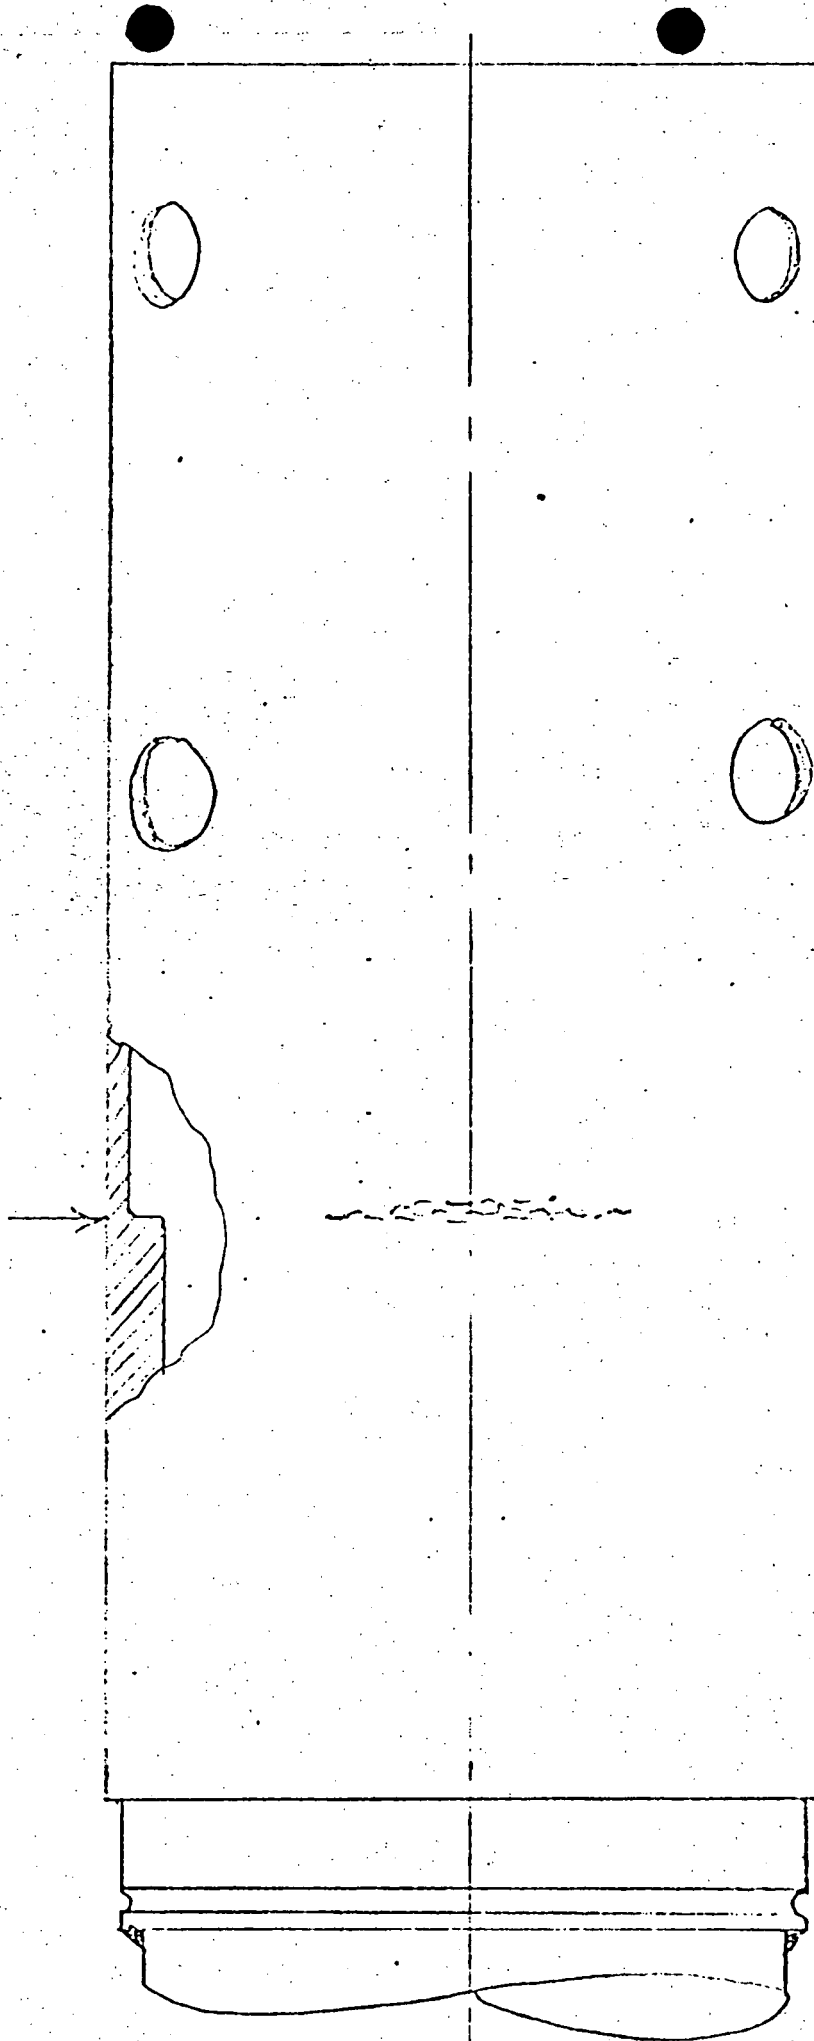
Slide #3

7. All the cracks have been on the outside diameter of the collet retainer tube, at the axial location where the cross-section changes, and between the water ports. The most severe cracks were located above the cooling water inlet at the bottom of the drive. GE has not been able to determine any correlation between cracking and number of scram cycles, location in core, or drive manufacturer (San Jose or Wilmington). Material history of individual retainer tubes can not be established. GE is therefore unable to correlate it to cracking.

Cracks found in  
Dresden 3 (typical).

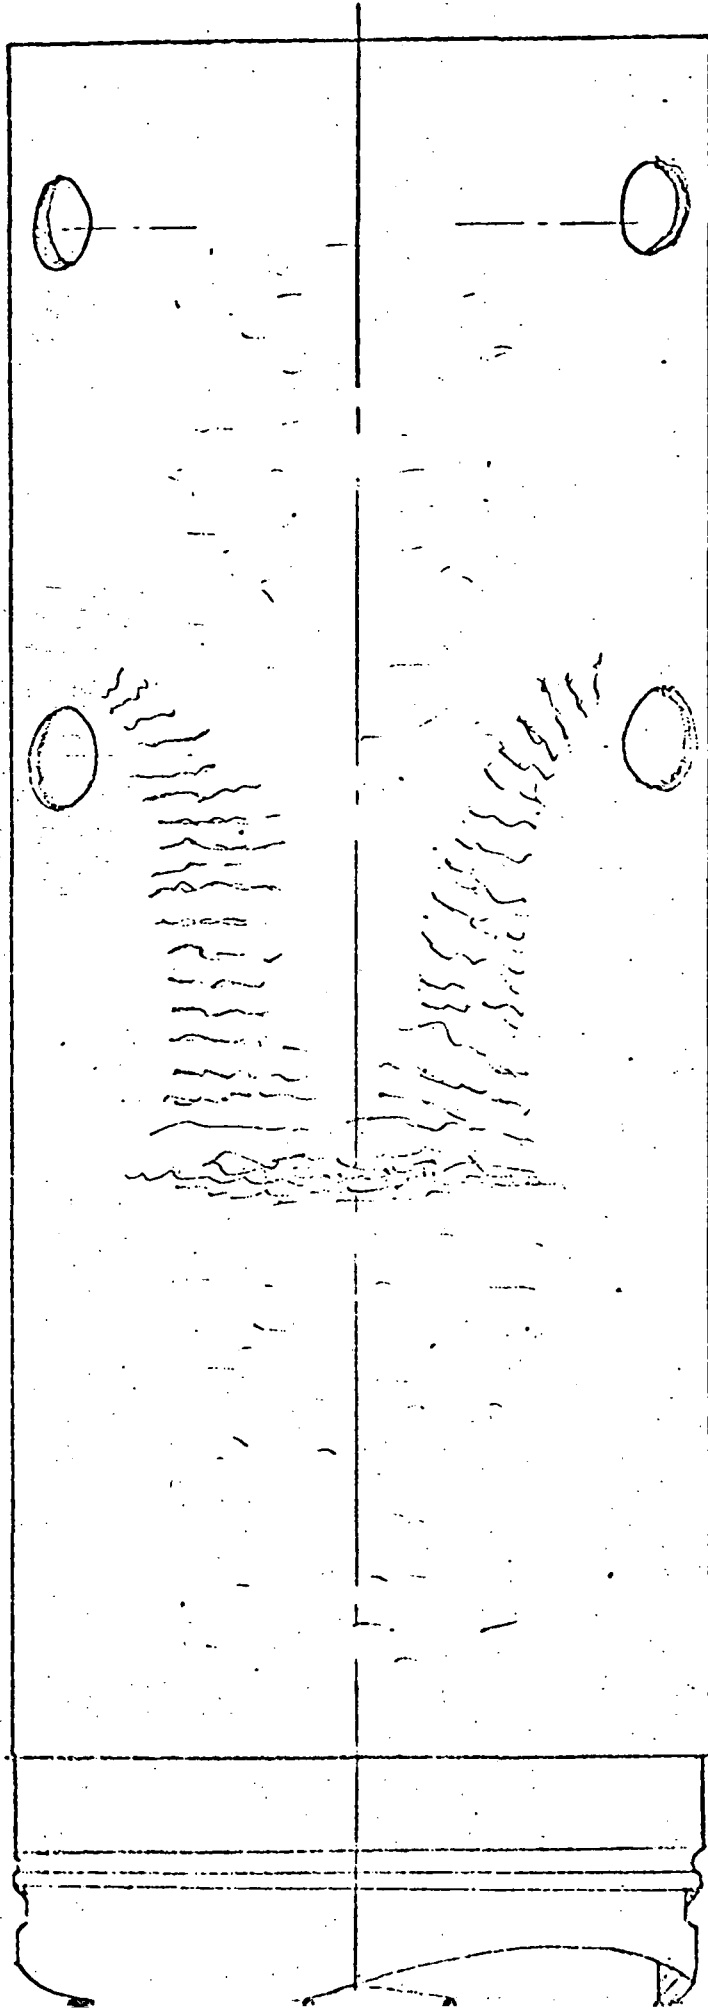
Slide 44

Worst cracking - found  
in test drive

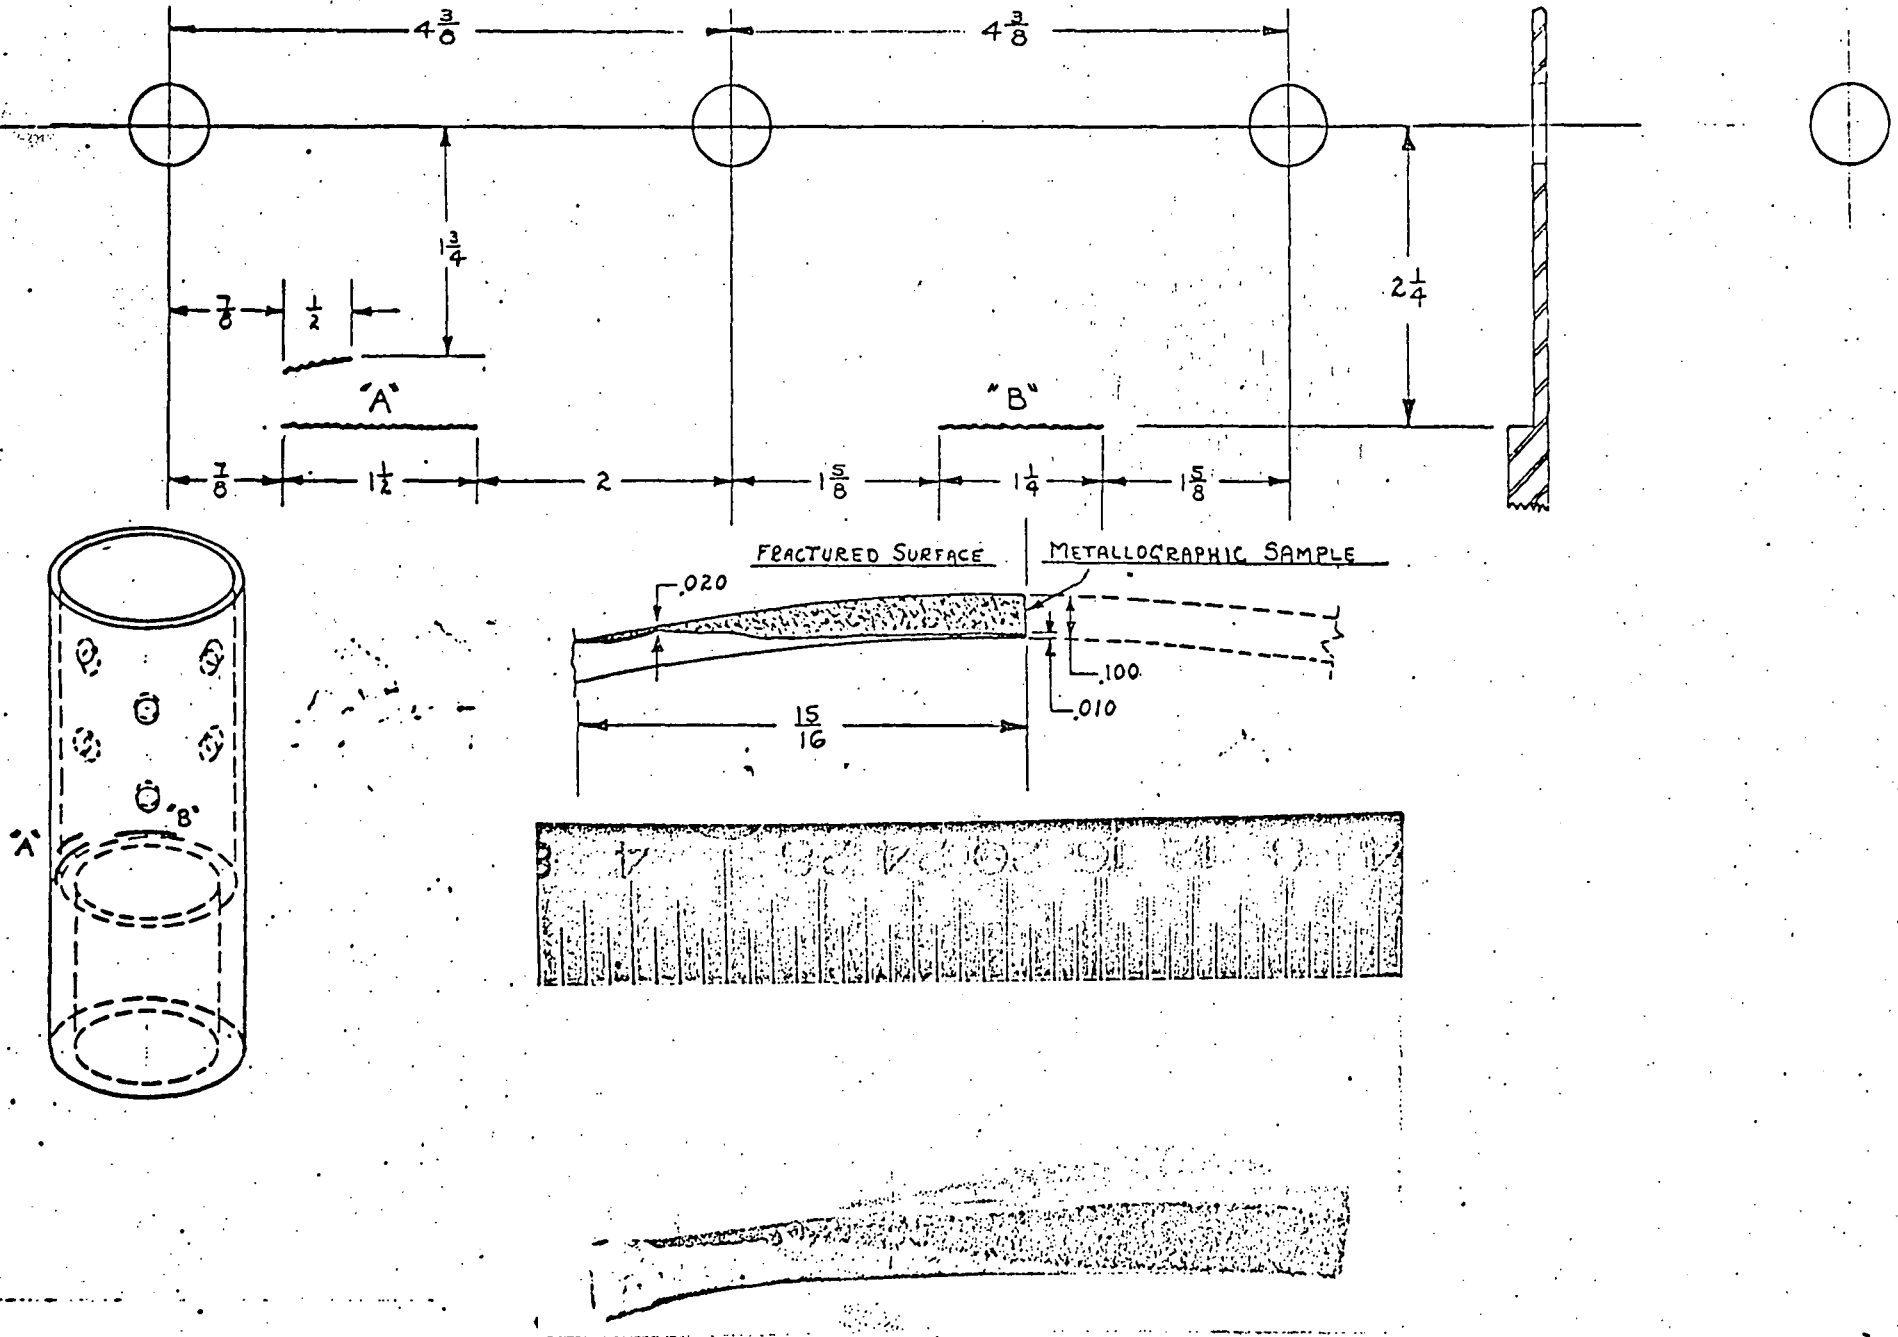
FIG. 1

OD OF CIRCUMFERENTIAL CRACKS

CRD COLLECT HOUSING - #20

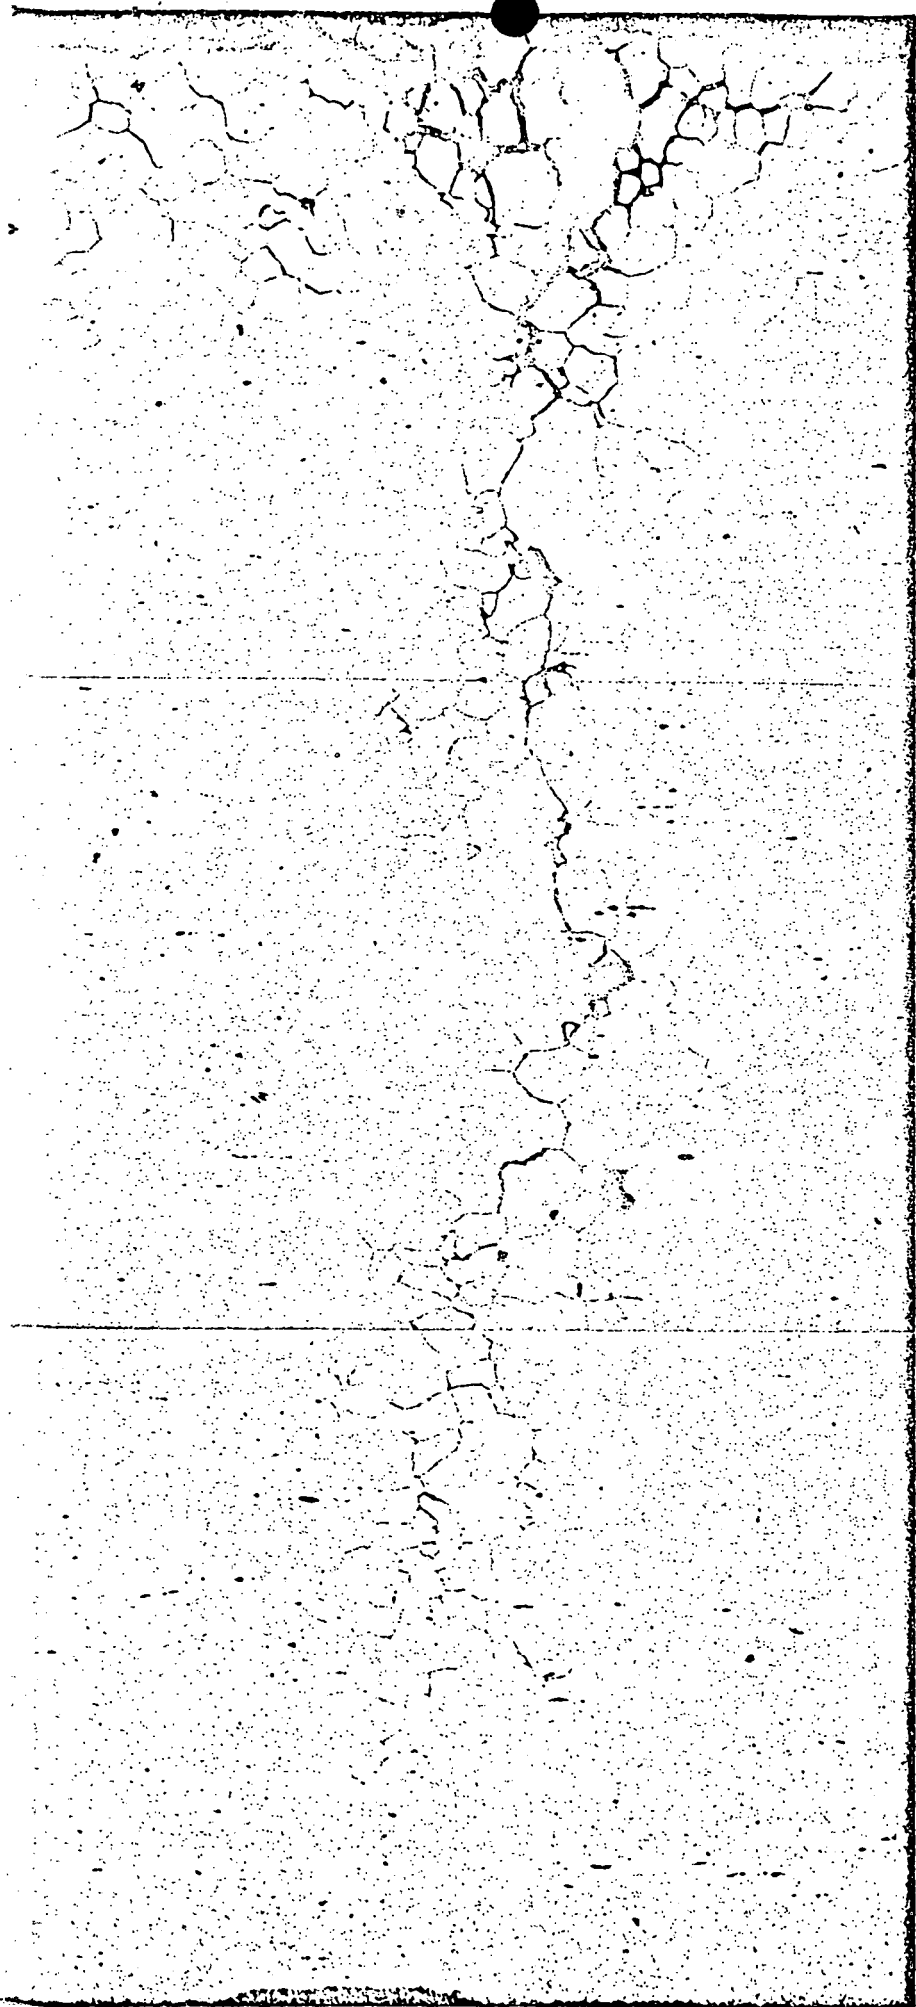
FIG. 1B.

CROSS SECTION OF  
CIRCUMFERENTIAL  
CRACK B

CRD COLLECT  
HOUSING - # 20

100X

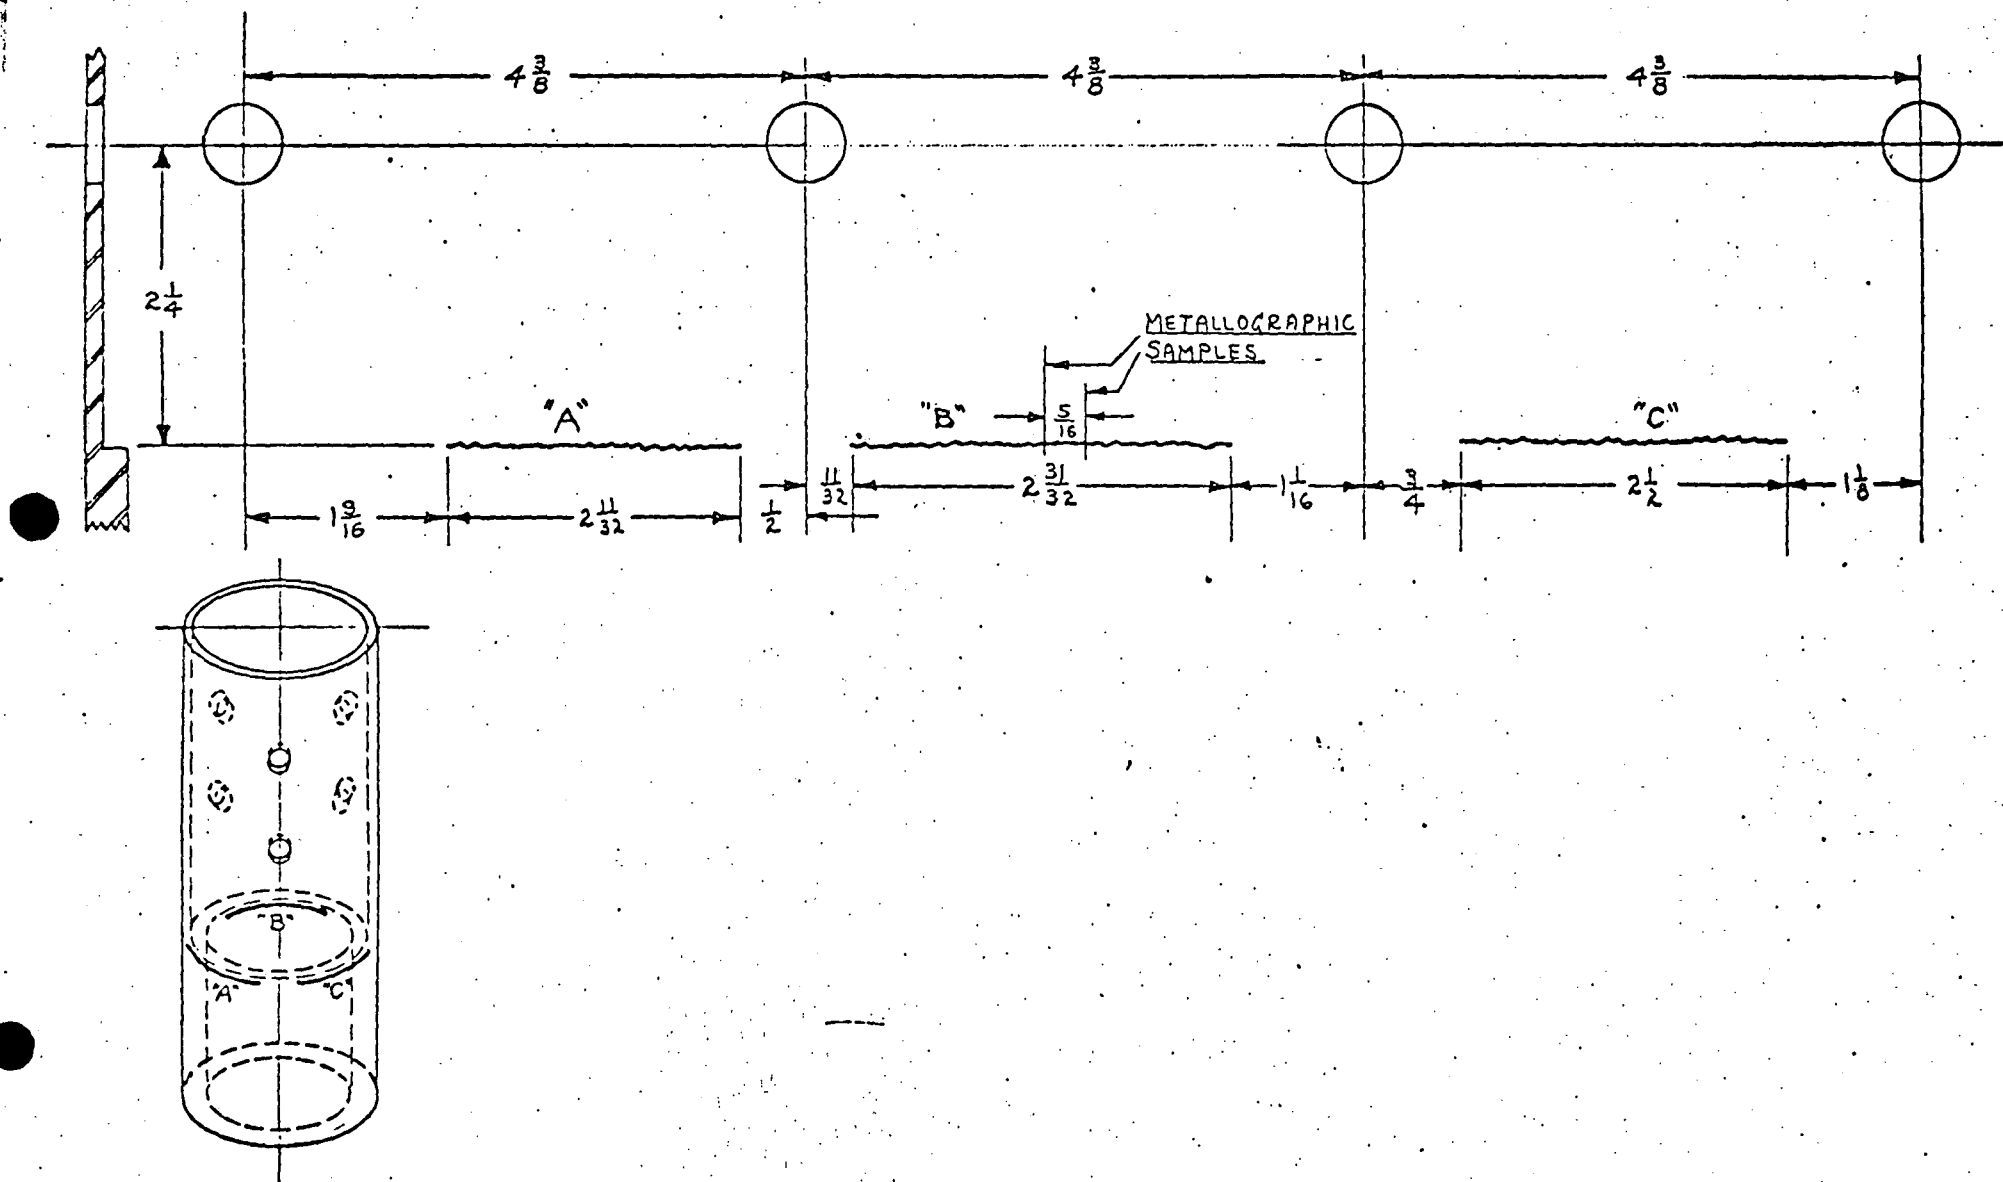
OD OF CIRCUMFERENTIAL CRACKS  
 CRD COLLECT HOUSING - #3271
