**UNITED STATES  
NUCLEAR REGULATORY COMMISSION**

EA-17-114

**SUBJECT: LASALLE COUNTY STATION, UNITS 1 AND 2—SPECIAL INSPECTION  
TEAM REPORT AND EXERCISE OF DISCRETION; INSPECTION  
REPORT 05000373/2017009; 05000374/2017009**

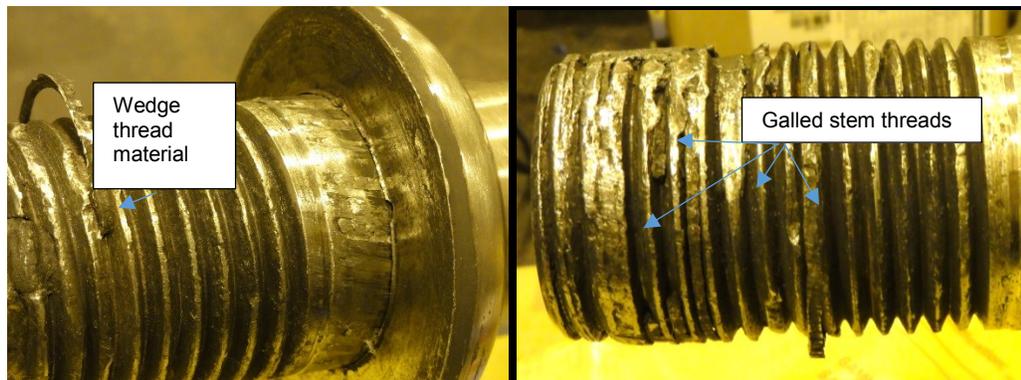
- On February 8, 2017, the valve stem was cleaned and lubricated. A stem rotation check was then performed during a scheduled refueling outage. The stem rotation check was verified to be less than approximately 5–10 degrees between the open and closed strokes. This met the procedural acceptance criteria.
- On February 8, 2017, a local leak rate test was performed using water with a differential pressure of 1000 psi gauge plus or minus 50 psi across the valve. The leak rate test passed with minimal leakage. System parameters indicated that the valve stem and wedge/disc were cycling without issue.
- On February 11, 2017, the valve stem was identified to have separated from the wedge during a system fill and vent activity. Pictures of the degraded stem and embedded wedge thread fragments are shown below.

Figure 1 - As-Found Stem of Failed 2E22-F004 Valve

- In February 2017, a 100 ton lift was used at near rated capacity to remove the wedge and disc from the seat. The 2E22-F004 valve was repaired using a new stem with an integral collar as compared to the pressed-fit collar on the original stem that shifted up as shown above. The new stem was pre-torqued into the wedge to approximately 7000 ft-lbs of torque.

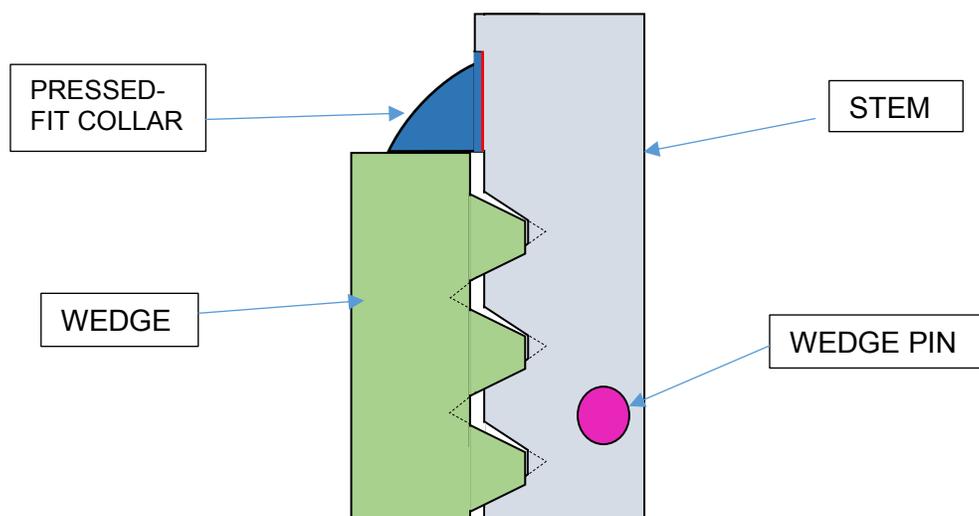
- **Initial Conditions.** The stem was manually threaded into the wedge with an initial preload that loaded the collar and put the stem threads into tension. The stem-to-wedge threaded connection was then pinned by drilling a hole through the wedge-stem-wedge. The initial installation torque and preload applied was very low and estimated to be less than 38,000 lbf based upon the pressed-fit collar capacity.

Figure 2 - Threaded Connection Diagram Initial Condition

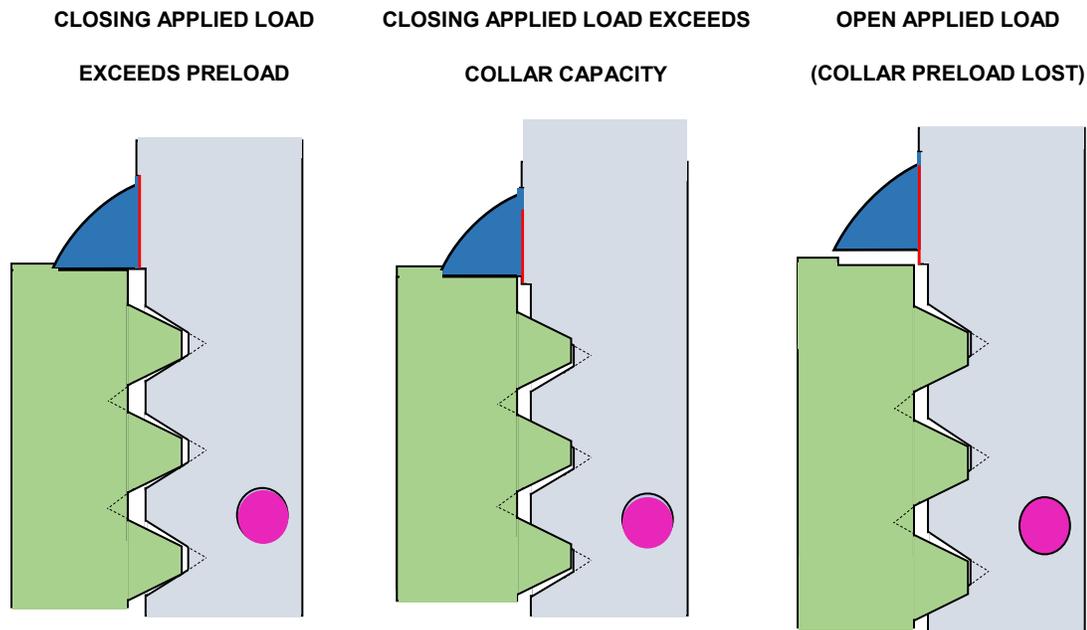
- **Collar Slip/Loss of Preload.** The normally applied closed thrust loads of over 200,000 lbf exceeded the pressed-fit collar load capacity, causing it to slip. Once the collar slipped, preload was lost.

Figure 3 - Threaded Connection Degradation Diagram

- **Pin Shear.** After loss of preload, a portion of the axial loads were applied to the wedge pin, along with torsional loads, which exceeded the capability of the thread and collar friction. The subsequent applied torsional loads in the closing direction failed the wedge pin.
