Recommendations to Resolve Flowserve 10CFR Part 21 Notification Affecting Anchor Darling Double Disc Gate Valve Wedge Pin Failures (Revision 4)

BWROG Valve Technical Resolution Group

IE19

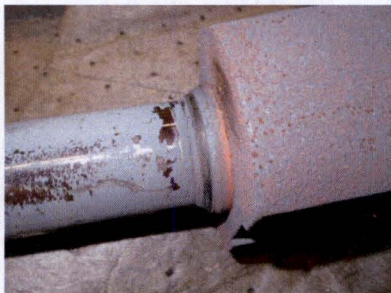
Disassembly Inspection Results of the 1-FCV-073-0002 Valve (11/2012 Failure)

Upon valve disassembly, it was identified that the shoulder of the stem was hard against the upper wedge (no gap) as shown left. The plant initially decided to try and unthread the stem from the upper wedge. The stem and wedge were secured in a chuck and the valve maintenance team attempted to unthread the stem from the wedge with a 48" pipe wrench. The stem did not move with the efforts of two able bodied men pulling on the end of the wrench. When the stem could not be unthreaded from the upper wedge, it was cut / machined to determine which way the stem had rotated as shown in the picture below. The picture below shows the stem had tightened in the upper wedge approximately 80°. This signifies the stem had tightened in the upper wedge going in the closed direction. After discussion with the valve vendor, it was concluded the stem to wedge connection was not torqued adequately when Flowserve assembled it at the factory. Flowserve identified they did not have any as-built documentation showing the stem was torqued into the upper wedge when the valve was assembled at the factory.

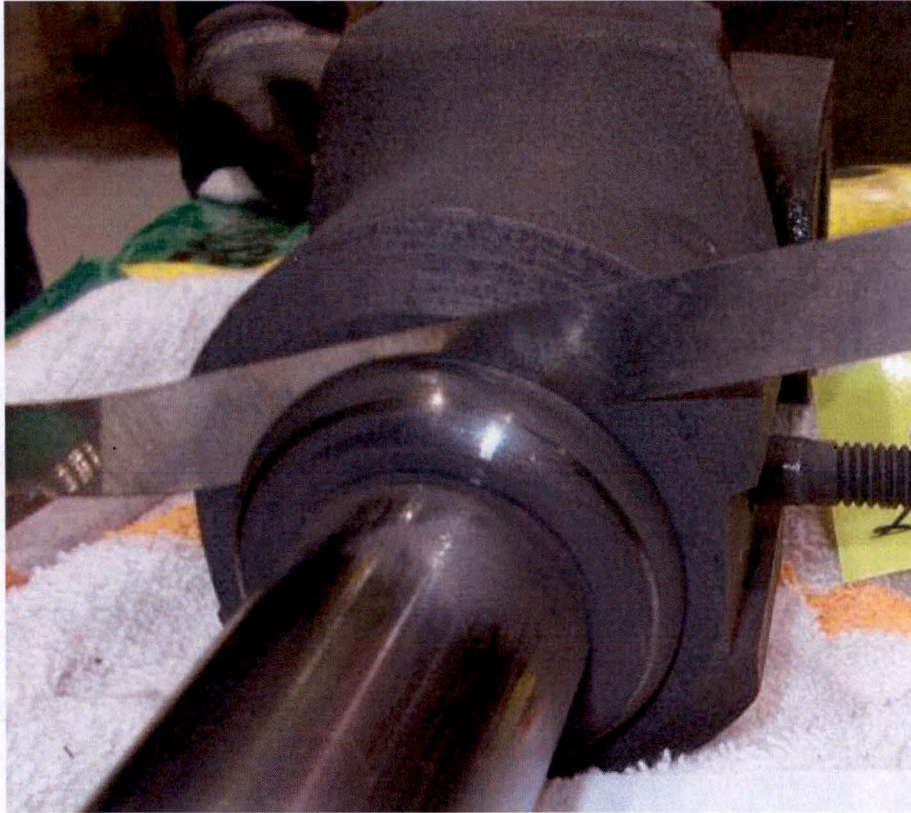
Photo (a); Stem, upper wedge, and pin assembled. Gage showing gap (i.e. loose connection)

Twenty-four MOVs were found with loose stem to wedge connections (i.e. no factory pre-torque). In all cases, the upper wedge could be unthreaded from the stem by hand after the pin was removed. In most cases, there was a measurable gap between the upper wedge and stem shoulder when the stem, wedge, and pin were completely assembled, see photo (a). In all cases the upper wedge, stem threads, and pin were in good condition. See photos (a), (b), (c), (d), (e).

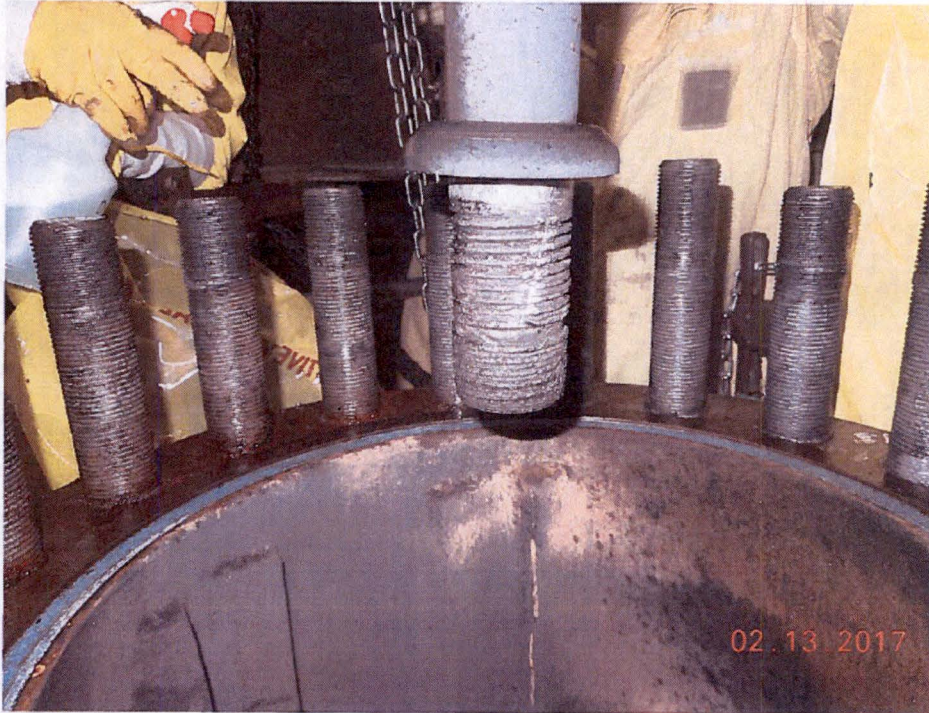
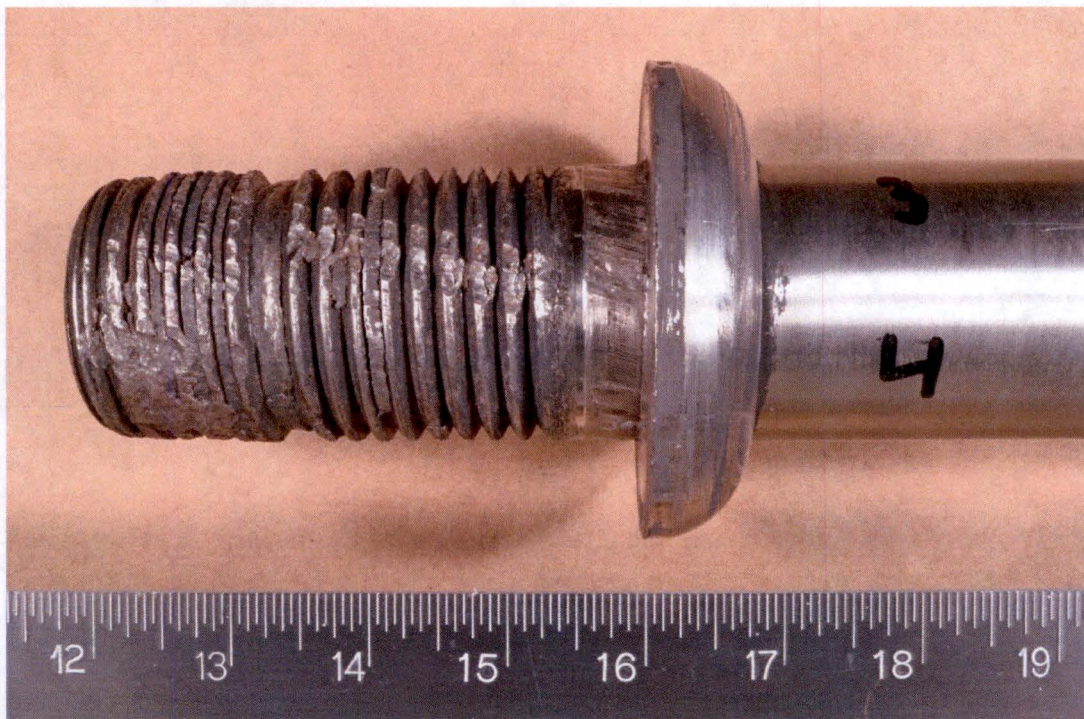
LaSalle 2E22-F004 - Stem with external threads with severe wear degradation

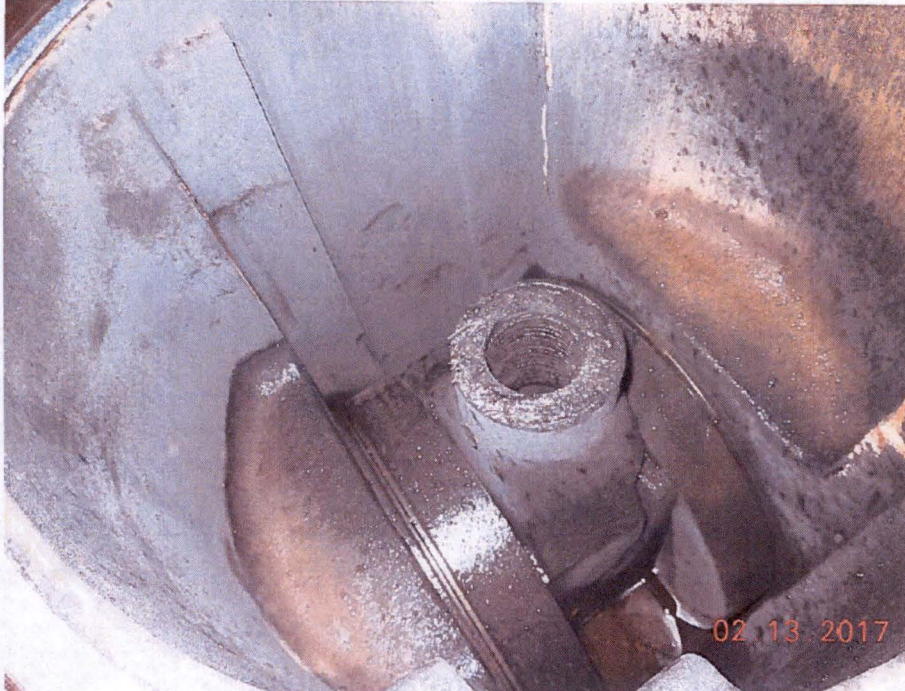
LaSalle 2E22-F004 – Upper wedge with internal threads with severe wear degradation, wedge pin was found sheared.

Post failure analysis of the 2015 2E22-F004 Diagnostic traces identified anomalies in the valve open pullout region that were not present during the previous 2011 and 2005 traces. Additional review of maintenance work order inspection data indicated that the stem rotation checks were at the maximum allowable value. A lesson learned from the event is that the MOV diagnostic test data anomalies were not attributed to a potentially degraded stem-disc connection (see diagnostic trace overlays in Section V.). Given that the failure occurred within just one operating cycle from possible detection in 2015, it is unlikely that this failure could have been prevented unless more aggressive corrective actions are instituted.

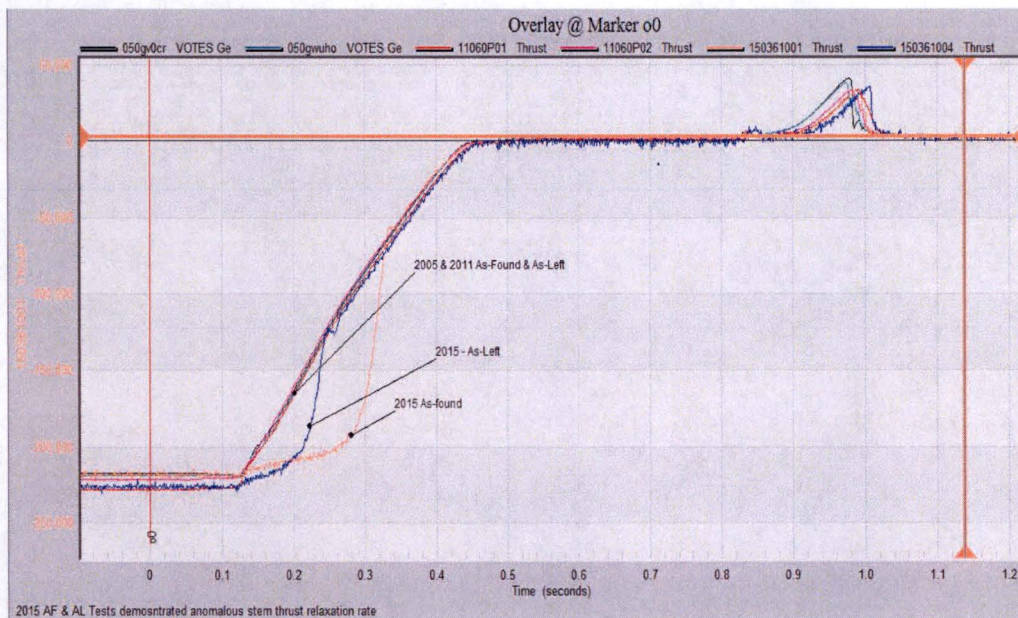
LaSalle MOV Thrust and Torque Signature Overlay Open Stroke @ Motor Start
(Tests from 2005, 2011 and 2015)

Anomalous characteristics were observed on both the as-found and as-left 2015 Quiklook Thrust and Torque Signatures in the open stem decompression region that were not observed in previous 2011 and 2005 tests. Also, note that in 2005 and 2011, anomalous torque plateaus were observed during the torque relaxation region just after motor start. Additionally, stem rotation checks performed in 2015, demonstrated 10 degrees of stem rotation which had previously (under TP-13-006 Rev.0) been at the extreme range of acceptability. No other Exelon MOV has demonstrated stem rotation checks beyond 5 degrees. Given the February 2017 LaSalle MOV failure, these observations are now considered indicative of active stem-disc connection degradation.

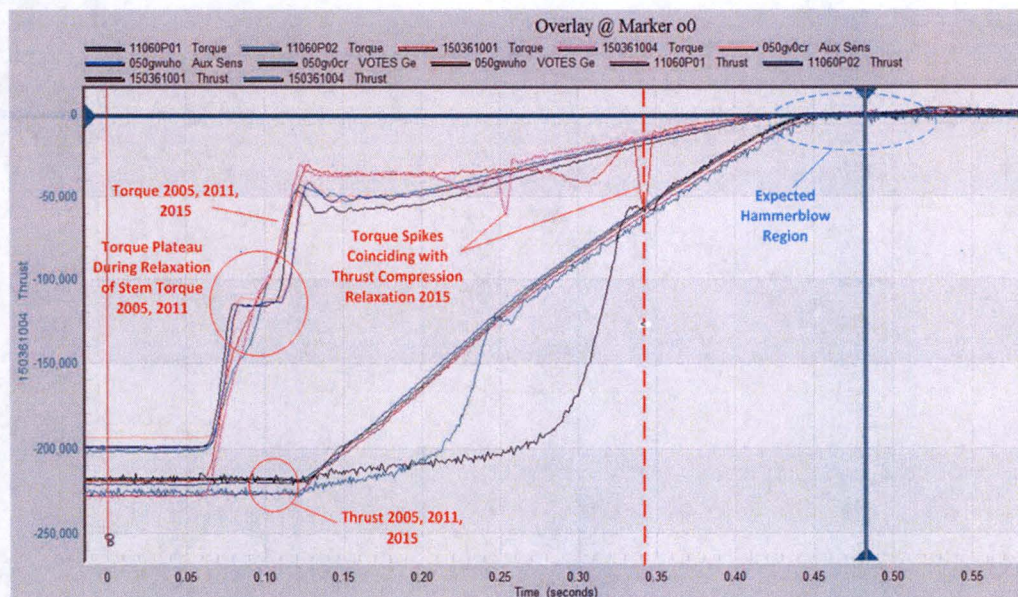
2E22-F004 Thrust Overlay showing anomalous thrust decompression on both 2015 AL & AL Diagnostic Tests

2E22-F004 Thrust and Torque Overlay showing unusual torque spikes coincident with 2015 Thrust decompression anomaly. Also, unusual torque plateau during torque relaxation in 2005 and 2011.

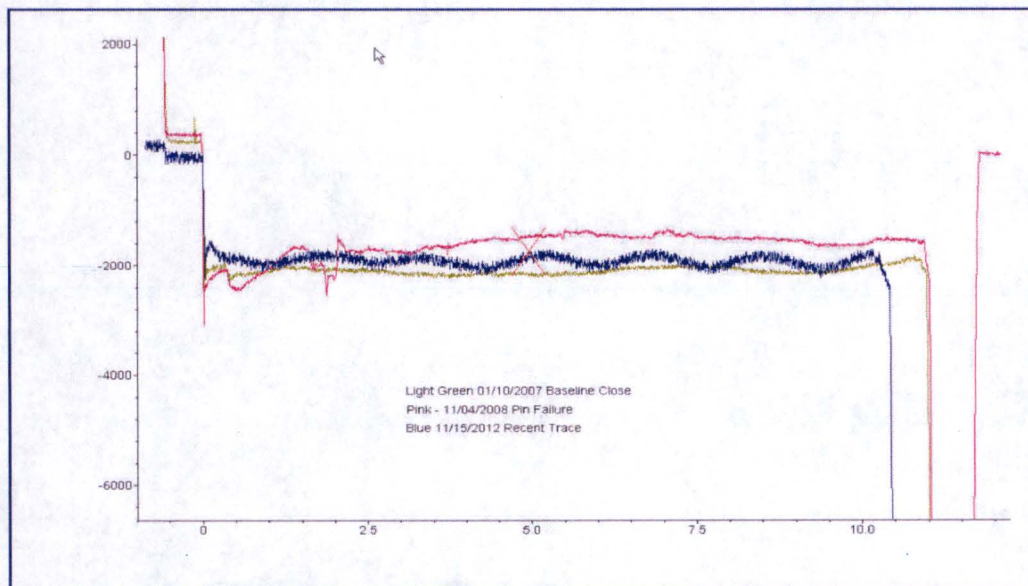
Both the 2008-BFN and 2007-Salem events were initially identified by diagnostic test trace anomalies. The diagnostic test traces shown below is from the 2008 BFN wedge pin failure. Both these traces showed anomalies in the running thrust/torque near the seating and unseating areas. Increasing time between trace markers C8 (Open light out) and C11 (Hard seat contact) and or C14 (Control switch trip) would be another potential indicator of wedge pin failure.

MOVATS Traces of BFN 1-FCV-073-0003 in 2007, 2008 (Failure) and 2012 (Close)

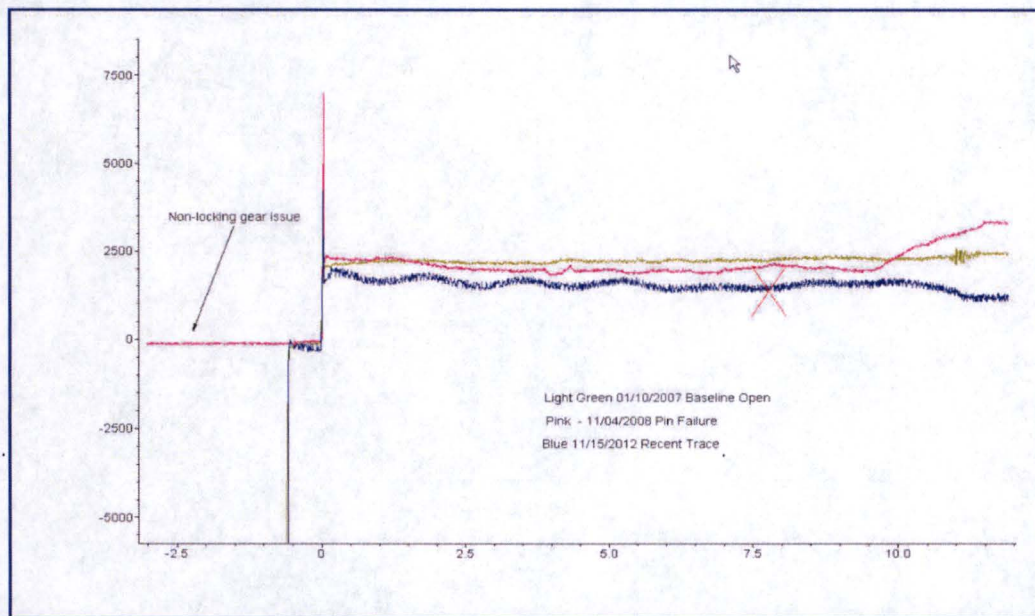
MOVATS Trace of BFN 1-FCV-073-0003 in 2007, 2008 (Failure) and 2012 Open)

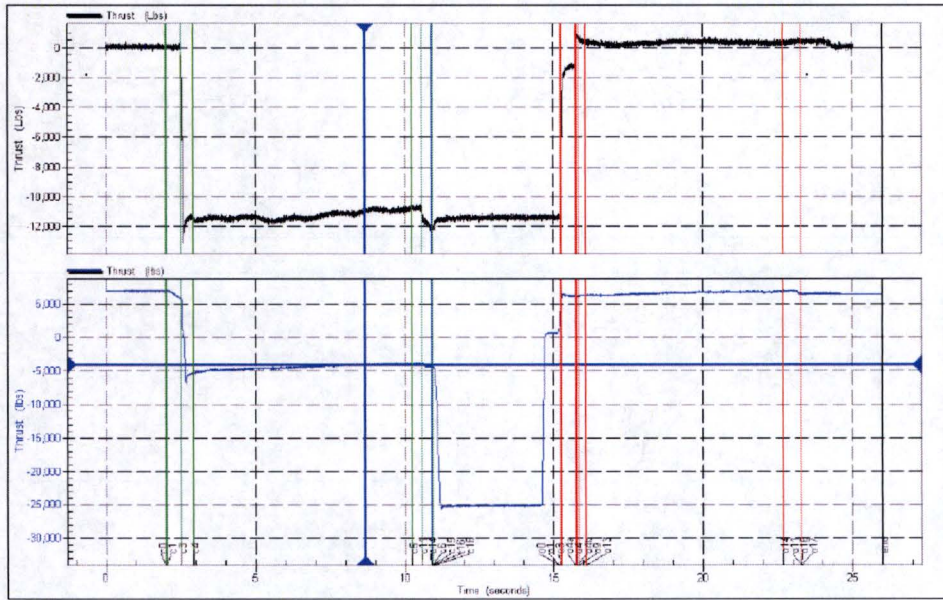
1SJ5 30104572 As-Left
10/24/2005 14:18:31 File 1SJ5 failure

Two diagnostic thrust traces are shown below. The top trace is from 2007 which shows the as-found thrust signature of the 1SJ5, 4-inch, 1500 # DD Anchor Darling valve – This is the trace where Salem discovered the failure – Very high running loads in the closing direction (Marker placed in running load region shows about 11,000 lbs. of running load). The bottom trace is the as left thrust signature from 2005.
