UNITED STATES
NUCLEAR REGULATORY COMMISSION
WASHINGTON, D. C. 20555

MEMORANDUM FOR: Thomas Murley, Director
Office of Nuclear Reactor Regulation

SUBJECT: RESEARCH INFORMATION LETTER 167 : NUCLEAR PLANT AGING
RESEARCH: WESTINGHOUSE DS-SERIES 480-VOLT CIRCUIT BREAKERS

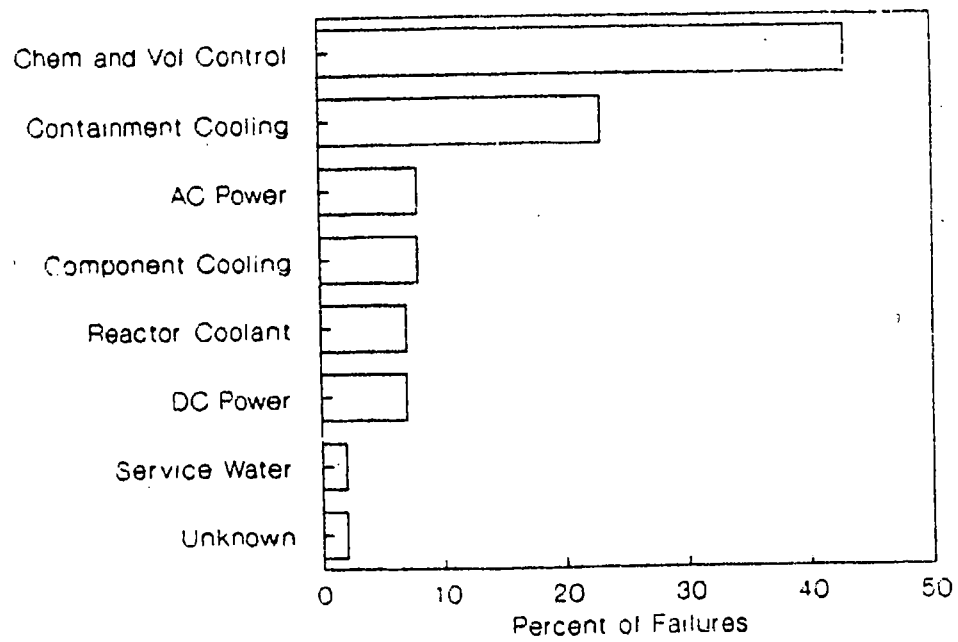
Figure 1. Systems affected

During 1970 through 1983, Westinghouse DS-416 reactor trip breakers exhibited problems with undervoltage trip attachments (UVTAs), which resulted in failure to trip on demand from the main control room. The problems came to a head when an ATWS event occurred at Salem in 1983. Consequently, Generic Letter 83-28 was issued requiring licensees to provide recommendations for improving the reliability of the reactor trip systems, including the circuit breakers. In response to pole shaft weld failures, which affected the operation of DS-416 and DS-206 breakers in reactor trip and other class 1E applications, Bulletin 88-01 was issued to require licensees to perform various inspections and measurements and report the results to the NRC. Figure 1 identifies systems affected by DS circuit breaker failures, in addition to the Reactor Protection System.

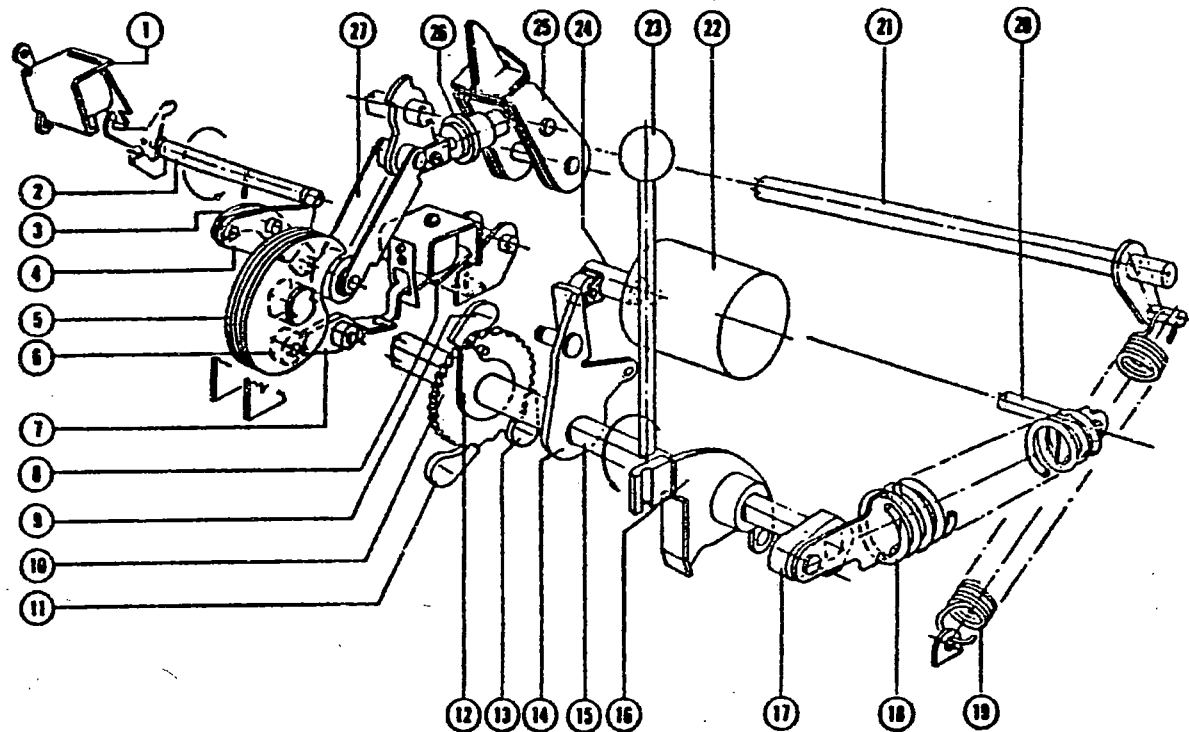
Figure 2. Arrangement of the principal parts of a completely power operated mechanism (the close spring is shown in the charged position)

In addition to the UVTA failures, a number of age-related problems were reported in recent years. These included cracking of welds in the pole shaft levers and secondary contact brackets, non-uniform wear on the closing-cam segments, misalignment of the main roller, broken spring-release latch levers and pivot pin to trip latch, loss of clearance between moving parts, and loss of spring tension in the cell switch spring return mechanism. Most of these failures are associated with the breaker operating mechanism that is illustrated in the attached Figure 2.

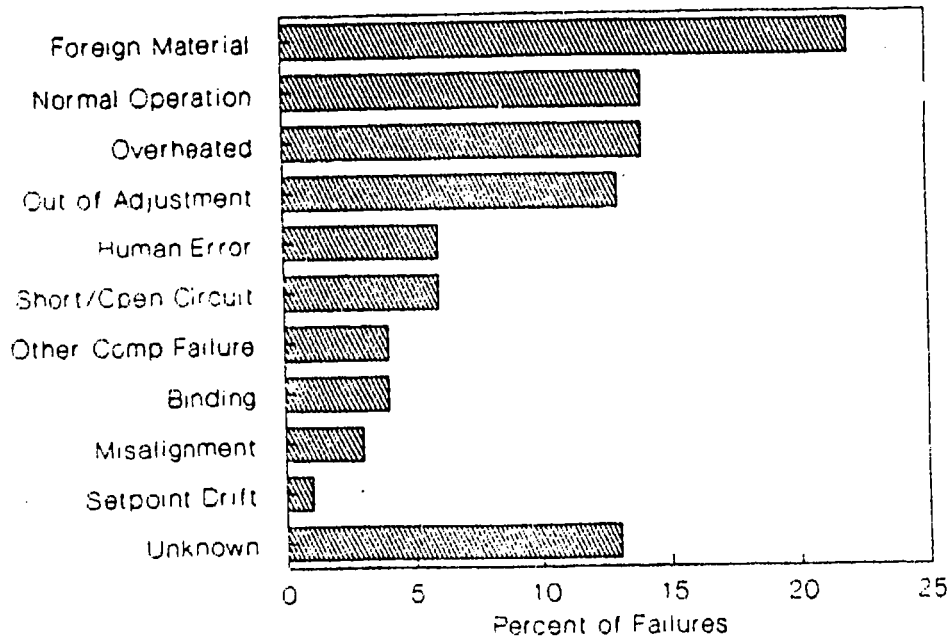
Figure 3. Failure cause

Figure 3 illustrates the causes of failure that have been identified. It can be observed that many of the causes (i.e., normal operation, out of adjustment, binding, misalignment, and setpoint drift) are aging-related and that the failures are related to the mechanical operation of the breaker and not the electrical portion.

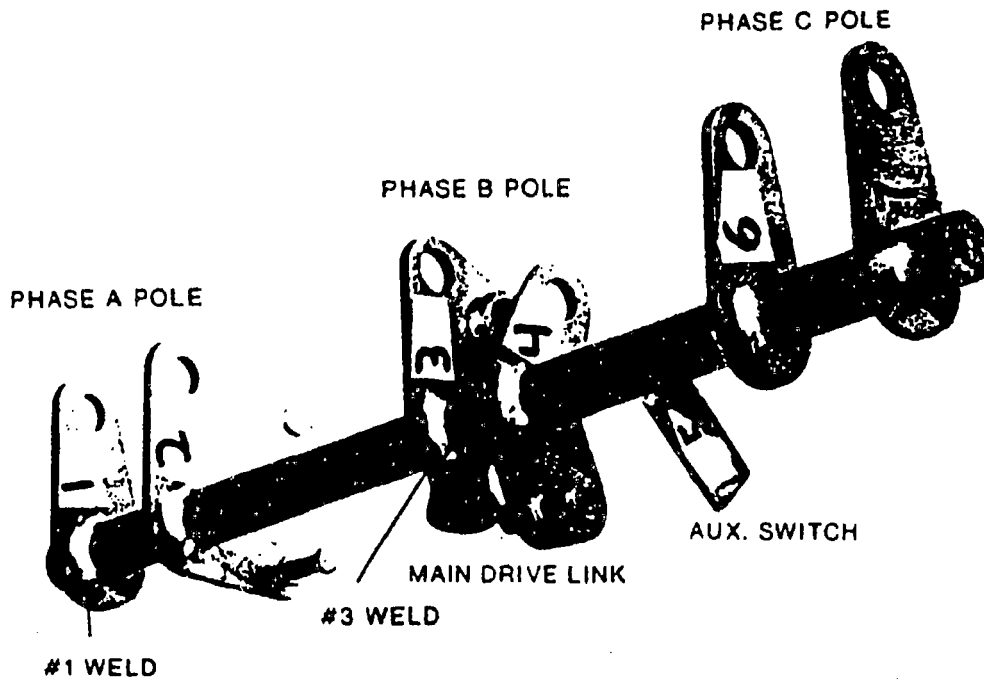
Figure 4. Pole Shaft with Seven Levers Welded on to it

Based on the results of the utility responses and the BNL testing, the pole shafts with substandard welds should be replaced or repaired to avoid any problems that could result from weld failures of the pole levers. The #3 lever weld experiences the worst stress condition under normal operation. Cracks in the #1 and #3 welds (Figure 4) start first and cause the breaker to be inoperable when they are allowed to grow to 25% of the weld length. Monitoring these two welds should be considered to avoid any problems stemming from the weld cracks.

- ° Inspection on receipt of new breakers should include an examination of pole shaft welds to verify 3/16-in. fillet welds of 180° coverage.
- ° The lubricant recommended by Westinghouse (BR-2) for bearings and linkages collected dust and contaminants. A dry film lubricant (i.e., NeoLube #2, Huron Industry) yielded better results. The lubricant (Lubriplate 130 graphite bearing grease) recommended for rubbing surfaces (cams, rollers, etc.) was not effective in reducing wear.
