UNITED STATES  
NUCLEAR REGULATORY COMMISSION  
WASHINGTON, D. C. 20555

SUBJECT: RESEARCH INFORMATION LETTER 167 : NUCLEAR PLANT AGING  
RESEARCH: WESTINGHOUSE DS-SERIES 480-VOLT CIRCUIT BREAKERS

The results of this work are reported in full in NUREG/CR-5280, Vol.1 (July 1990) and Vol.2 (November 1990), "Age-Related Degradation of Westinghouse 480-Volt Circuit Breakers." These NUREG reports received an extensive peer review, e.g., IEEE, Westinghouse, EPRI/NUMARC, national laboratories. Recommendations are made regarding maintenance practices including the frequency of maintenance. Specifically, the NUREG report recommends a method to track operating cycles imposed on each circuit breaker. This research provides a sound technical basis for developing procedures and criteria that are called for in NRC Generic Letter 83-28 and provides input to the resolution of technical issues of NRC Bulletin 88-01.

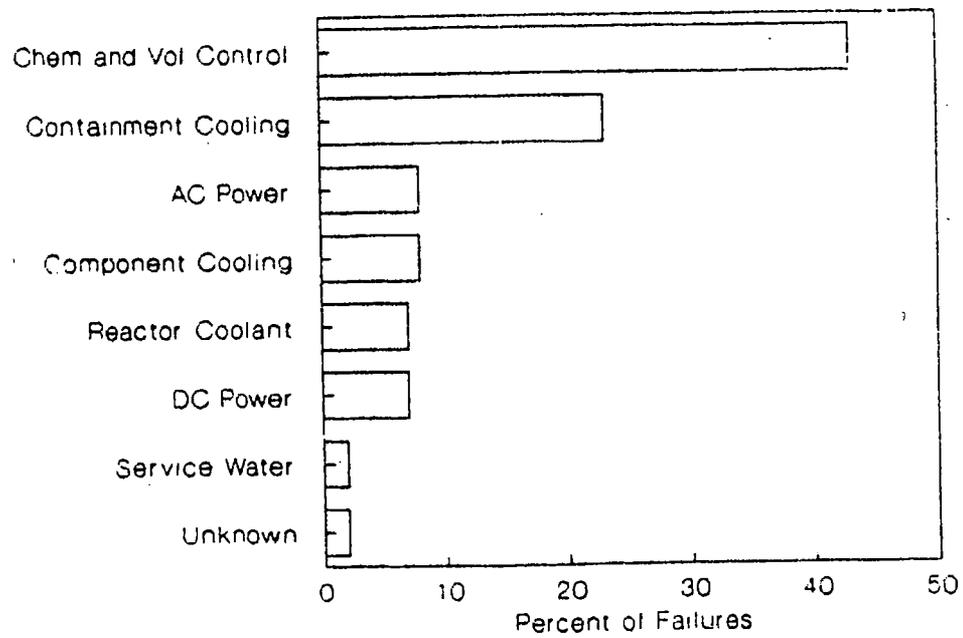
**Figure 1. Systems affected**

During 1970 through 1983, Westinghouse DS-416 reactor trip breakers exhibited problems with undervoltage trip attachments (UVTAs), which resulted in failure to trip on demand from the main control room. The problems came to a head when an ATWS event occurred at Salem in 1983. Consequently, Generic Letter 83-28 was issued requiring licensees to provide recommendations for improving the reliability of the reactor trip systems, including the circuit breakers. In response to pole shaft weld failures, which affected the operation of DS-416 and DS-206 breakers in reactor trip and other class 1E applications, Bulletin 88-01 was issued to require licensees to perform various inspections and measurements and report the results to the NRC. Figure 1 identifies systems affected by DS circuit breaker failures, in addition to the Reactor Protection System.

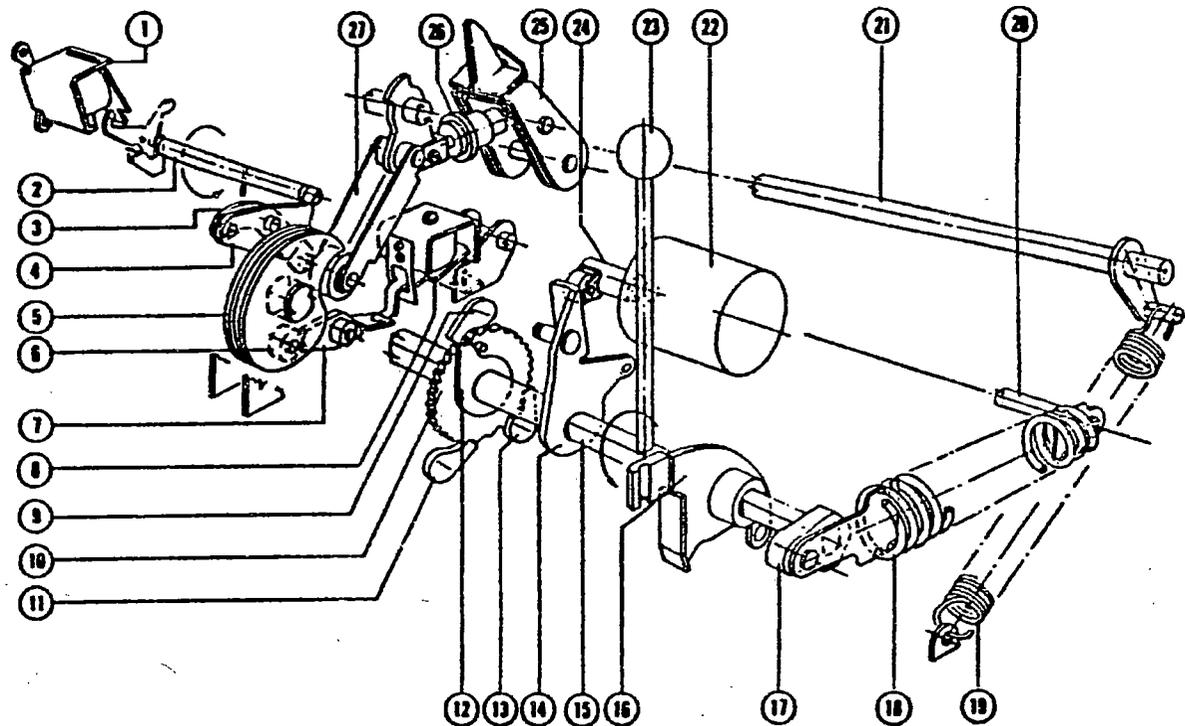
Figure 2. Arrangement of the principal parts of a completely power operated mechanism (the close spring is shown in the charged position)

In addition to the UVTA failures, a number of age-related problems were reported in recent years. These included cracking of welds in the pole shaft levers and secondary contact brackets, non-uniform wear on the closing-cam segments, misalignment of the main roller, broken spring-release latch levers and pivot pin to trip latch, loss of clearance between moving parts, and loss of spring tension in the cell switch spring return mechanism. Most of these failures are associated with the breaker operating mechanism that is illustrated in the attached Figure 2.

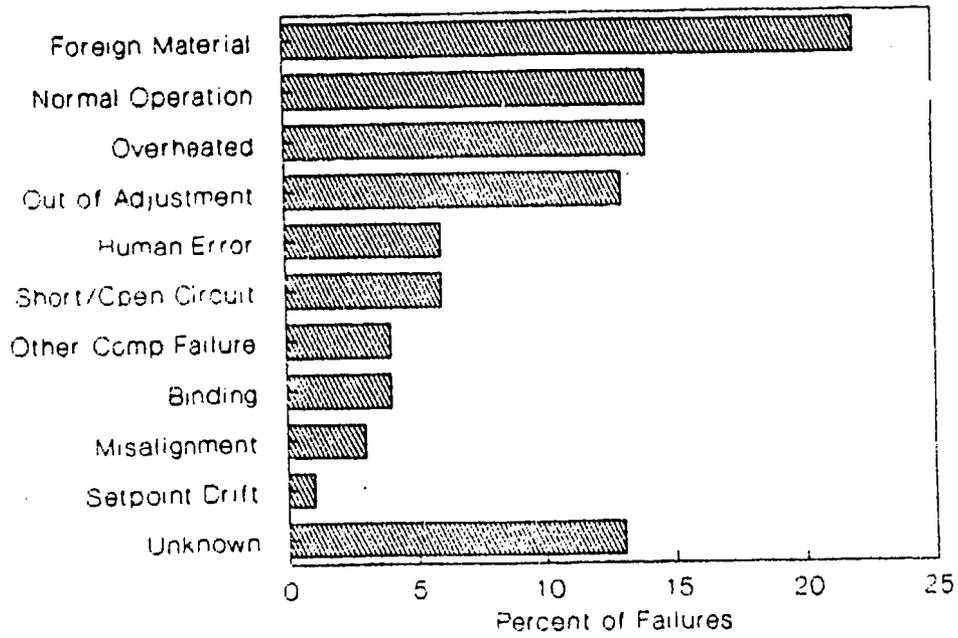
Figure 3. Failure cause

Figure 3 illustrates the causes of failure that have been identified. It can be observed that many of the causes (i.e., normal operation, out of adjustment, binding, misalignment, and setpoint drift) are aging-related and that the failures are related to the mechanical operation of the breaker and not the electrical portion.

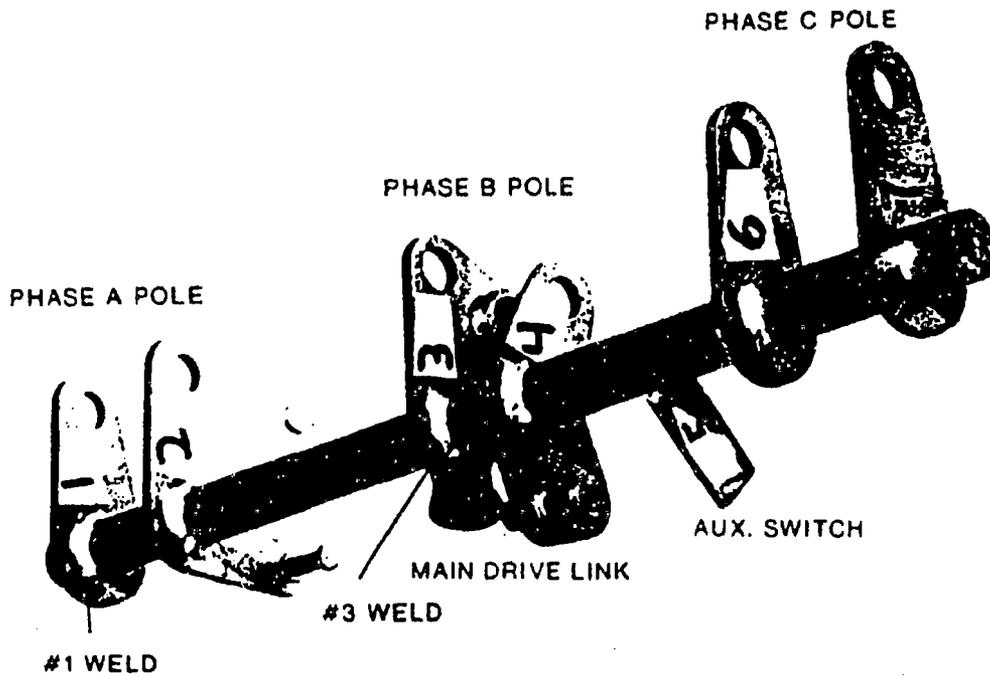
Figure 4. Pole Shaft with Seven Levers Welded on to it

Based on the results of the utility responses and the BNL testing, the pole shafts with substandard welds should be replaced or repaired to avoid any problems that could result from weld failures of the pole levers. The #3 lever weld experiences the worst stress condition under normal operation. Cracks in the #1 and #3 welds (Figure 4) start first and cause the breaker to be inoperable when they are allowed to grow to 25% of the weld length. Monitoring these two welds should be considered to avoid any problems stemming from the weld cracks.

- ° Inspection on receipt of new breakers should include an examination of pole shaft welds to verify 3/16-in. fillet welds of 180° coverage.
- ° The lubricant recommended by Westinghouse (BR-2) for bearings and linkages collected dust and contaminants. A dry film lubricant (i.e., NeoLube #2, Huron Industry) yielded better results. The lubricant (Lubriplate 130 graphite bearing grease) recommended for rubbing surfaces (cams, rollers, etc.) was not effective in reducing wear.
