UNITED STATES
NUCLEAR REGULATORY COMMISSION
WASHINGTON, D. C. 20555

SUBJECT: RESEARCH INFORMATION LETTER 167 : NUCLEAR PLANT AGING
RESEARCH: WESTINGHOUSE DS-SERIES 480-VOLT CIRCUIT BREAKERS

The results of this work are reported in full in NUREG/CR-5280, Vol.1 (July 1990) and Vol.2 (November 1990), "Age-Related Degradation of Westinghouse 480-Volt Circuit Breakers." These NUREG reports received an extensive peer review, e.g., IEEE, Westinghouse, EPRI/NUMARC, national laboratories. Recommendations are made regarding maintenance practices including the frequency of maintenance. Specifically, the NUREG report recommends a method to track operating cycles imposed on each circuit breaker. This research provides a sound technical basis for developing procedures and criteria that are called for in NRC Generic Letter 83-28 and provides input to the resolution of technical issues of NRC Bulletin 88-01.

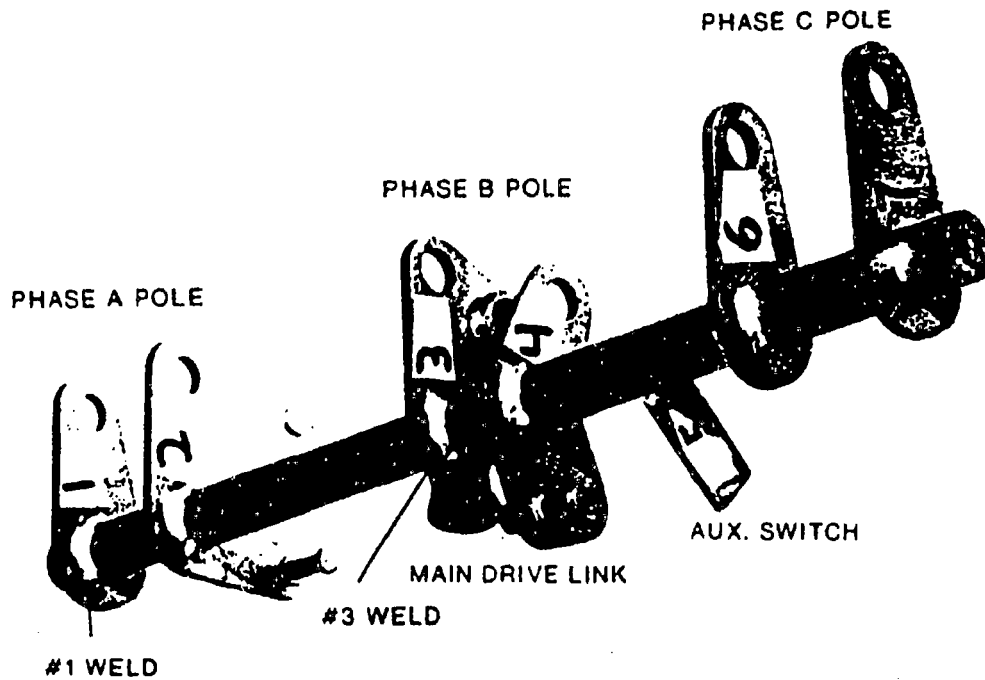
Figure 4. Pole Shaft with Seven Levers Welded on to it

Based on the results of the utility responses and the BNL testing, the pole shafts with substandard welds should be replaced or repaired to avoid any problems that could result from weld failures of the pole levers. The #3 lever weld experiences the worst stress condition under normal operation. Cracks in the #1 and #3 welds (Figure 4) start first and cause the breaker to be inoperable when they are allowed to grow to 25% of the weld length. Monitoring these two welds should be considered to avoid any problems stemming from the weld cracks.

- ° Inspection on receipt of new breakers should include an examination of pole shaft welds to verify 3/16-in. fillet welds of 180° coverage.
- ° The lubricant recommended by Westinghouse (BR-2) for bearings and linkages collected dust and contaminants. A dry film lubricant (i.e., NeoLube #2, Huron Industry) yielded better results. The lubricant (Lubriplate 130 graphite bearing grease) recommended for rubbing surfaces (cams, rollers, etc.) was not effective in reducing wear.
