Re: Colorado Radioactive Materials License # 317-02, Response to NRC Geologists
Report Regarding Groundwater at the Hecla-Durita Site

This letter is in response to the NRC Report entitled **Assessment of Hydrogeologic Conditions and Need for Long-Term Groundwater Monitoring at the Former Durita Uranium mill, Naturita, Colorado** prepared by Gene Peters and Randall Fedors of the U. S. Nuclear Regulatory Commission (NRC) dated May 3, 2007. This report was written following a site visit on July 12, 2006 that was intended to advance discussions concerning monitoring well abandonment and license termination. The NRC Report concluded that ground water monitoring was necessary and appropriate to demonstrate reasonable assurance of the absence of potentially unacceptable risk to human health and the environment. However, it is the state's opinion that this report relied on an incomplete understanding of the site geology and the decommissioning and reclamation work performed at the site. The report conclusions are speculative, and rely only on inferences from "lack of data" rather than relying on actual data that we believe supports license termination. To emphasize this point, the report

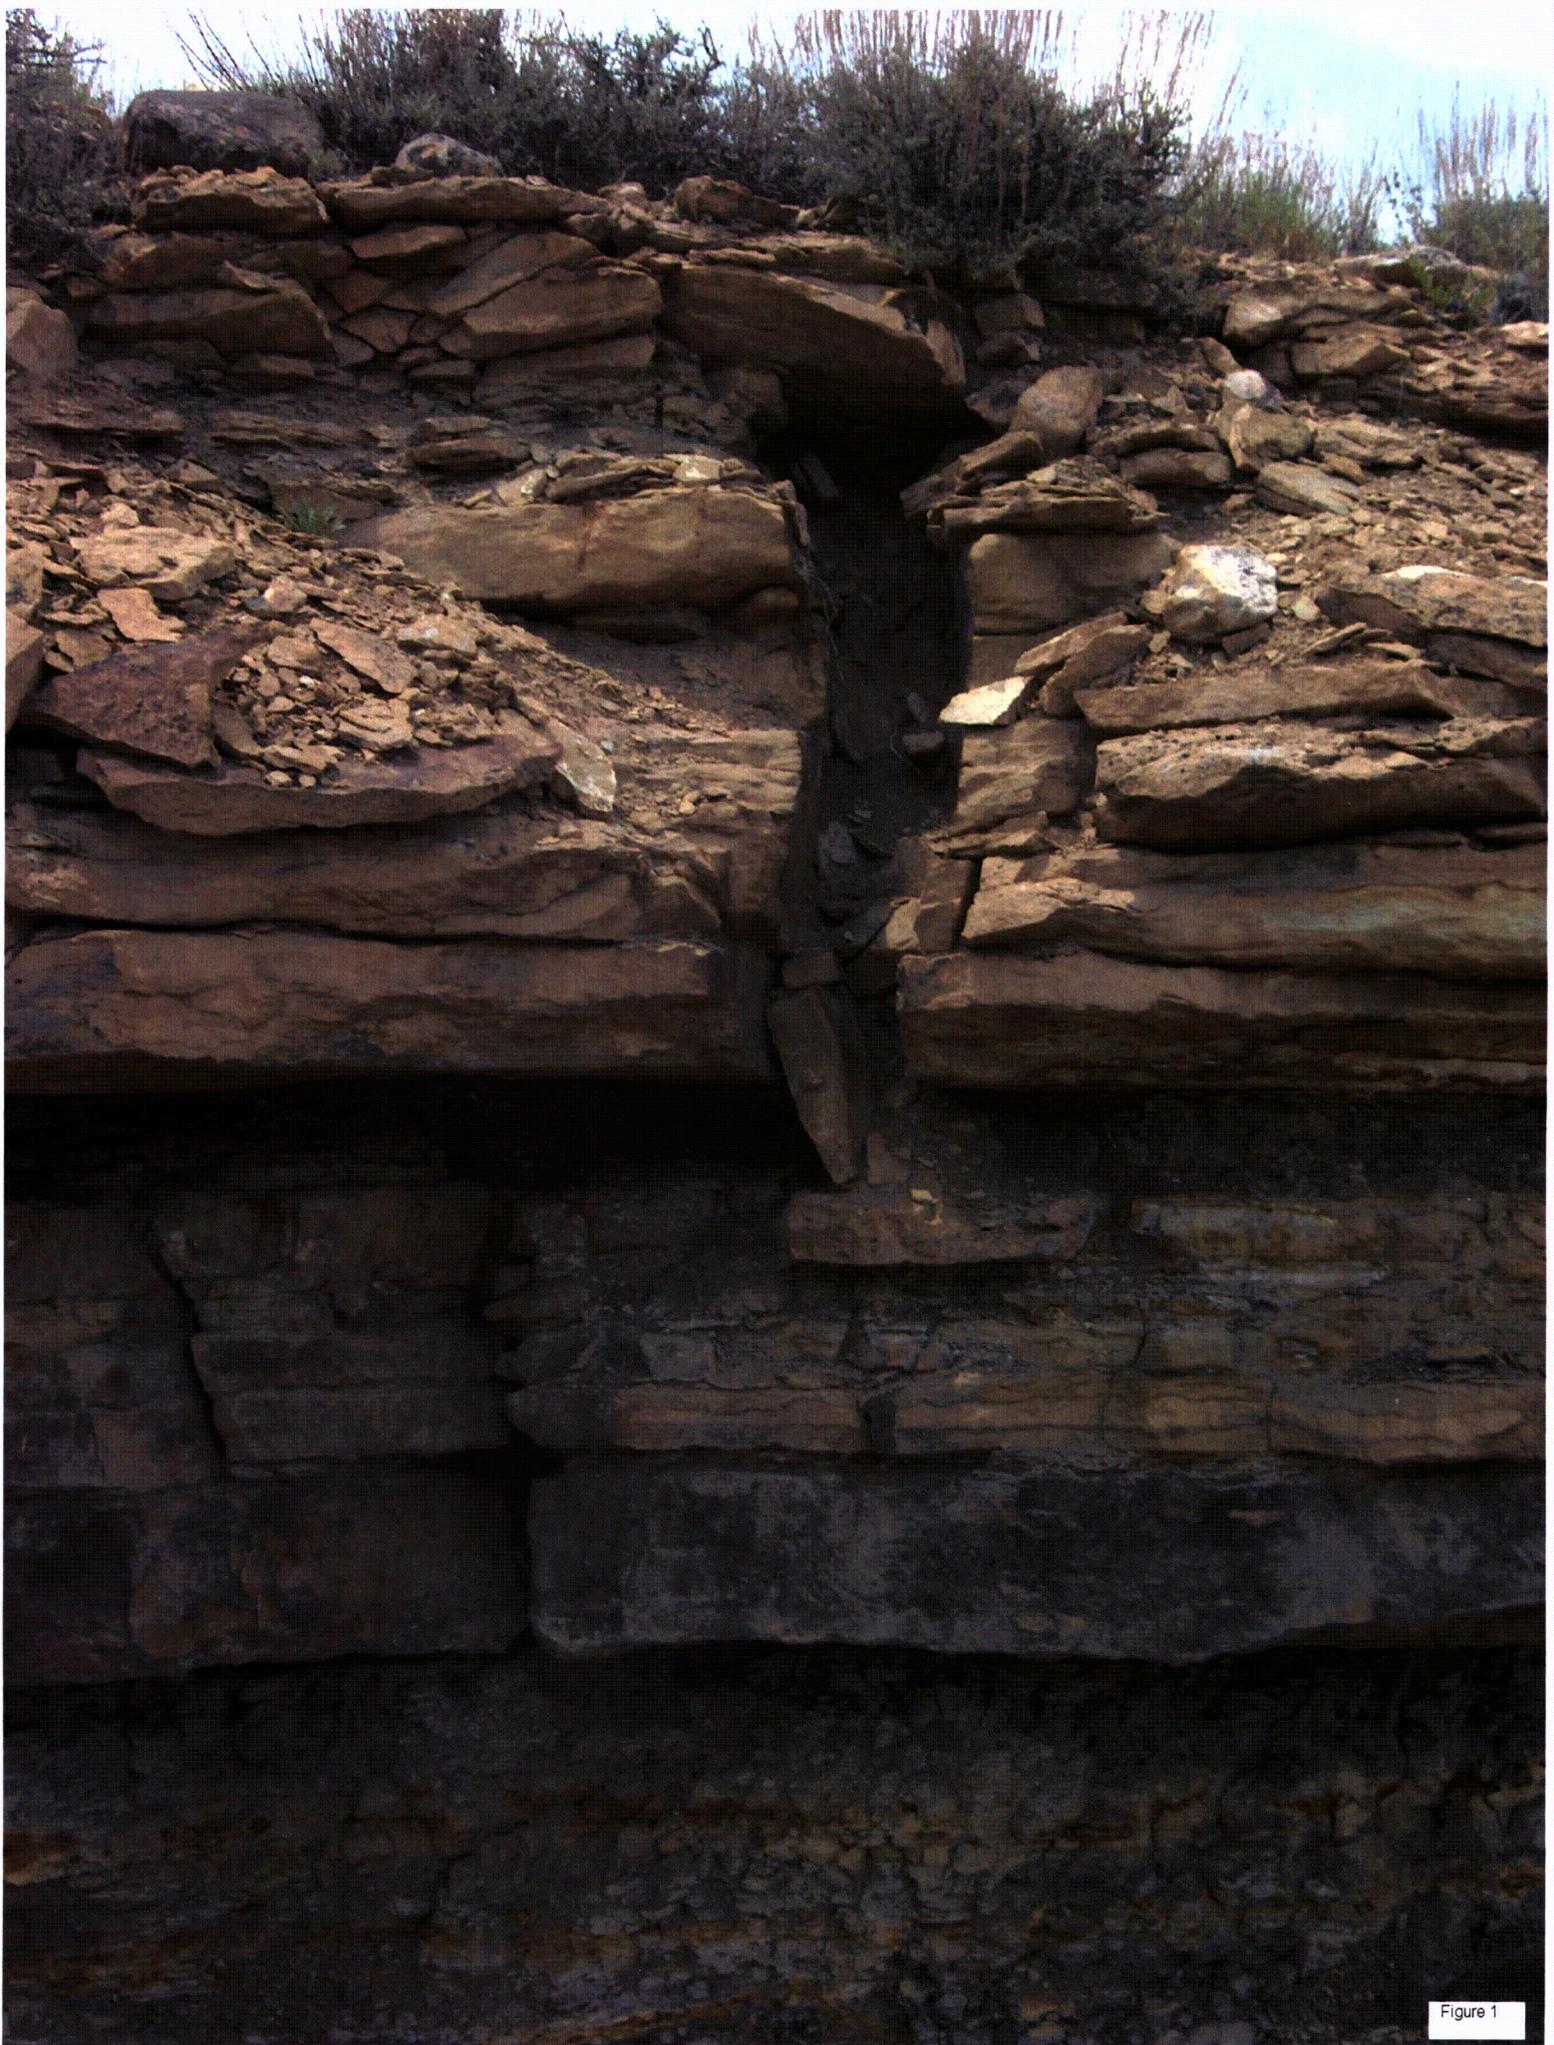
Figure 1 Photo of Fractures being non continuous

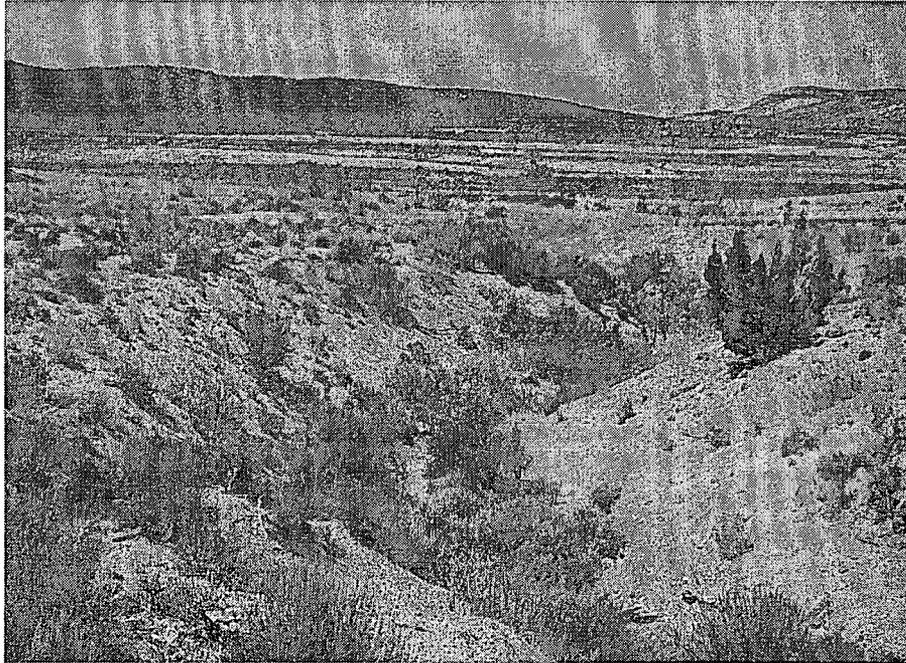
Therefore, these open fractures are surficial phenomena and are not persistent with depth. The Mancos Hill cut was made during site closure, and the Dry Creek cut bank is an actively eroding exposure that continues to slough to fresh surfaces; neither exposure is old enough to have weathered to soil. With time the shale slakes to finer fragments and finally to a clay soil. As the exposed Km surfaces weather, the shale breaks down to a clay soil consistency; this weathering is evident in a number of relatively recent Km cuts around the site that are only a few decades old (see photos 1 and 2). No open fractures are preserved in these surfaces.

Photo 1 – Outcrop of Mancos shale in an arroyo east of Durita site showing weathering to soil consistency and absence of vertical fractures.
