FINAL COMPLETION REVIEW REPORT

**For the Hecla Mining Company Durita Facility
Montrose County, Colorado**

Colorado Radioactive Materials License No. 317-02

March 2, 2016

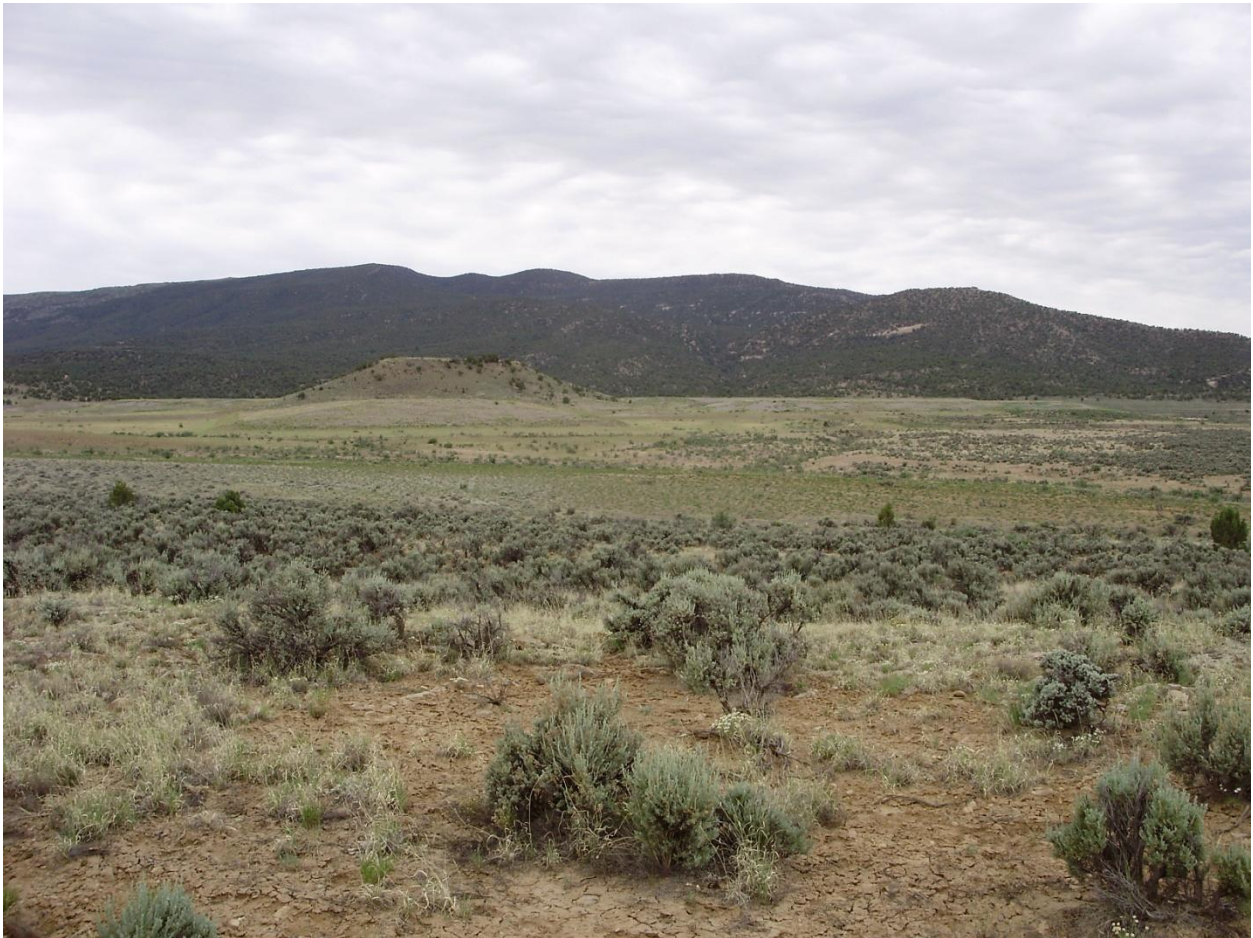
Photograph 1: View of the Durita site looking southwest. Mancos Hill is visible in the middle distance. The disposal cell is between the viewer and Mancos Hill. Leach pads LT-201 and LT-202 are to the right of Mancos Hill and leach pad LT203 is to the left and behind Mancos Hill.

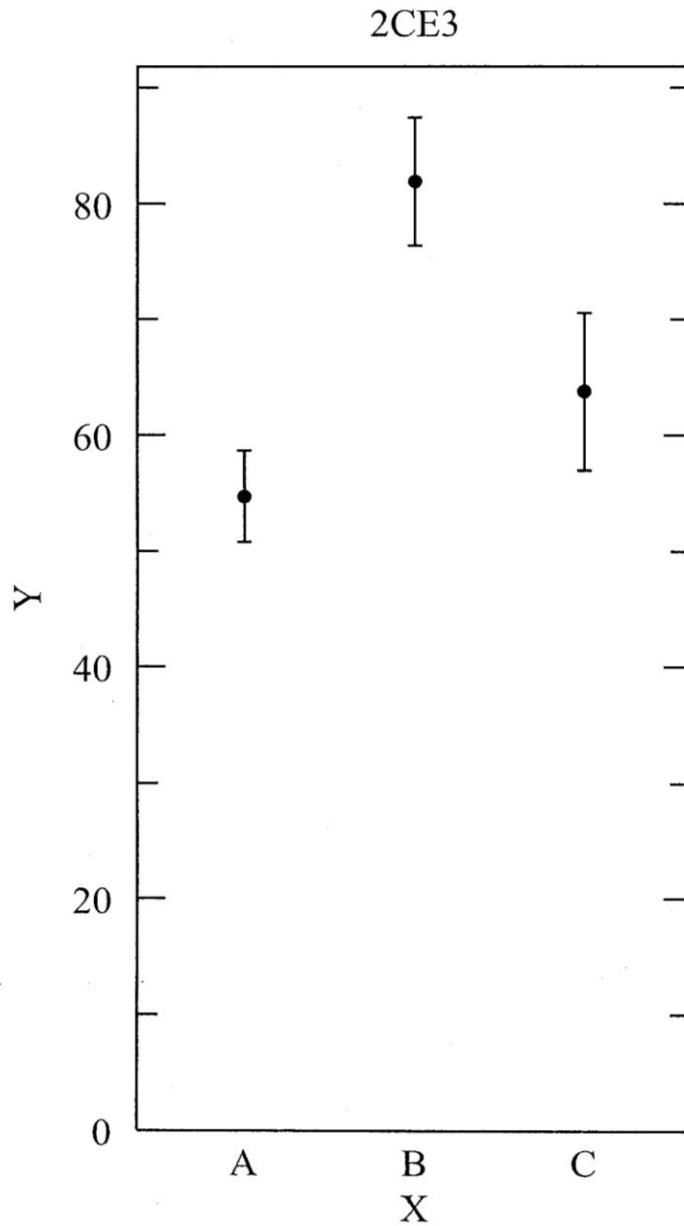
Plot of means with 95 percent confidence interval of the chloride content populations for monitor well MW-4. Population A is the analyses from April 1977 to August 1986. Population B is the analyses from November 1986 to October 1989. Population C is the chloride analyses from December 1989 to November 1991. Population B shows a distinct statistical character from population A and C.

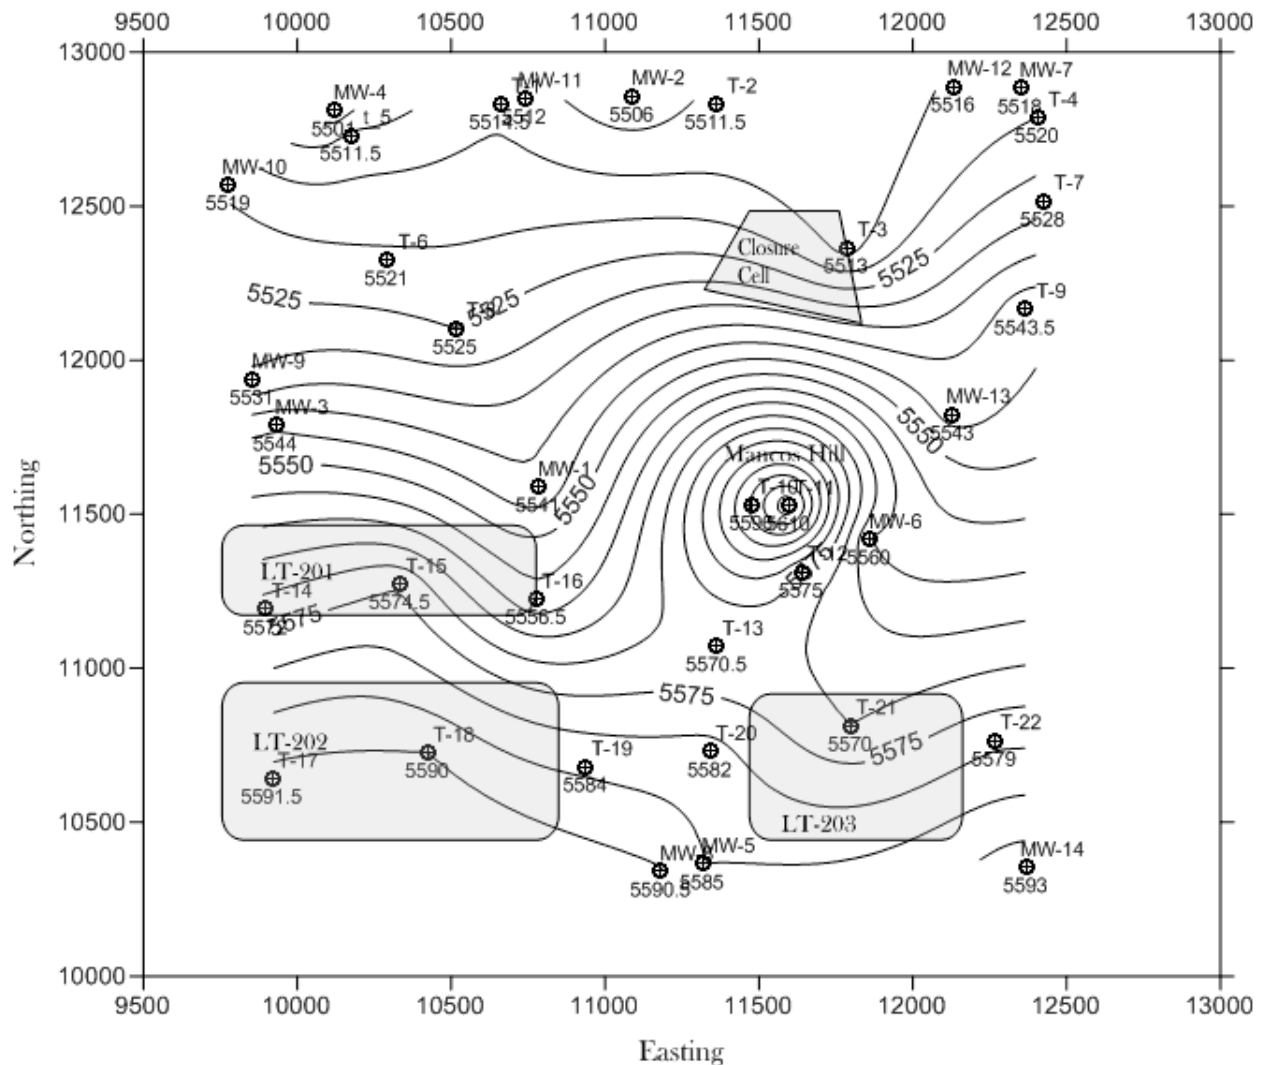
Durita Site Shallow Aquitard Contours
 based on test holes and monitor wells
 stratigraphic data. Kriging interpolation.

Figure 7.3. The drilling description of MW-1 shows the presence of unconfined groundwater at this interface. MW-1 appears to be in the channel of this aquitard surface. This aquitard-surface channel appears to go from the vicinity of MW-8 through MW-1 to the vicinity of MW-4 and MW-10. This channel collects the unconfined flow from the area between T-22 and T-15. Water in the low point of the aquitard surface was seen during the drilling program conducted in Four Corners Environmental Research and reported in 1977. Because of the location of test holes, the prominent positive feature associated with Mancos Hill is displaced to the south.
