UNITED STATES  
NUCLEAR REGULATORY COMMISSION  
WASHINGTON, D. C. 20555

SUBJECT: RESEARCH INFORMATION LETTER # 123 PERFORMANCE OF  
ELECTRICAL TERMINAL BLOCKS EXPOSED TO A LOCA OR  
STEAM ENVIRONMENT

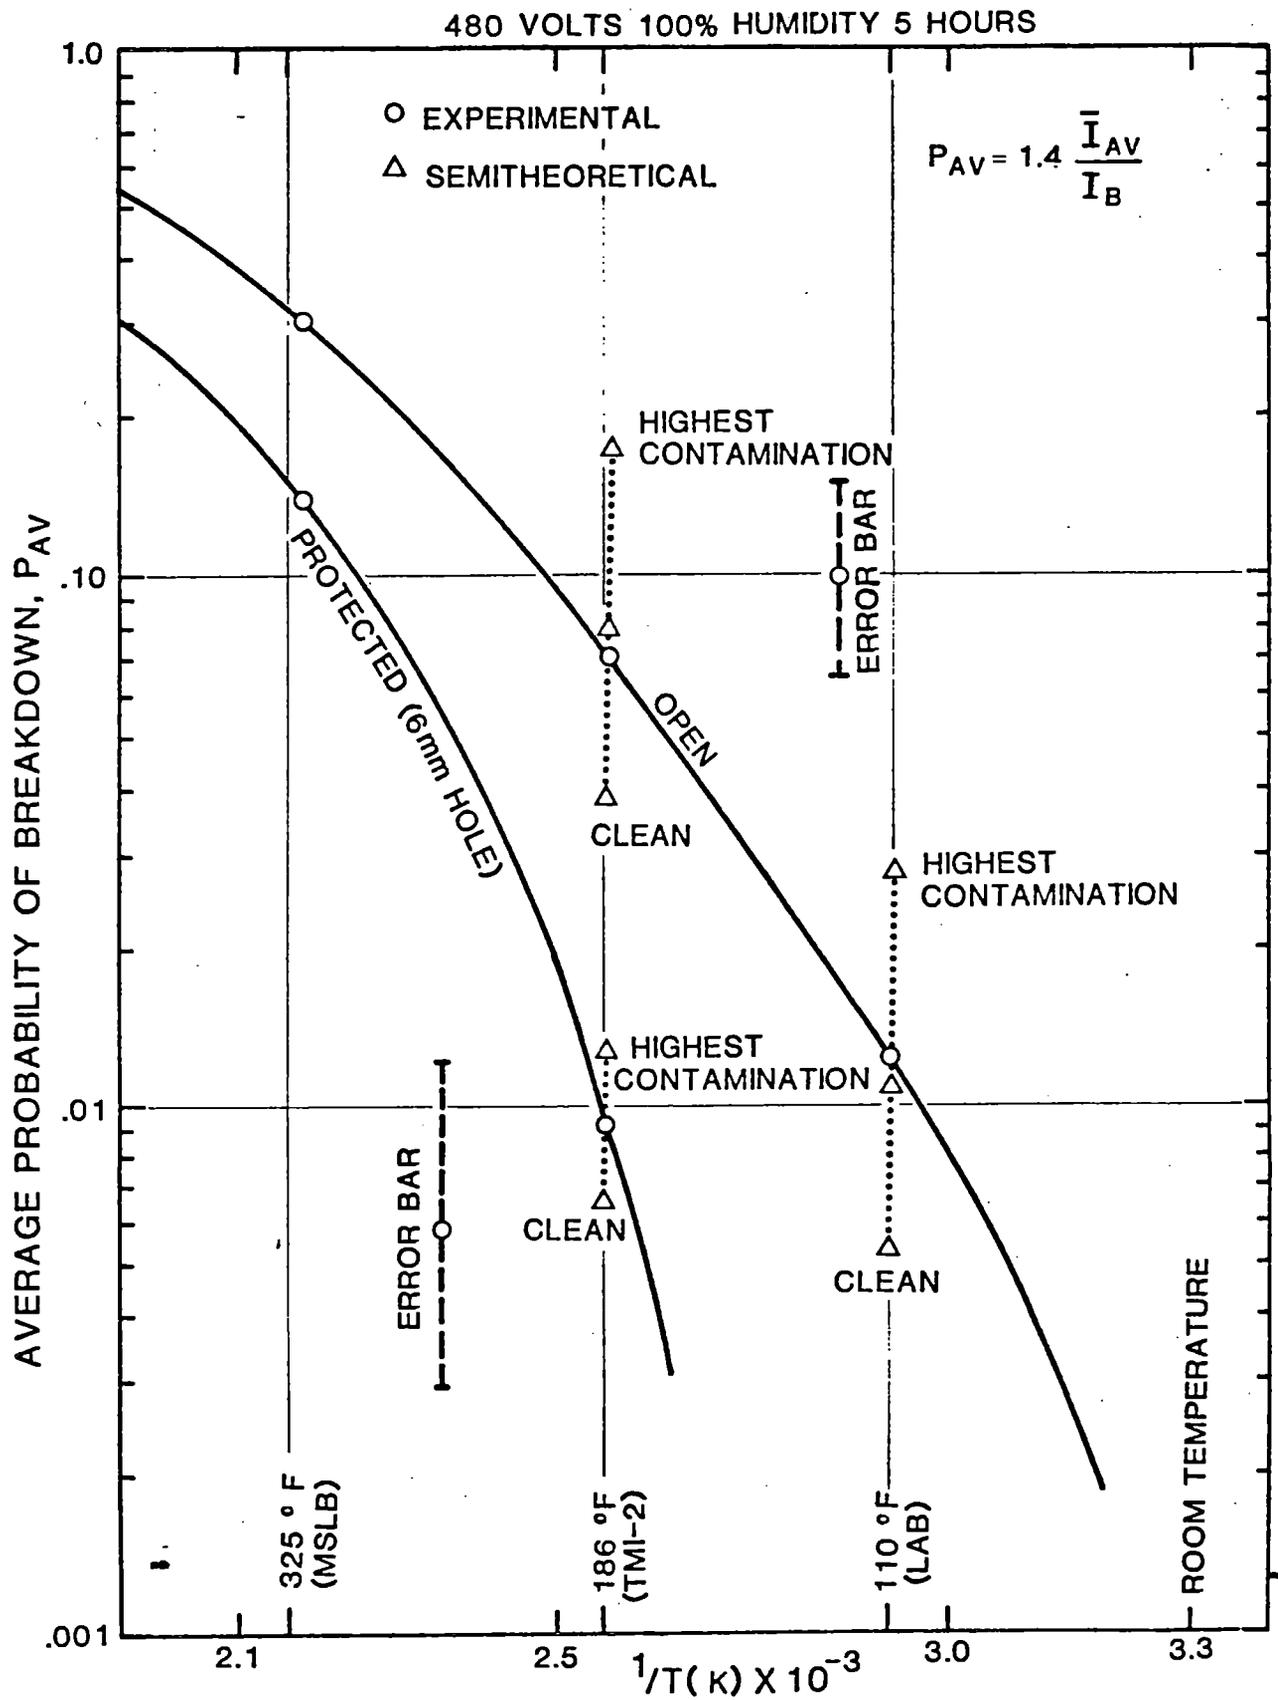
Fig. 1

1. Figure 1 and Table I show, in summary form, the results of the experiments and the conclusions drawn by use of the probability model.

The data relate the probability of terminal-to-ground low-voltage breakdown as a function of the inverse temperature. Curves are drawn through experimental data points for both the open and enclosed terminal blocks. Also, data are shown for various conditions of relative contamination at 186°F. (TMI-2 peak containment temperature) and at 100°F. for both the open and enclosed terminal blocks. All experimental data and model predictions are for an approximate 100% relative humidity condition in the test chamber and for 480 volts applied between the terminals and ground.

The curves drawn through the experimental data represent an average contamination in that they are a composite of both clean and contaminated terminal blocks.

These data show that, under a full LOCA condition, the probability of failure is 14% for a non-hermetically sealed terminal block with a 6mm drainage hold. As can be seen (from Fig. 1), this failure probability is higher if the terminal blocks are unusually dirty or left uncovered. Table I shows a summary of the data obtained including the terminal failures detected.
