UNITED STATES
NUCLEAR REGULATORY COMMISSION
WASHINGTON, D. C. 20555

MEMORANDUM FOR: Harold R. Denton, Director
Office of Nuclear Reactor Regulation

FROM: Robert B. Minogue, Director
Office of Nuclear Regulatory Research

SUBJECT: RESEARCH INFORMATION LETTER # 123 PERFORMANCE OF
ELECTRICAL TERMINAL BLOCKS EXPOSED TO A LOCA OR
STEAM ENVIRONMENT

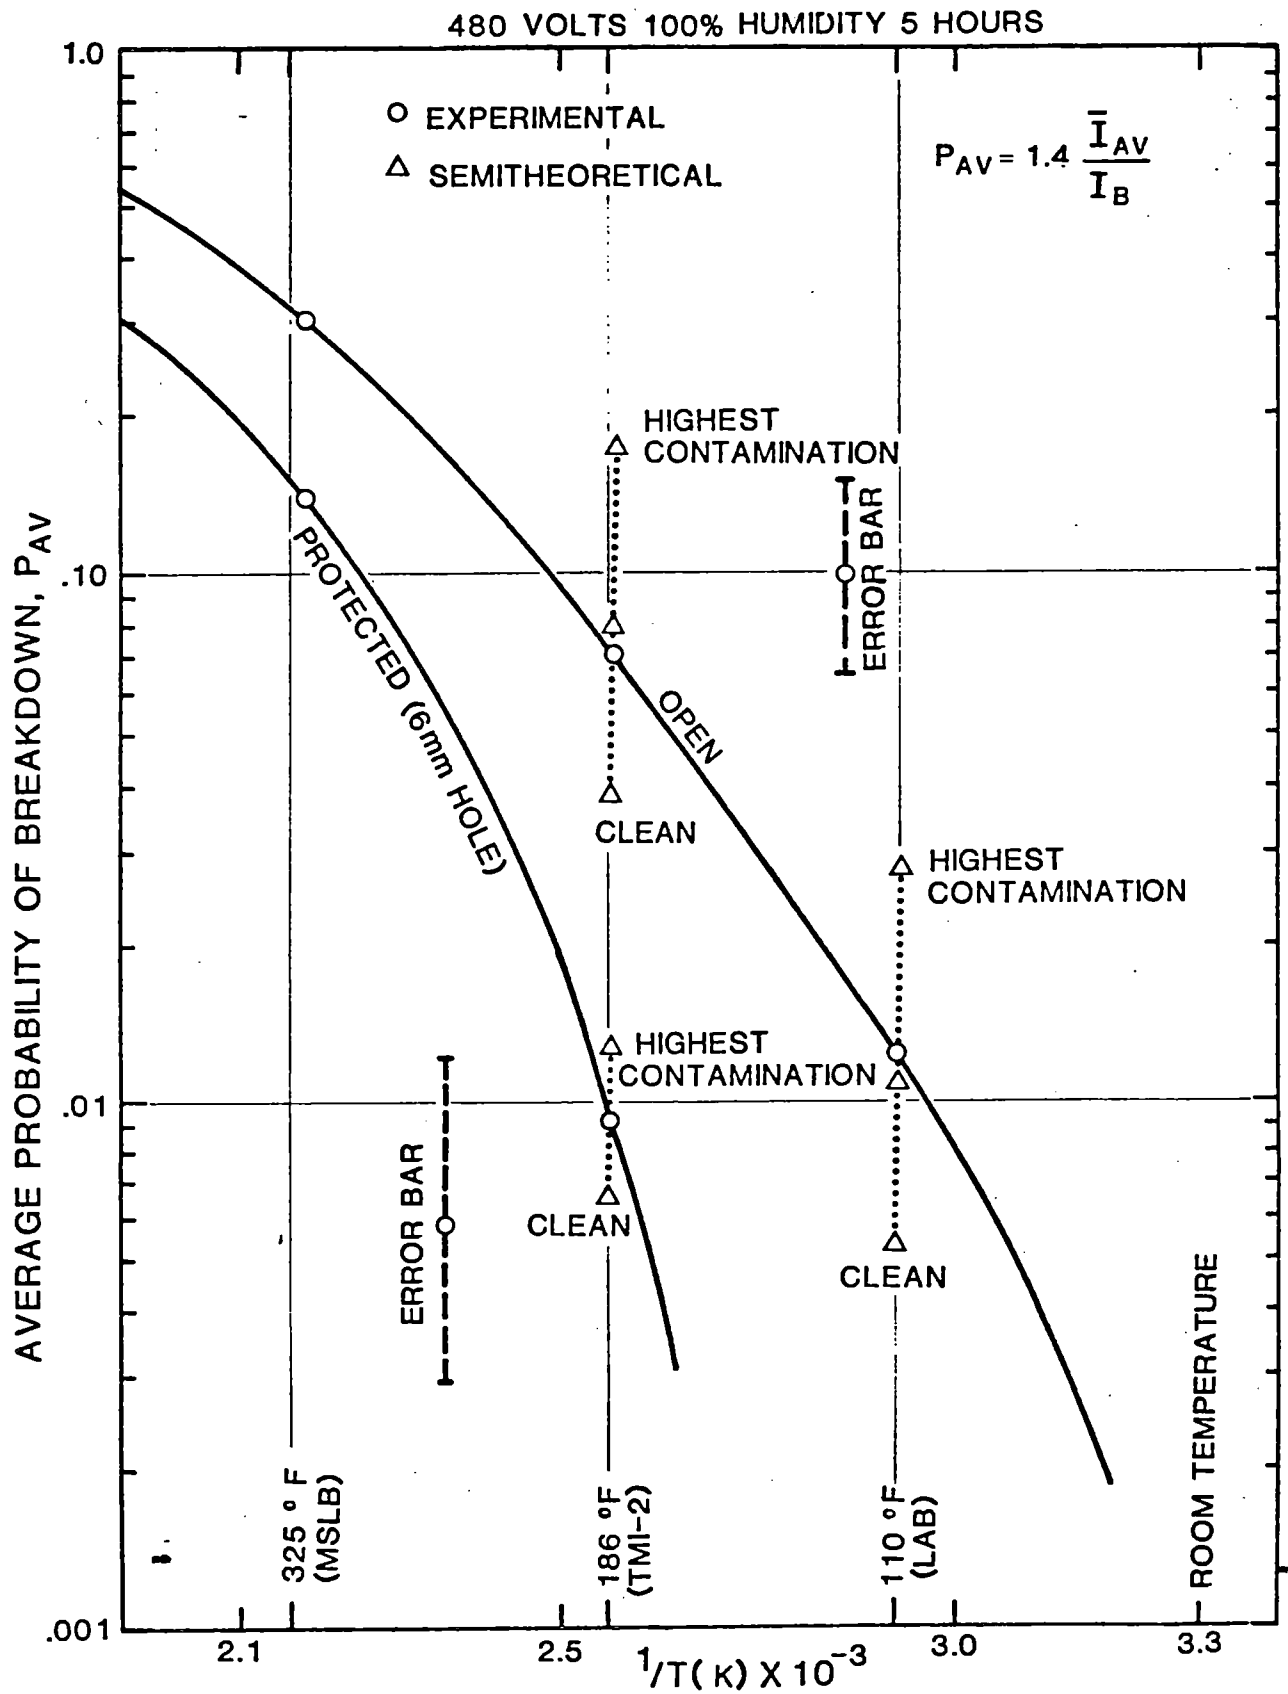
Fig. 1

1. Figure 1 and Table I show, in summary form, the results of the experiments and the conclusions drawn by use of the probability model.

The data relate the probability of terminal-to-ground low-voltage breakdown as a function of the inverse temperature. Curves are drawn through experimental data points for both the open and enclosed terminal blocks. Also, data are shown for various conditions of relative contamination at 186°F. (TMI-2 peak containment temperature) and at 100°F. for both the open and enclosed terminal blocks. All experimental data and model predictions are for an approximate 100% relative humidity condition in the test chamber and for 480 volts applied between the terminals and ground.

The curves drawn through the experimental data represent an average contamination in that they are a composite of both clean and contaminated terminal blocks.

These data show that, under a full LOCA condition, the probability of failure is 14% for a non-hermetically sealed terminal block with a 6mm drainage hold. As can be seen (from Fig. 1), this failure probability is higher if the terminal blocks are unusually dirty or left uncovered. Table I shows a summary of the data obtained including the terminal failures detected.
