WCAP-9663

METALLURGICAL INVESTIGATION OF CRACKS
IN THE PRESSURIZER NOZZLE-TO-SAFE-END
WELD OF THE ROBERT EMMETT GINNA
NUCLEAR POWER GENERATING STATION

February 1980

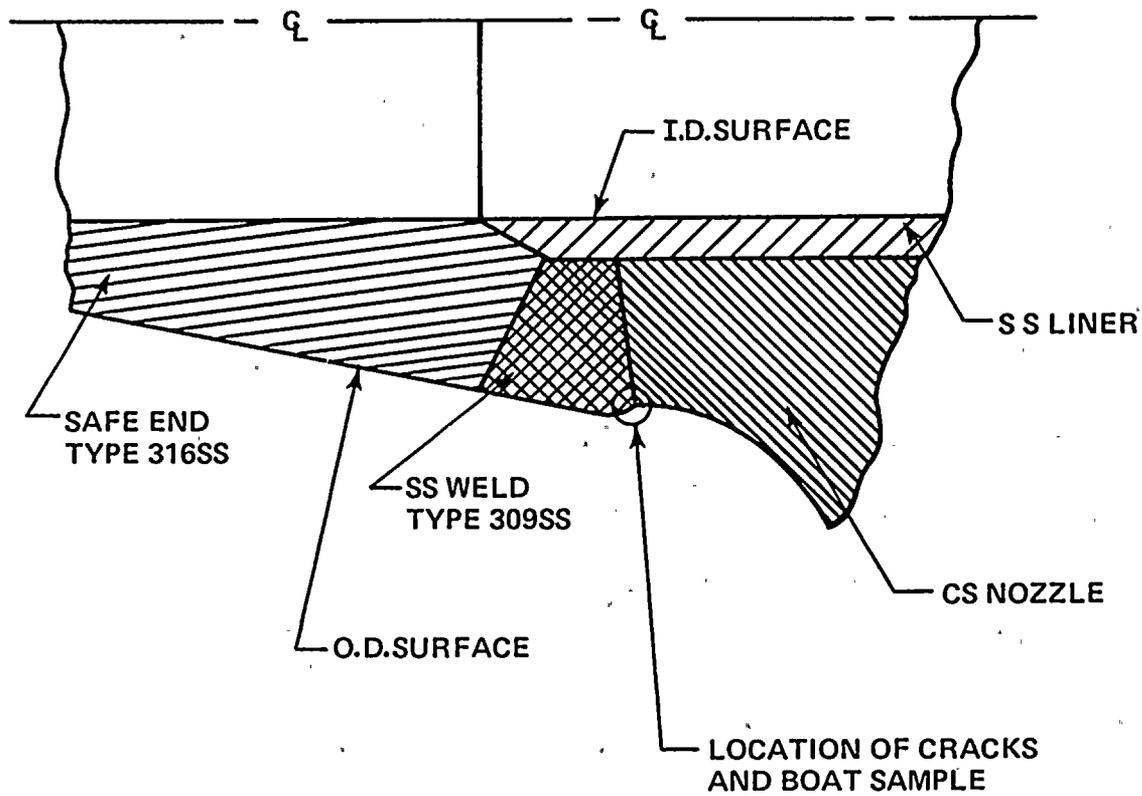
Figure 1-1. Schematic of RGE Pressurizer Relief Nozzle-to-Safe-End Weld Assembly Showing the Location of Cracks and the Boat Sample

An examination of the nozzle-to-safe-end assembly shown in figure 1-1 suggests that the geometric discontinuity at the carbon steel/weld metal interface (where cracking was observed) can be a source of appreciable local strains arising both from the restraint of the joint assembly and from the thermal stresses generated during freezing. Thus, in the absence of adequate delta ferrite in the weld metal, it is believed that the strains generated at the carbon steel/weld metal interface induced "hot cracking" in the weld metal. The formation of high-temperature metal oxide film on the fracture faces and the various fractographic features observed by light optic and scanning electron optic methods consistently support this hypothesis. The presence of islands of cohesive material bridging the two mating faces of the crack is yet another evidence reinforcing the hot cracking argument.

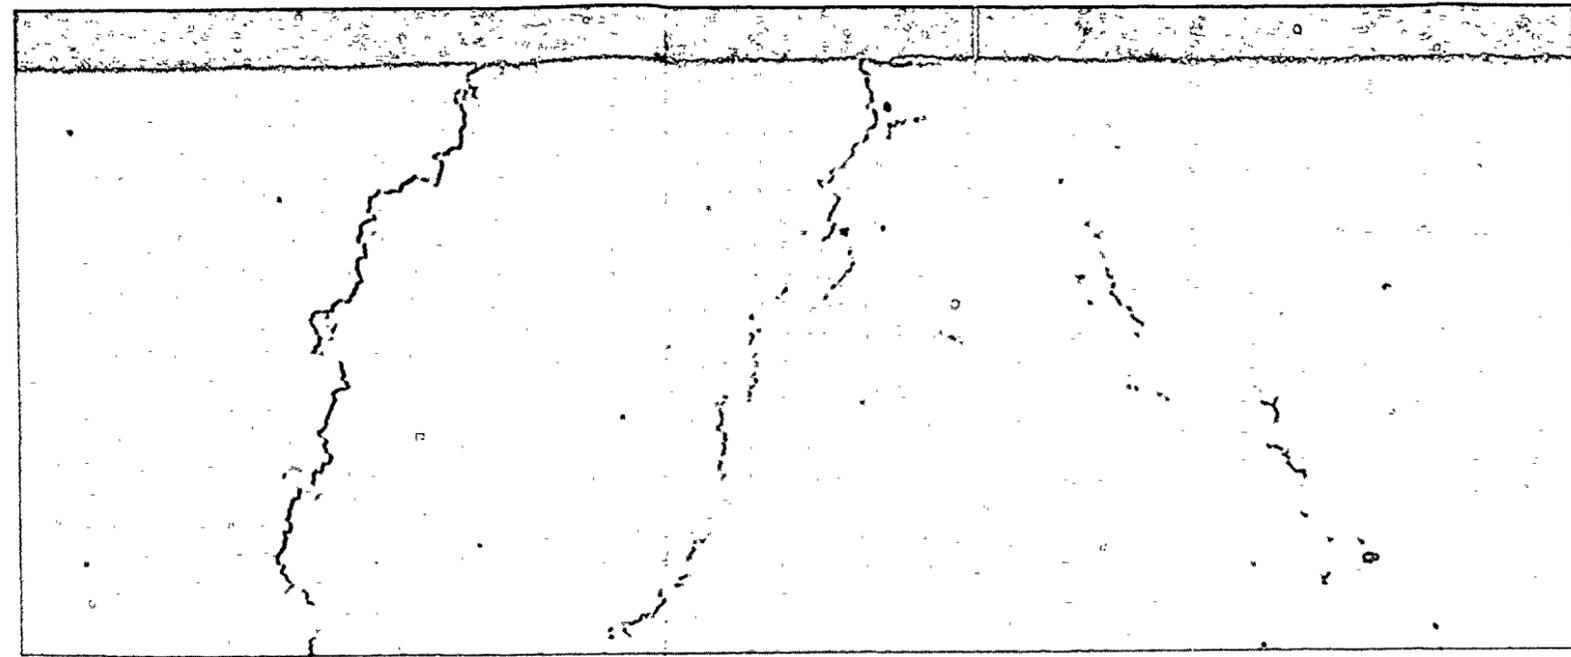
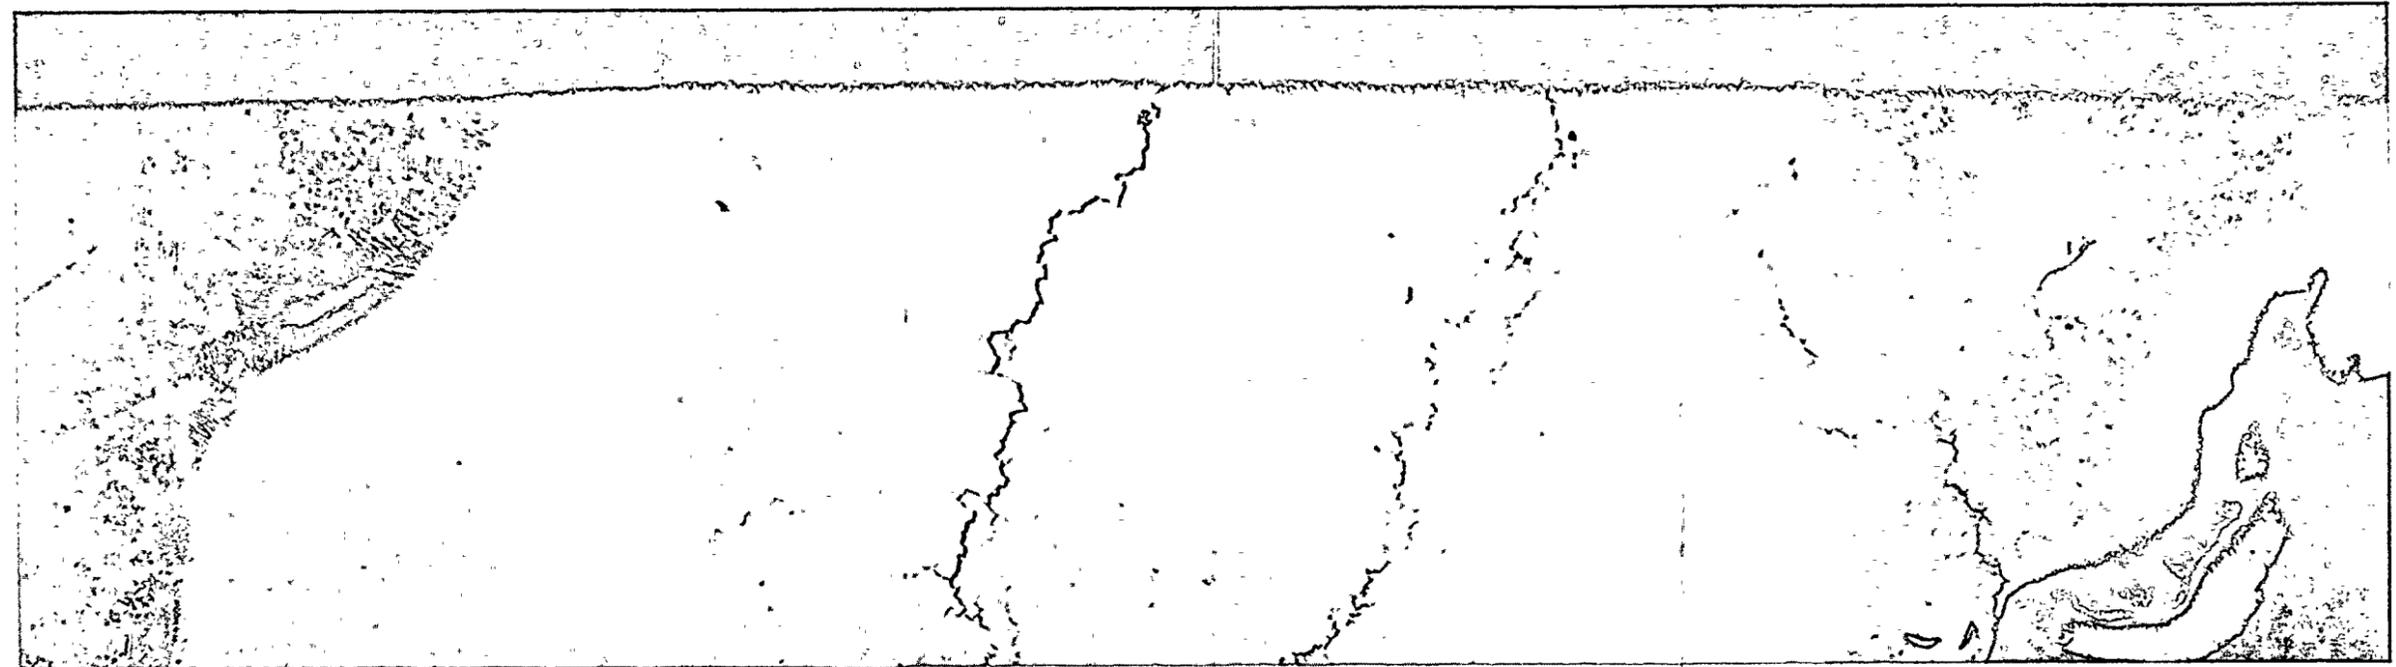
Specimen B from the boat sample which contained some of the deepest cracks was metallographically polished and examined to study the morphology and distribution of cracks. The metallography was conducted both on the OD surface of the specimen as well as on sections normal to the cracks. Optical micrographs of the cracks on the two planes are shown in figures 2-2 and 2-3 respectively. Magnified views of the major cracks are also shown in figures 2-4 and 2-5. Figure 2-6 shows the distribution of a cluster of fine cracks seen on the top surface of the boat sample in unetched condition. The above micrographs clearly illustrate that the general nature of cracking is intergranular and that some cracks extend from the OD surface of the Type 309 stainless steel weld to as deep as the stainless steel/carbon steel interface. Detailed discussion of these results is considered in a later section.

Figure 2-2. Light Optical Micrographs Showing Morphology and Distribution of Cracks on a Section Parallel to the Surface of the Boat Sample; (a) Unetched, (b) Etched With 10% Oxalic

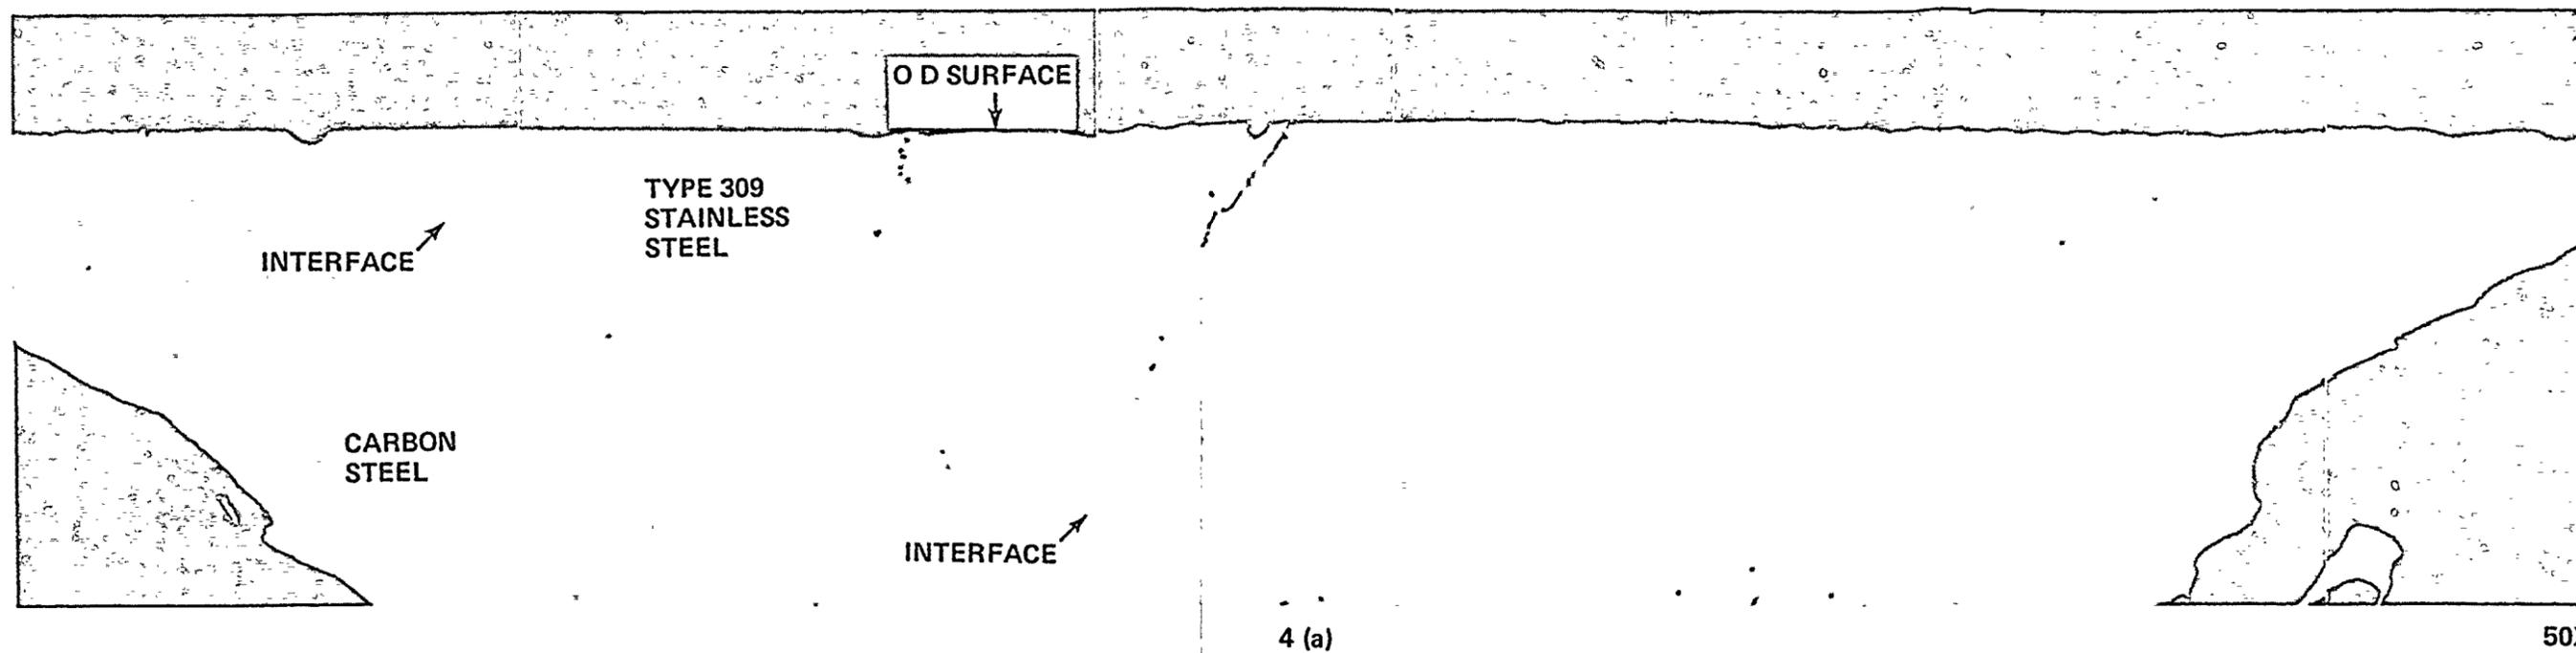
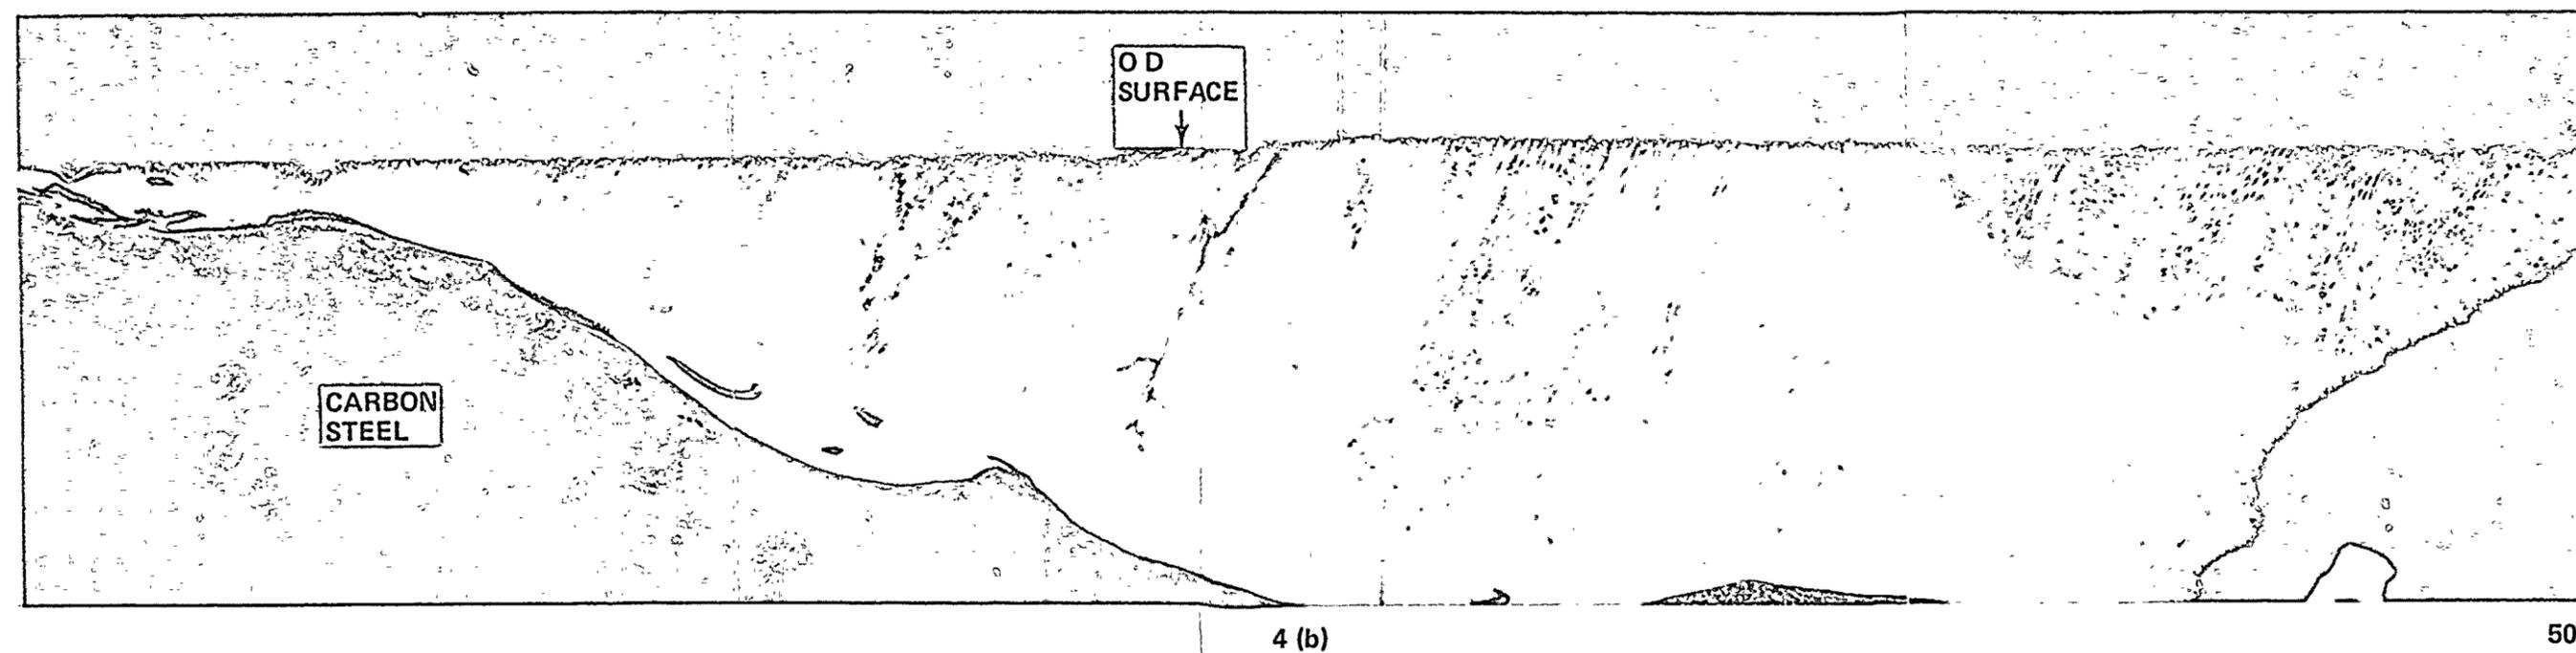
Figure 2-3. Optical Micrographs Showing the Morphology and Distribution of Cracks on a Section of the Boat Sample Normal to the Cracks; (a) Unetched, (b) Etched with 10% Oxalic

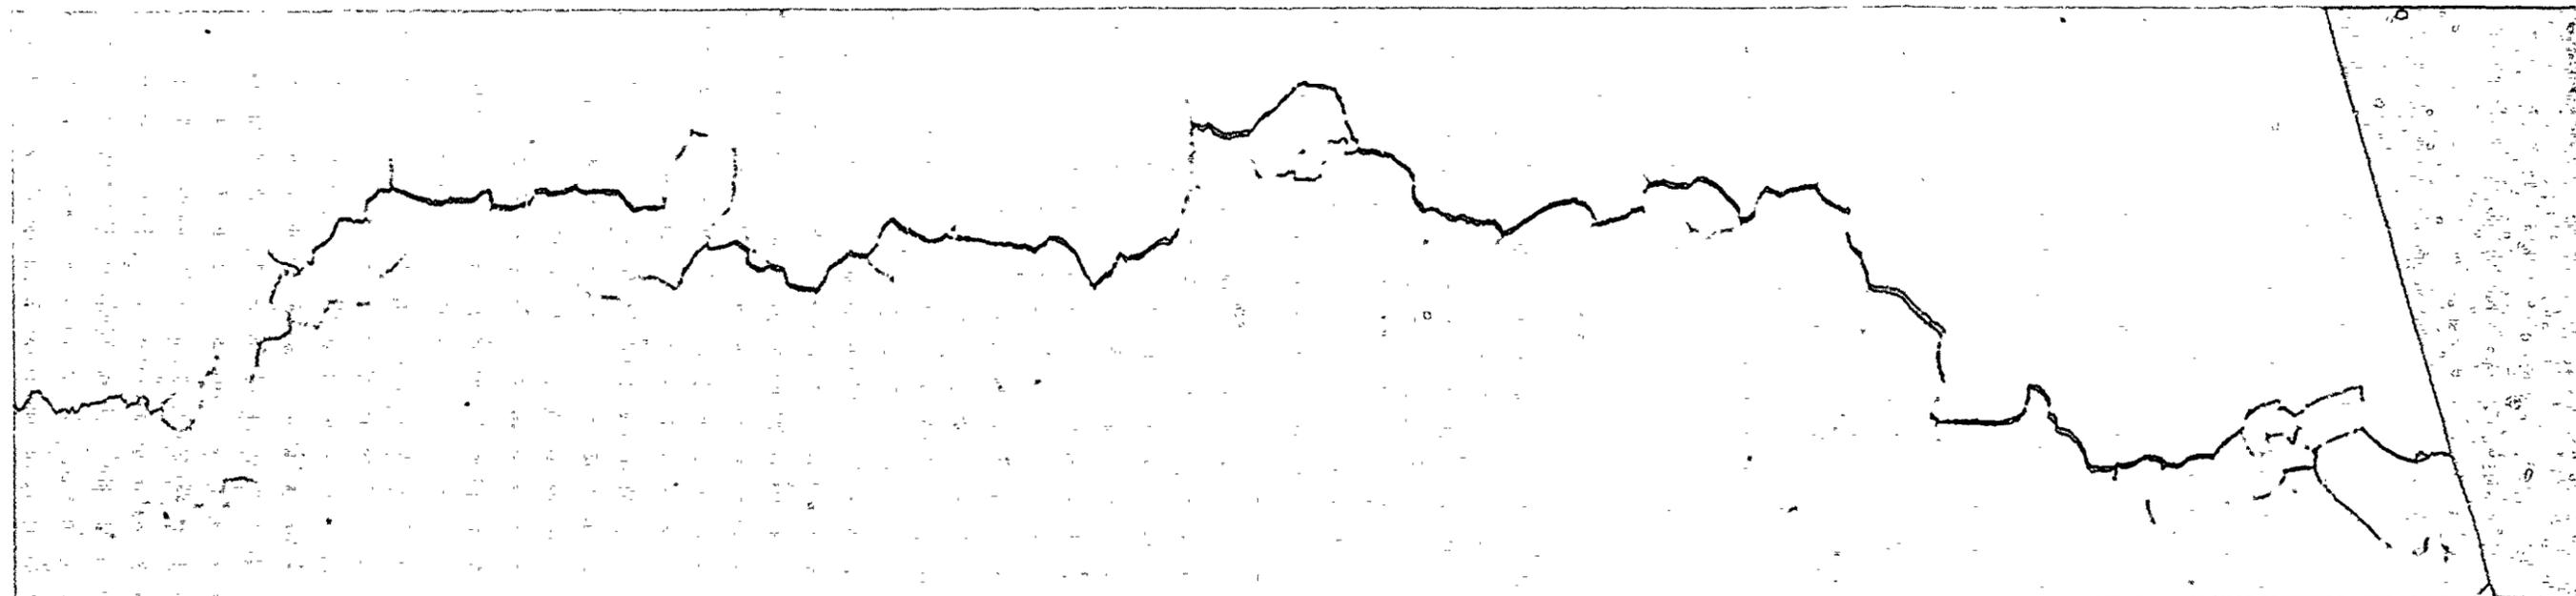
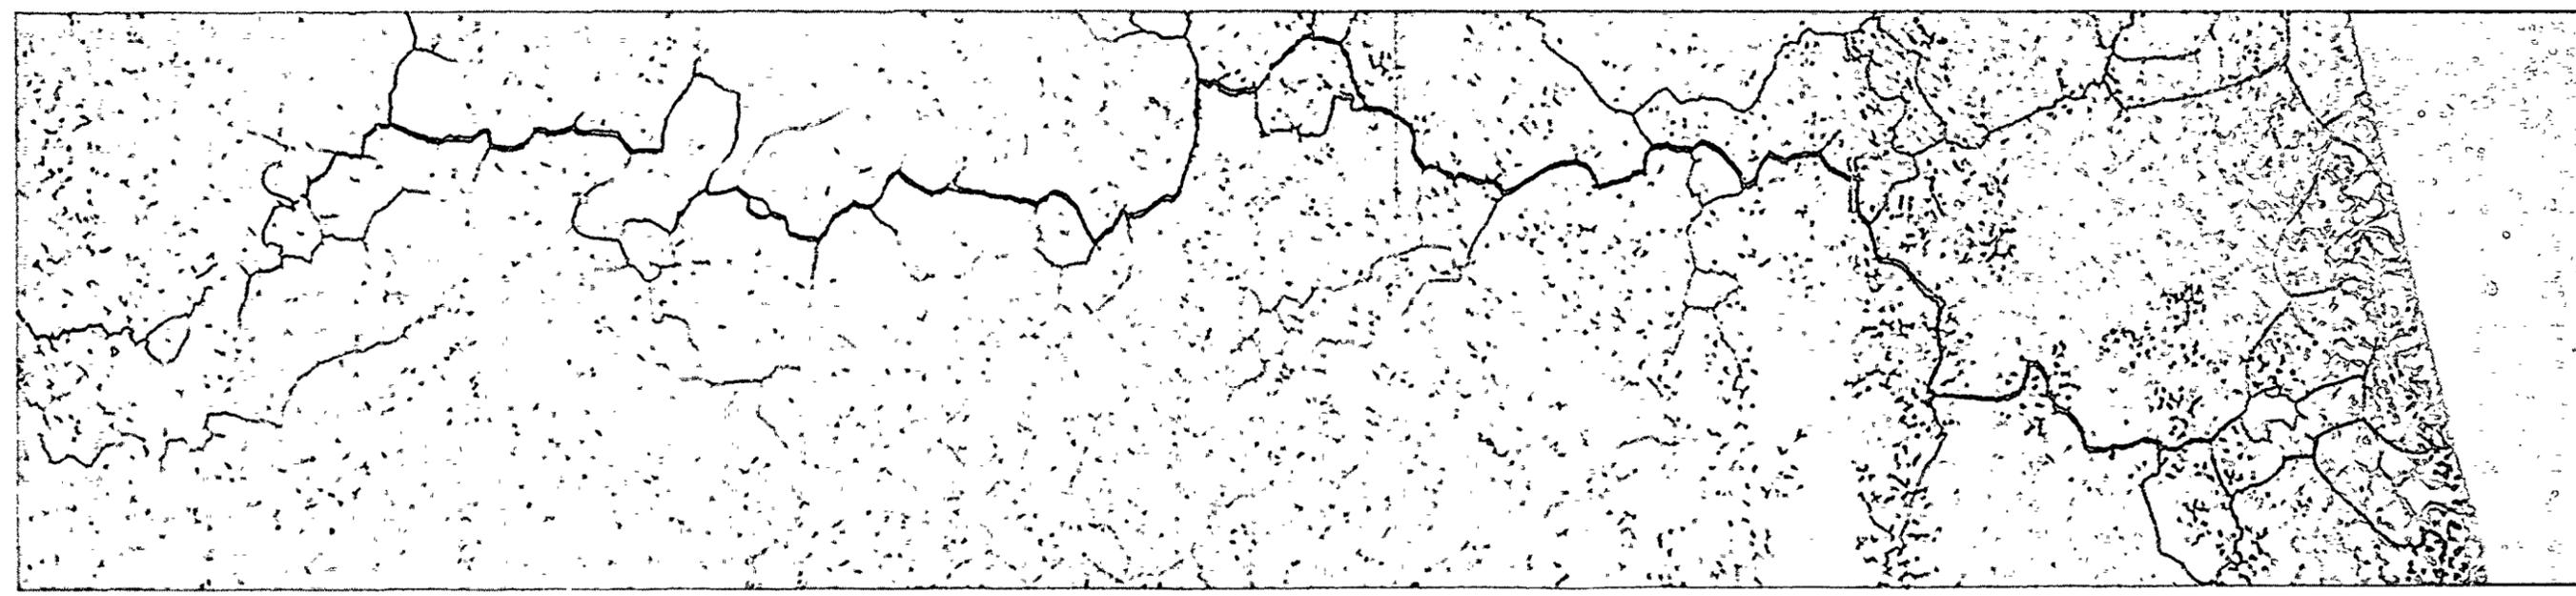
Figure 2-4. Optical Micrograph Showing the Largest Crack on the Surface (OD Surface of Nozzle-to-Safe-End Weld) of Boat Sample; (a) Unetched, (b) Etched Condition

Surface examinations of the boat sample showed that the cracks are generally oriented along the longitudinal direction of the boat sample, which corresponded to the circumferential direction of the nozzle-safe-end weld. Metallographic examination of the sections containing some of the deepest cracks showed that the cracks are intergranular in nature and extended from the OD surface of the weld metal to as deep as the base metal interface. All the cracks, however, are contained within the weld metal (figures 2-2 through 2-5), with the deepest crack measuring approximately .04 inches. The cracks appear to have been initiated at the OD surface where they appeared wider and tended to narrow down as they penetrated deeper into the weld metal. Examination of regions where some of the finer cracks appeared on the OD surface showed some evidence of cellular (interdendritic) cracking (figure 2-6). Measurements on the delta ferrite content of the weld metal by metallographic methods revealed rather low delta ferrite numbers, ranging from 2.5 percent to a maximum of 3 percent (figure 2-7). Fine structural studies by thin foil transmission electron microscopy showed no appreciable evidence of intergranular carbide precipitation (figure 2-8).

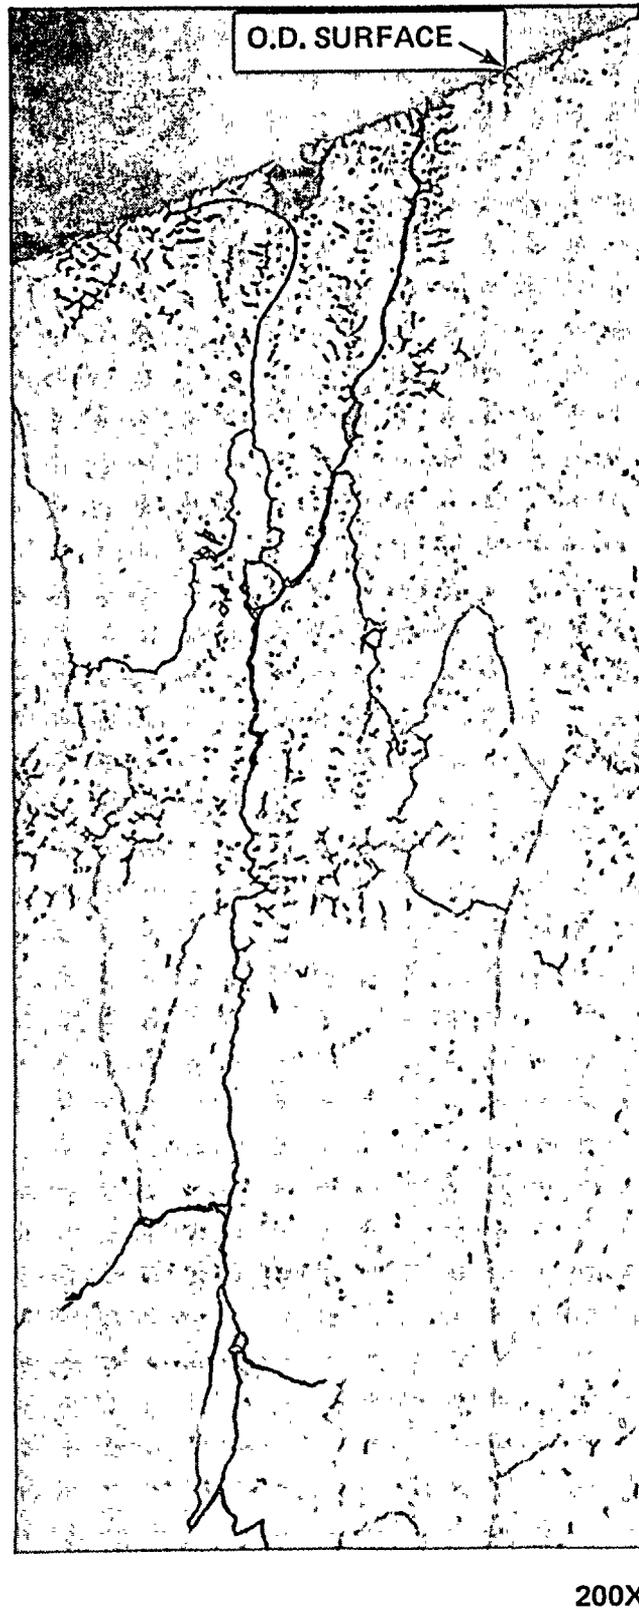
Figure 2-5. Metallographic Section Containing the Deepest Crack, Shown at Higher Magnification

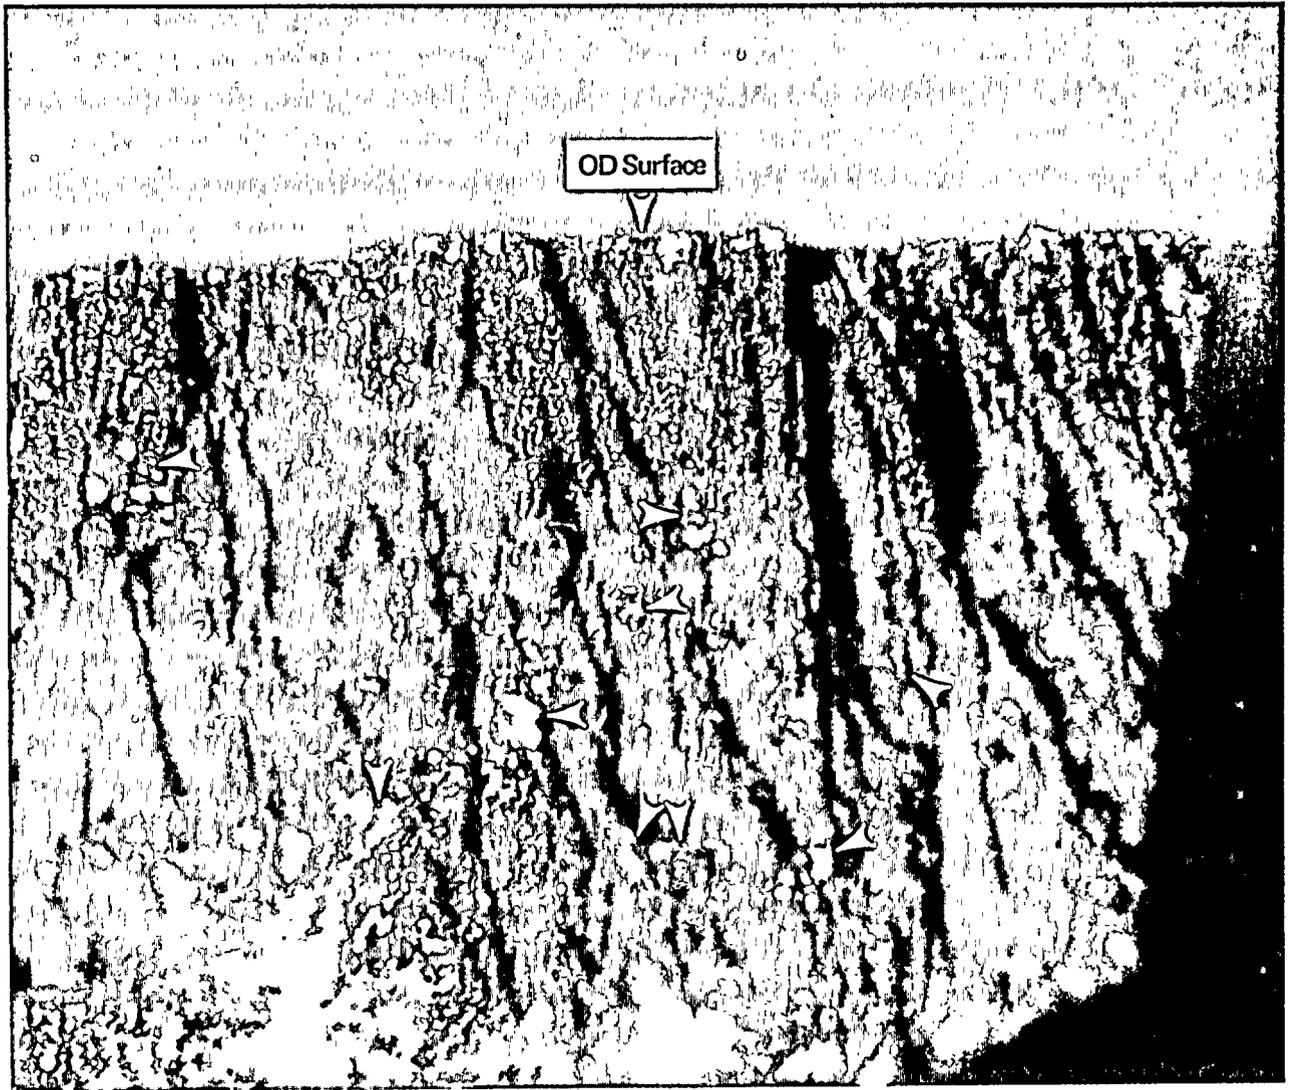
Another interesting observation is that islands of cohesive material bridging the two crack faces were present prior to the laboratory opening of the crack. This is clearly evidenced by the bright reflective areas both at the bottom of the fractograph (figure 2-10) and at isolated locations (indicated by arrows) on the fracture face where laboratory fracture occurred during the opening of the crack at room temperature. The implications of various fractographic features described here will be brought out in detail in the discussion section of the report.

Figure 2-10. Light Optic Color Photo of Fracture Surface Showing Regions Where Laboratory Fracture Occurred

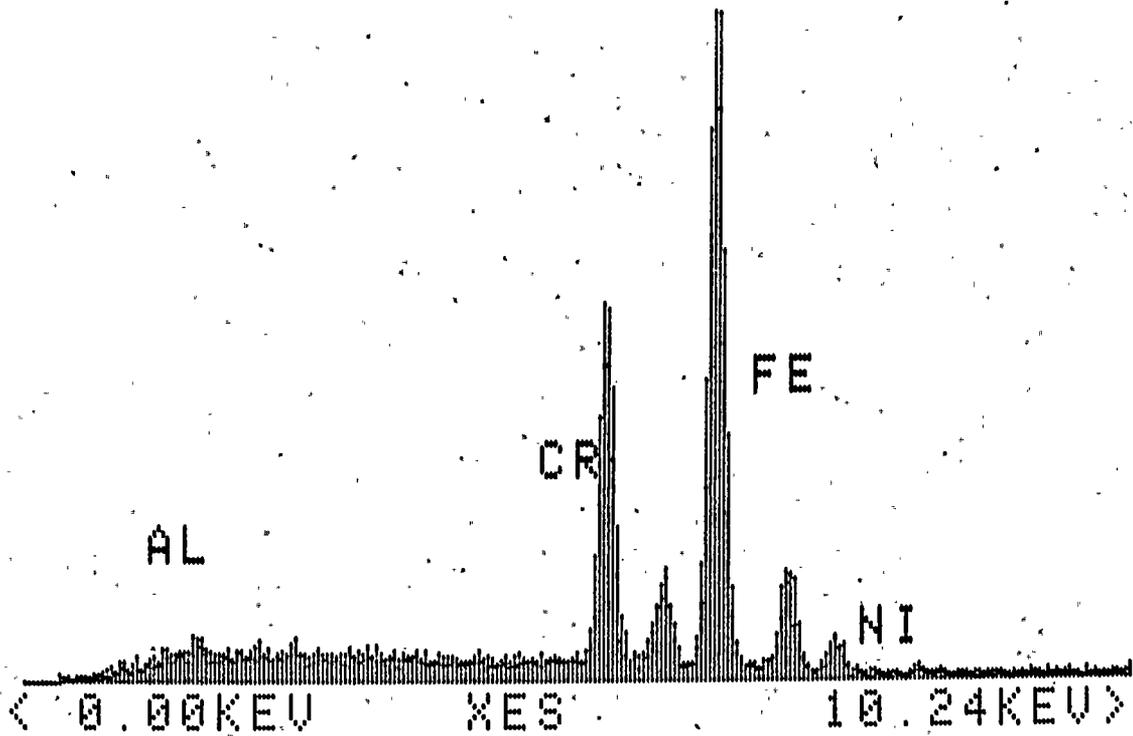
The fracture surface material and deposits, if any, were analyzed using energy dispersive x-rays. The results are shown in figure 2-13. The EDAX spectrum basically indicates weld metal chemistry, namely Fe, Cr, and Ni, and shows no evidence of corrosion products such as chlorides, sulphides, etc.

Figure 2-13. EDAX Spectrum Taken From Freshly Opened Crack Surface

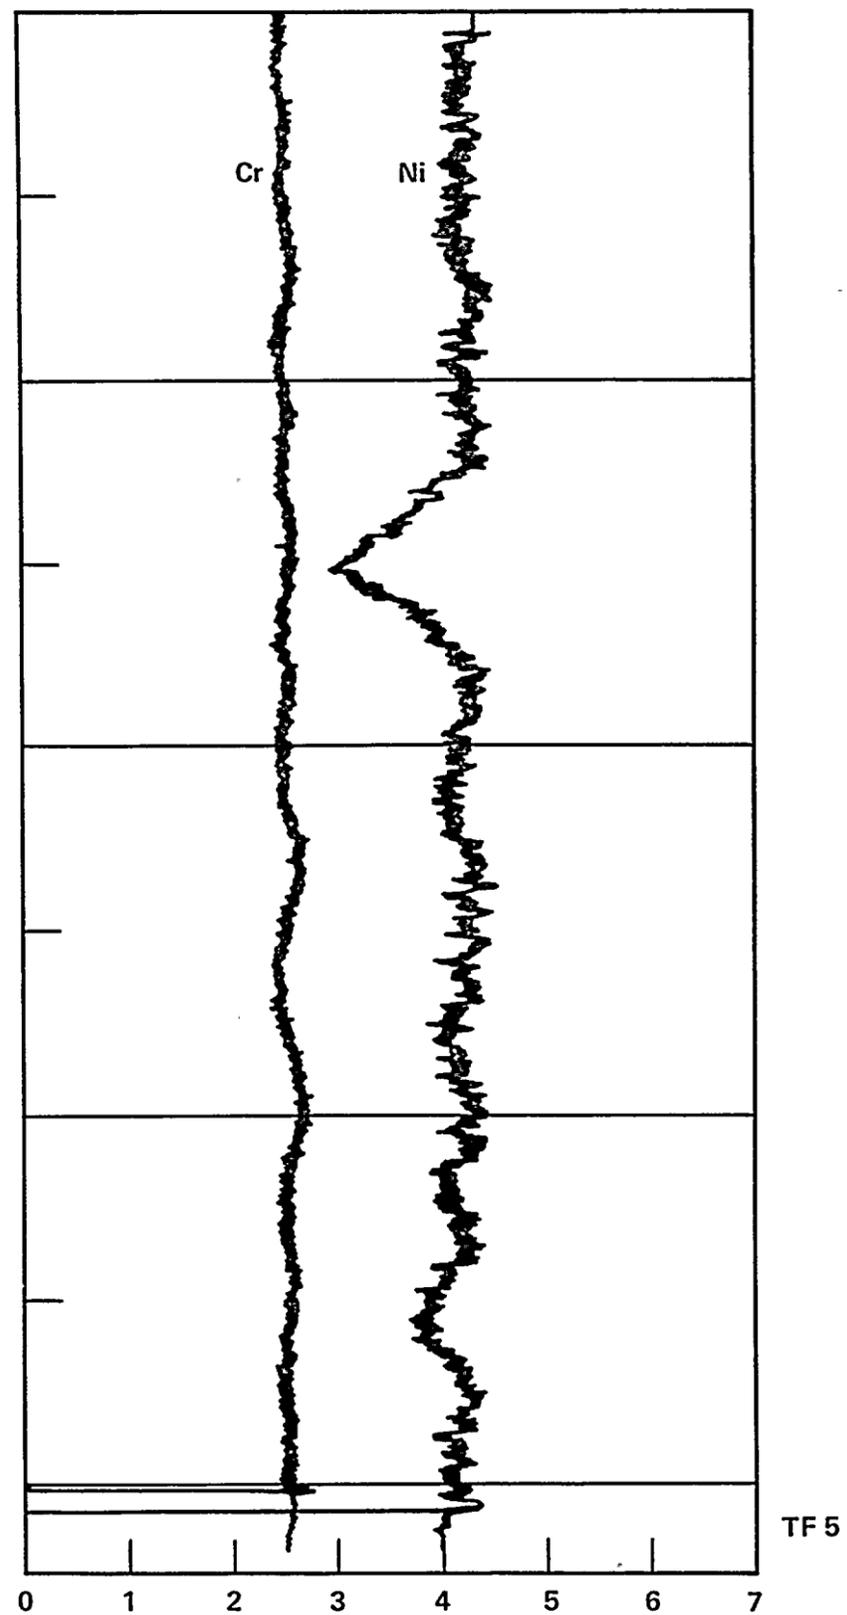
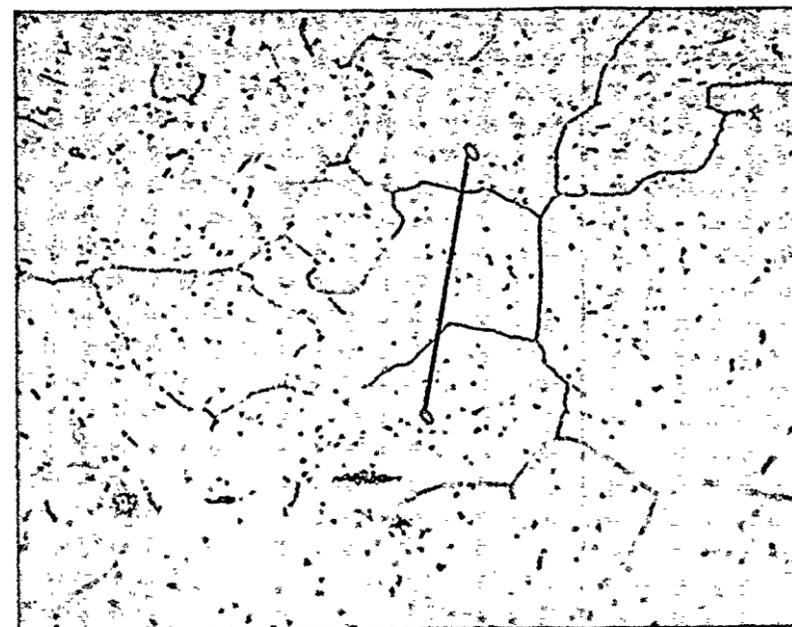
Electron microprobe trace analysis was conducted across several grain boundaries on metallographic sections containing cracks. The purpose here was to see if there is any detectable chromium depletion existing along the grain boundaries due to a possible sensitization of the weld metal. No such depletion could be detected. Figure 2-14 shows the results of a probe analysis across two grain boundaries near the vicinity of a crack.

Figure 2-14. Electron Microprobe Trace for Variation of Chromium Concentration Across Grain Boundaries
