Subject: Dresden Station Units 2 and 3
Request for Exemption from 10 CFR 50,
Appendix R for Drywell Expansion Gap
NRC Docket Nos. 50-237 and 50-249

New Appendix R Exemption Request For
The Drywell Expansion Gap

11.0 APPENDIX R DRYWELL EXPANSION GAP EXEMPTION REQUEST

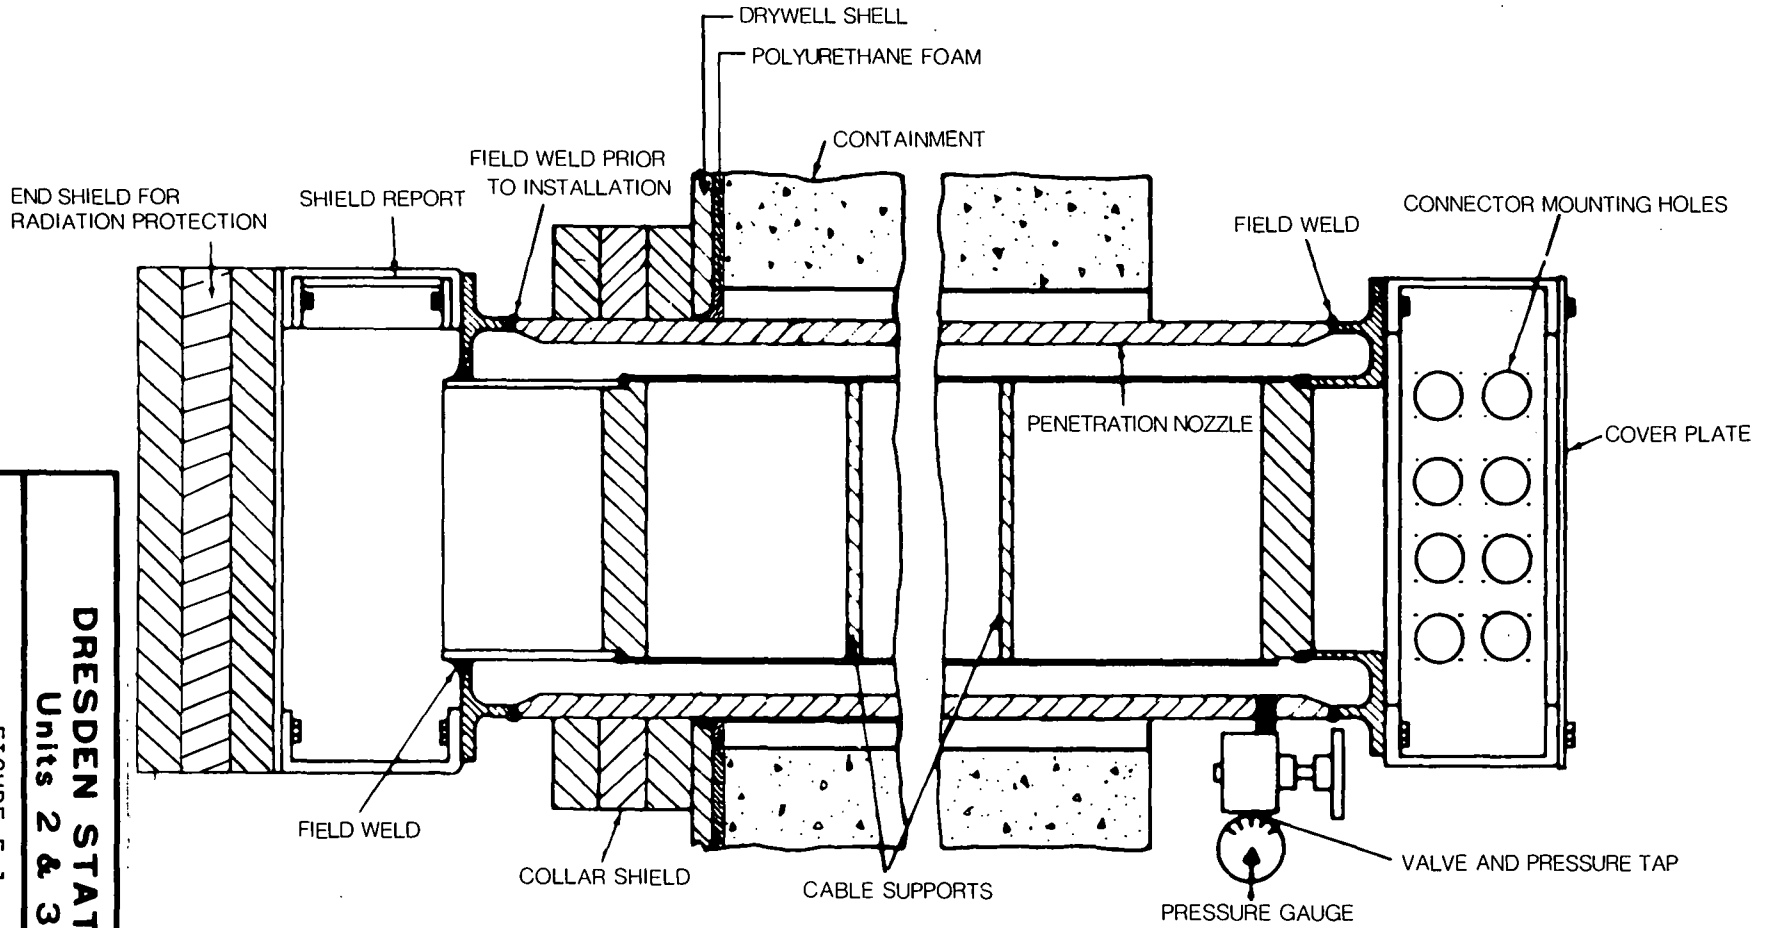
DRESDEN STATION
Units 2 & 3
FIGURE E-1
TYPICAL ELECTRICAL PENETRATION
ASSEMBLY CANISTER

Also providing a barrier to fire spread are the electrical cable penetration assemblies and the mechanical penetrations. There are three standard types of electrical penetration assemblies present; Low Voltage Power and Control Cable Penetration, High Voltage Power Cable Penetration, and the Shielded Cable Penetration. Each type of electrical penetration has the same basic configuration shown in Figure E-1. An assembly is sized to be inserted in the penetration nozzles which are 12-inch schedule 80 steel pipe (wall thickness of 0.688 inches). They are furnished as part of the containment structure and the design and fabrication of each assembly is in accordance with the requirements of the ASME Boiler & Pressure Code, Section III, Class B Vessel. The assembly extends approximately 1 foot beyond the drywell wall on both sides of the penetrations. The drywell wall, in the vicinity of the electrical penetrations, is at least 6 feet thick.

Since the polyurethane foam is located on the drywell side of the concrete wall, the only mechanism for fire spread from the expansion gap through electrical penetration assemblies to the fire areas outside the drywell or vice versa is by conduction of sufficient heat through the penetration assembly to reach the autoignition temperature of the cables (600°F) or the foam (1000°F). This is an unlikely event due to the construction of the assembly. As can be seen in Figure E-1, the penetration assembly is a metal canister into which a sleeve, two header plates and cable support plates have been inserted. Electrical conductors are contained within the sleeve and are passed through the sleeve through openings in the header plates. A potting compound has been applied at each end of the penetration to seal between the header plates and cable. The highest temperatures of the drywell side of the steel shell during the January 20, 1986 polyurethane fire was 500°F (see Reference 1). An analysis has shown that at a distance of 3 feet from a hot spot on the steel shell, the maximum temperature was 94°F (see Figure E-3). Thus, if the hot spot was next to a penetration, the temperature at the outside of the penetration, which is about 6 feet away, would be very low. Furthermore, conservative calculations indicate that if an 1800° exposure (i.e., flame impingement) were to occur in either the polyurethane foam or the reactor building, it would take at least 24 hours to conduct sufficient heat through the stainless steel penetration to threaten ignition of combustible materials on the outside surface of the drywell wall. Therefore, it is unlikely that a fire would spread through an electrical penetration assembly into another fire area or from the fire area into the gap.

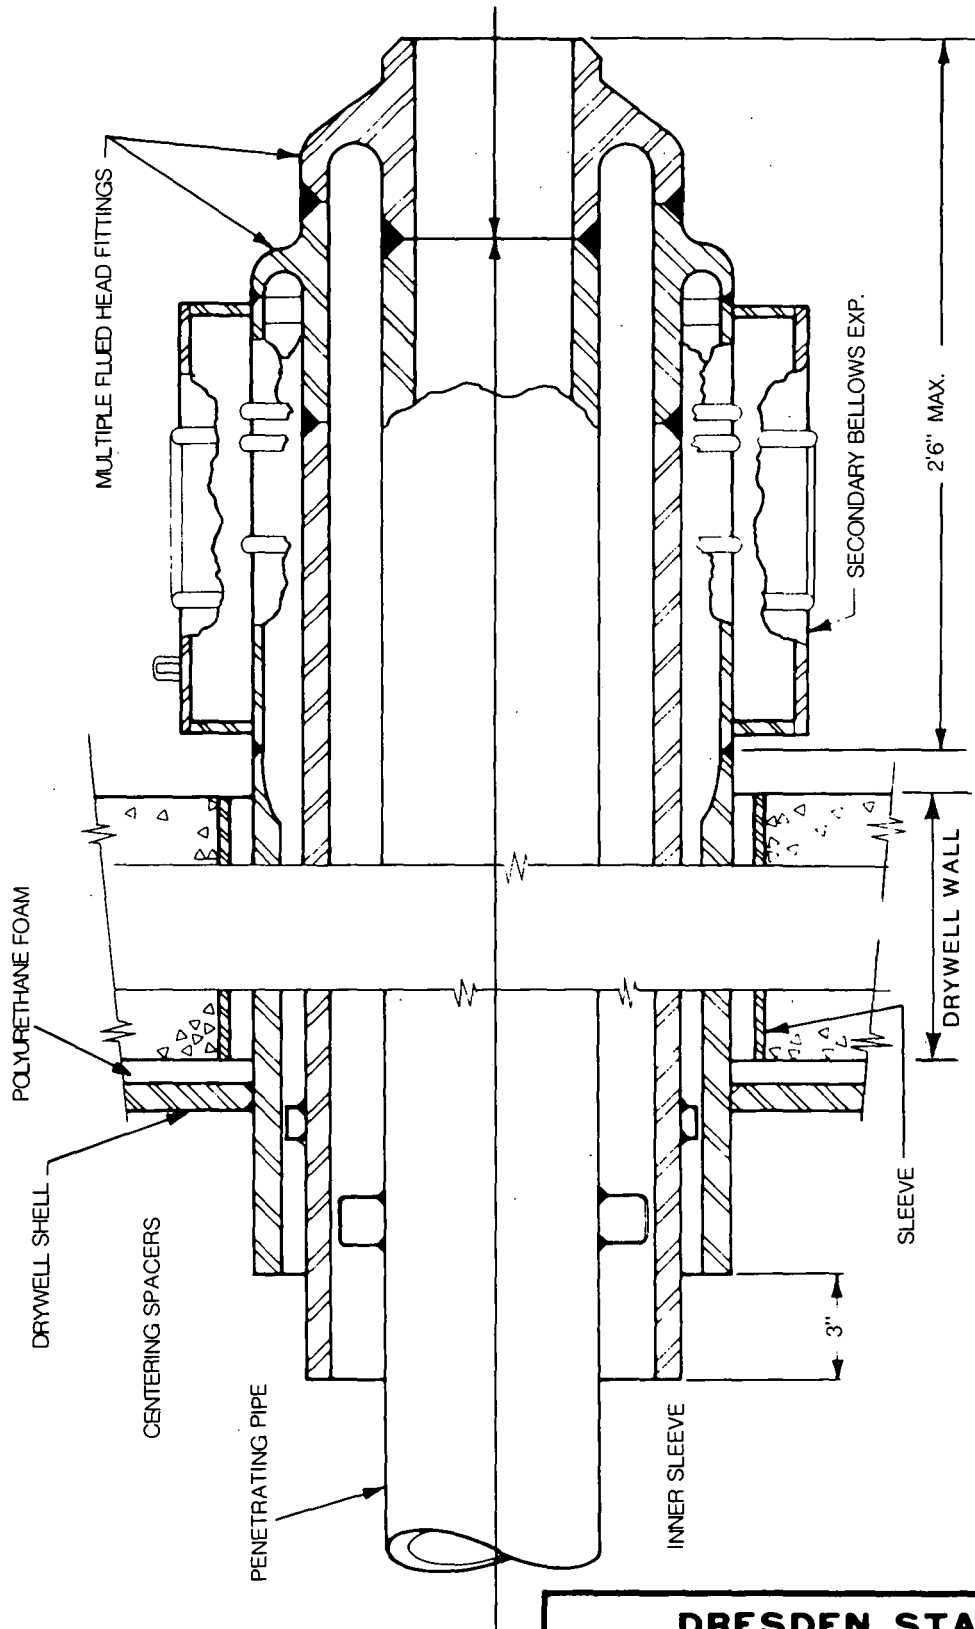
TYPICAL MECHANICAL PENETRATION ASSEMBLIES (SHEET 1 OF 2)

The mechanical penetrations are of two types; those which accommodate thermal movement (hot) and those which experience relatively little thermal stress (cold). The hot fluid line penetrations have a guard pipe between the hot

line and the penetration nozzle in addition to a double-seal arrangement (see Figure E-2, Sheet 1). This permits the penetration to be vented to the drywell should a rupture of the hot line occur within the penetration. The guard pipes are designed to the same pressure and temperature as the fluid line and is attached to a multiple flued head fitting, a one-piece forging with integral flues or nozzles. This fitting was designed to the ASME Pressure Vessel Code, Section VIII. The penetration sleeve is welded to the drywell and extends through the biological shield where it is welded to a bellows which in turn is welded to the guard pipe. The bellows accommodates the thermal expansion of the steam pipe and drywell relative to the steam pipe. A double bellows arrangement permits remote leak testing of the penetration seal. The lines have been constrained at each end of the penetration assembly to limit the movement of the line relative to the containment, yet will permit pipe movement parallel to the penetration.

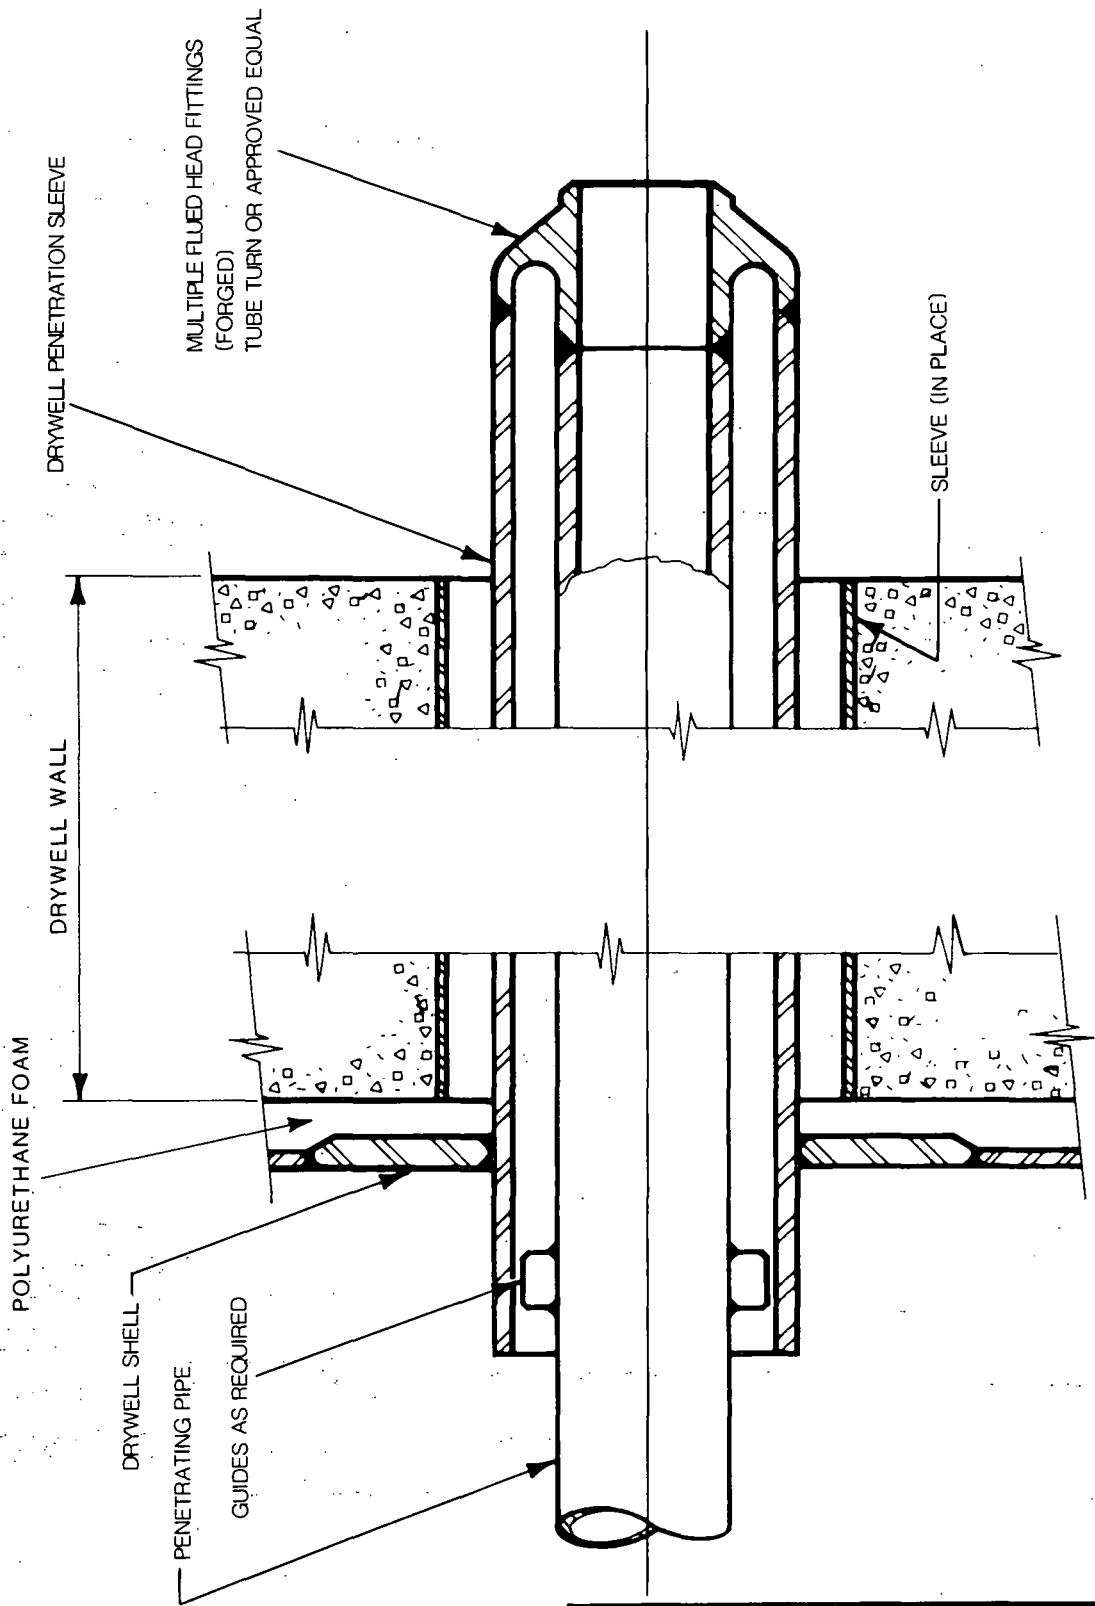
TYPICAL MECHANICAL
PENETRATION ASSEMBLIES
(SHEET 2 OF 2)

The penetration details of cold piping lines are shown on Figure E-2, Sheet 2. These penetrations have a double-seal arrangement, however, the guard pipe provided for the hot piping line penetrations is not provided.

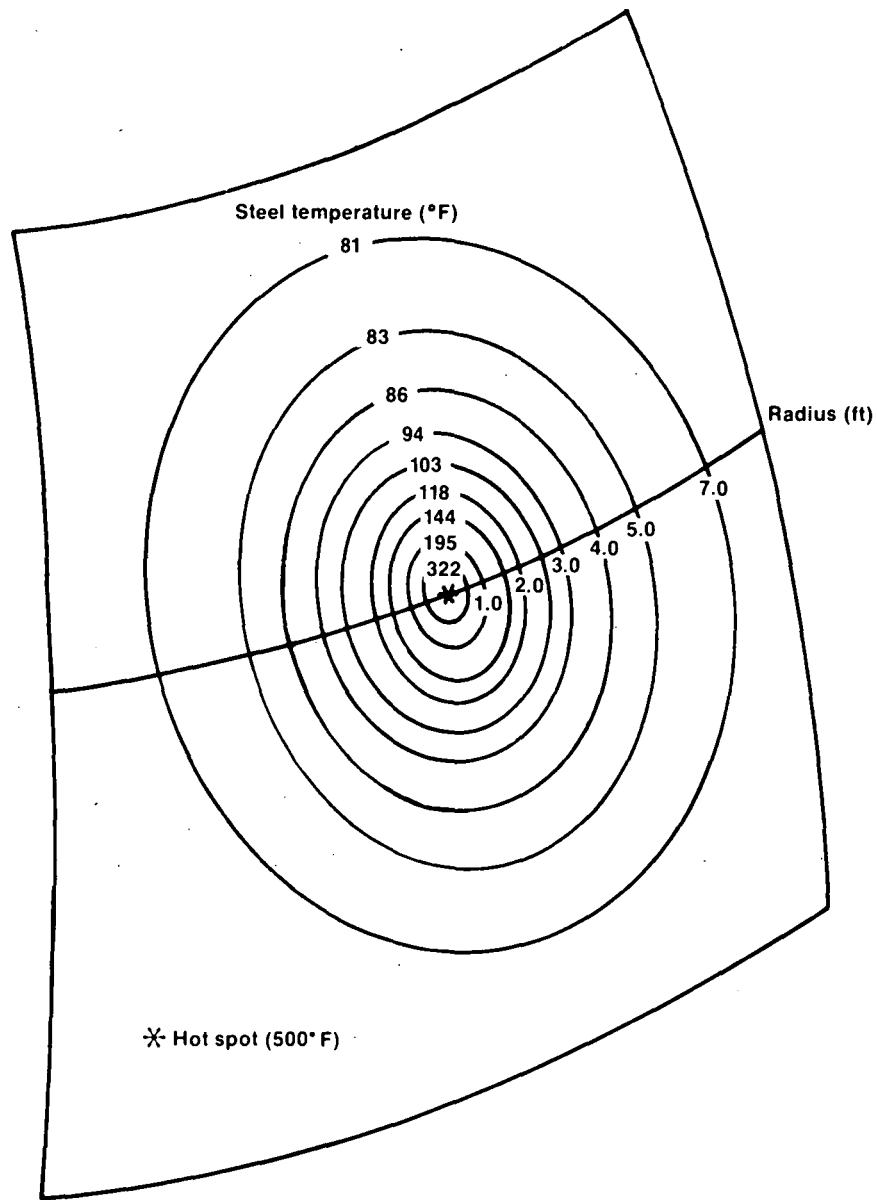
STEEL CONTAINMENT TEMPERATURE PROFILES

annulus around the pipe or conduction through the pipe penetration. Since there are no combustible materials in contact with the pipes in the vicinity of the penetrations, it is unlikely that a fire would spread out of the gap. This conclusion is supported by an analysis of the January 20, 1986 fire. Analysis of the January 20, 1986 fire shows that on the steel shell at a distance of 3 feet from any hot spot, the temperature was 94⁰F. Therefore, at the outside end of the penetrations, the temperatures of the penetration could not have been high enough to ignite any combustible material in the vicinity of the penetration. (The calculations previously referenced are sufficiently conservative to also account for thermal radiation effects through the annulus around mechanical penetrations.)
