SUBJECT: REPORT OF UNUSUAL EVENT PER SECTION 6.6.C OF THE TECHNICAL SPECIFICATIONS
FEEDWATER SPARGER FAILURES

Report Number: 50-249/75-27

Facility: Dresden Nuclear Power Station, Morris, Illinois

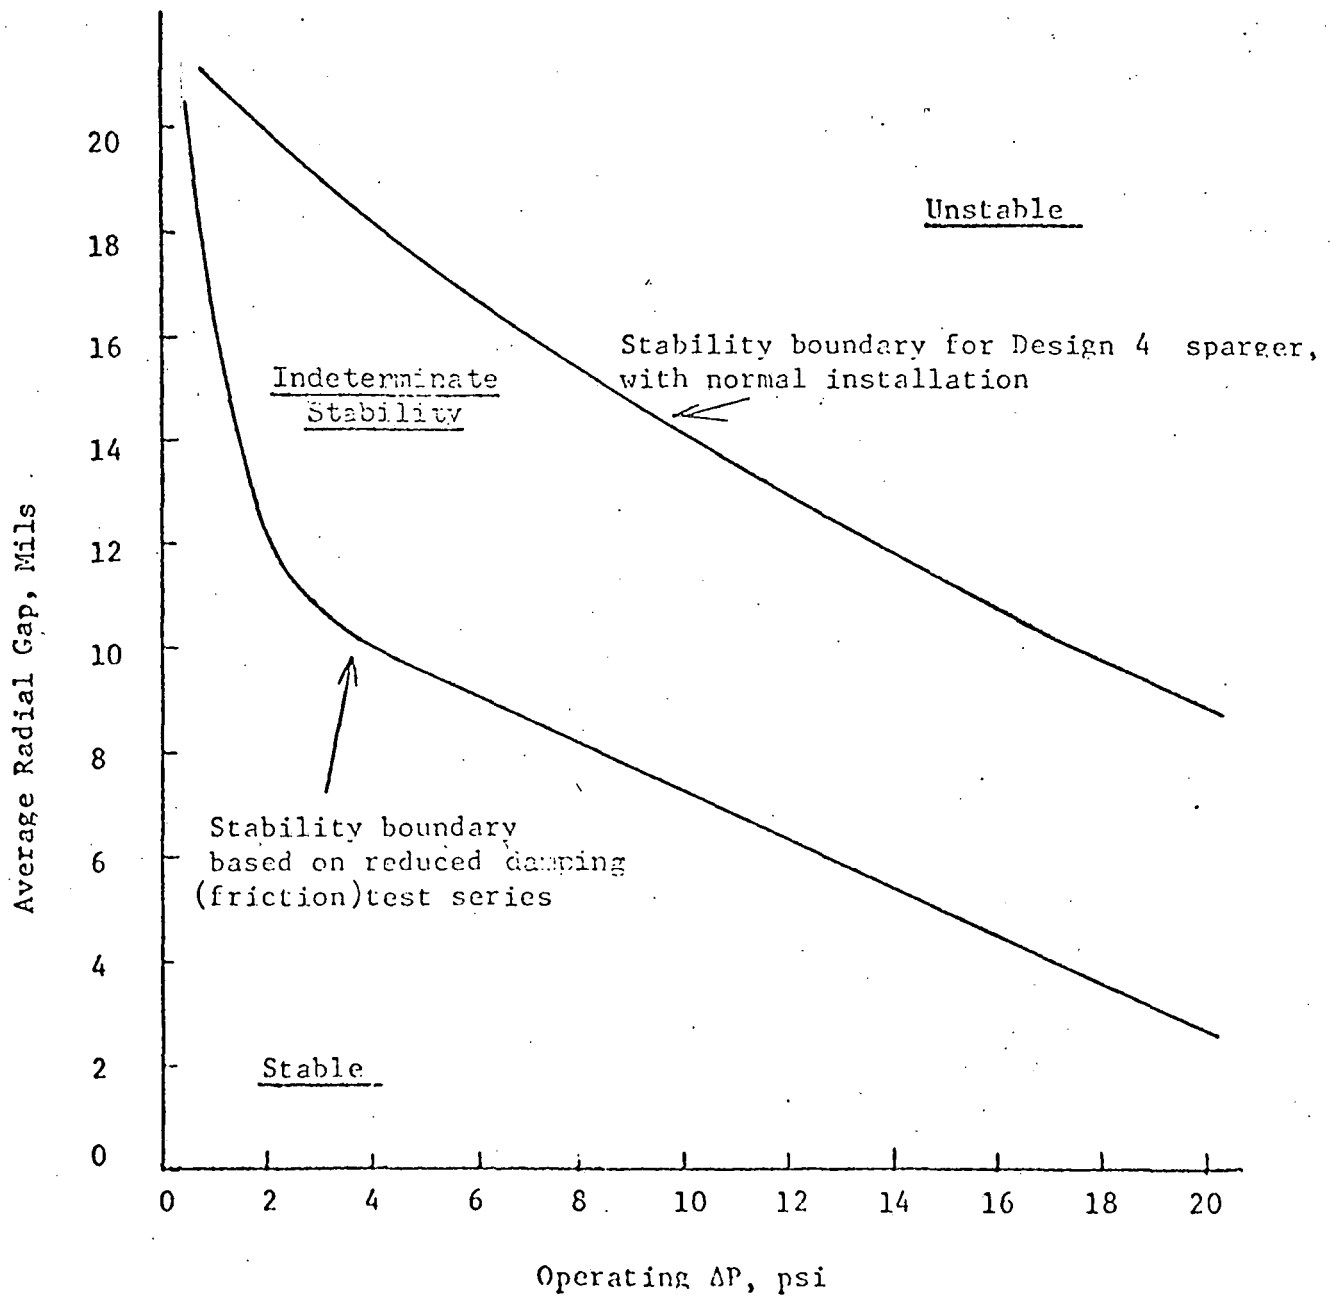
Figure I . Conditions for Sparger Instability Based on Cold Flow Testing

Although the Dresden 3 thermal sleeve was designed to allow only a 0.003-inch radial gap, the error band of the stability boundaries (Figure I), the operating pressure drop across the sparger of about 16 psi, and the methods of construction and installation which could produce a much larger radial gap than specified makes it entirely possible that the Dresden 3 spargers experienced flow induced vibration. The actual radial gaps found on another BWR unit with cracked spargers (Ref. #4) were significantly greater than specified. The unusual service and environmental conditions of changing feedwater flow rate, the temperature difference between the feedwater and the water in the vessel, and the movement of water within the vessel also contribute to the problem by producing thermal cycling, thermal stress, and effects on the damping.

The third design feature was incorporated to lower the pressure drop at rated flow from 16 psi for the first designs to 11 psi for the new designs which increases the stability margin (See Figure I).
