Consolidated Edison Company of New York, Inc.
4 Irving Place, New York, N Y 10003
Telephone (212) 460-3819

November 30, 1973

Re Indian Point Unit No. 2
Docket No. 50-247
Facility Operating
License No. DPR-26

In accordance with the discussion held on November 27, 1973 with Mr. Brunner of your office, this letter is to provide you with supplemental information concerning the incident which occurred at Indian Point Unit No. 2 on November 13, 1973.

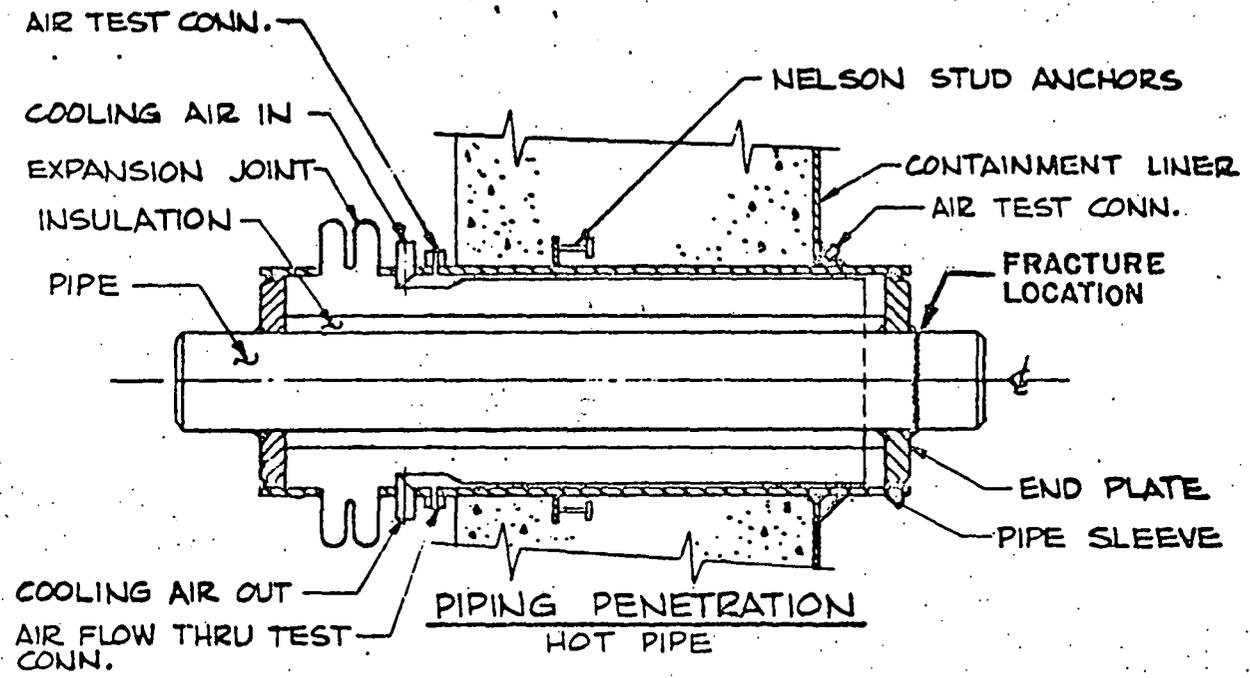
A visual inspection of the 18-inch diameter feedwater line inside containment indicated a fracture adjacent to a fillet weld between the feedwater line and the end plate which is welded into the penetration sleeve in the containment wall. The fracture extended approximately 180° around the pipe. The origin of the fracture was at the 3 to 4 o'clock position (from inside the containment when facing the containment wall). At the 3 to 4 o'clock location, the fracture was at the toe of the fillet weld. The fracture appeared to have propagated up to the 12 o'clock position, and down to the 6 o'clock position, and its path led away from the toe of the weld approximately 1/2 inch. Immediately above the 3 o'clock position, a short branch of the crack traveled along the toe of the weld.

The fractured portion of the pipe was offset from that portion remaining in the penetration so that at the 12 o'clock and at the 3 o'clock positions, it was raised 1/4 of an inch. The maximum measured width of the crack was 5/32 of an inch.

1. The failed section of feedwater piping has been removed and is being replaced with a new section of feedwater piping. The section to be replaced extends from the first elbow outside of containment, through the penetration, to near the first elbow inside containment (see Figure A attached to this report). In addition, the containment penetration end plates and expansion joint are being replaced. The undamaged containment penetration sleeve and penetration cooling coil will be retained.
2. As mentioned previously, the feedwater regulating valve in the feedwater line to Steam Generator No. 22 has been removed and sent to the vendor for inspection and maintenance as necessary.
3. All damaged or removed insulation will be replaced or repaired as necessary.
4. All piping supports and other components and/or structures removed for access will be reinstalled.
