Main Title	REPAIR OF TENDON V-75 FOR R.E. GINNA NUCLEAR POWER PLANT
Sub-Title	REPAIR REPORT

ANTHONY L. FELDER, P.E. ASSISTANT CHIEF ENGINEER

This report presents the results of repair work conducted on tendon V-75 of the Ginna Power Plant. This tendon had been damaged during the 3rd Year Surveillance and Inryco was called upon to provide a repair procedure and technical assistance.

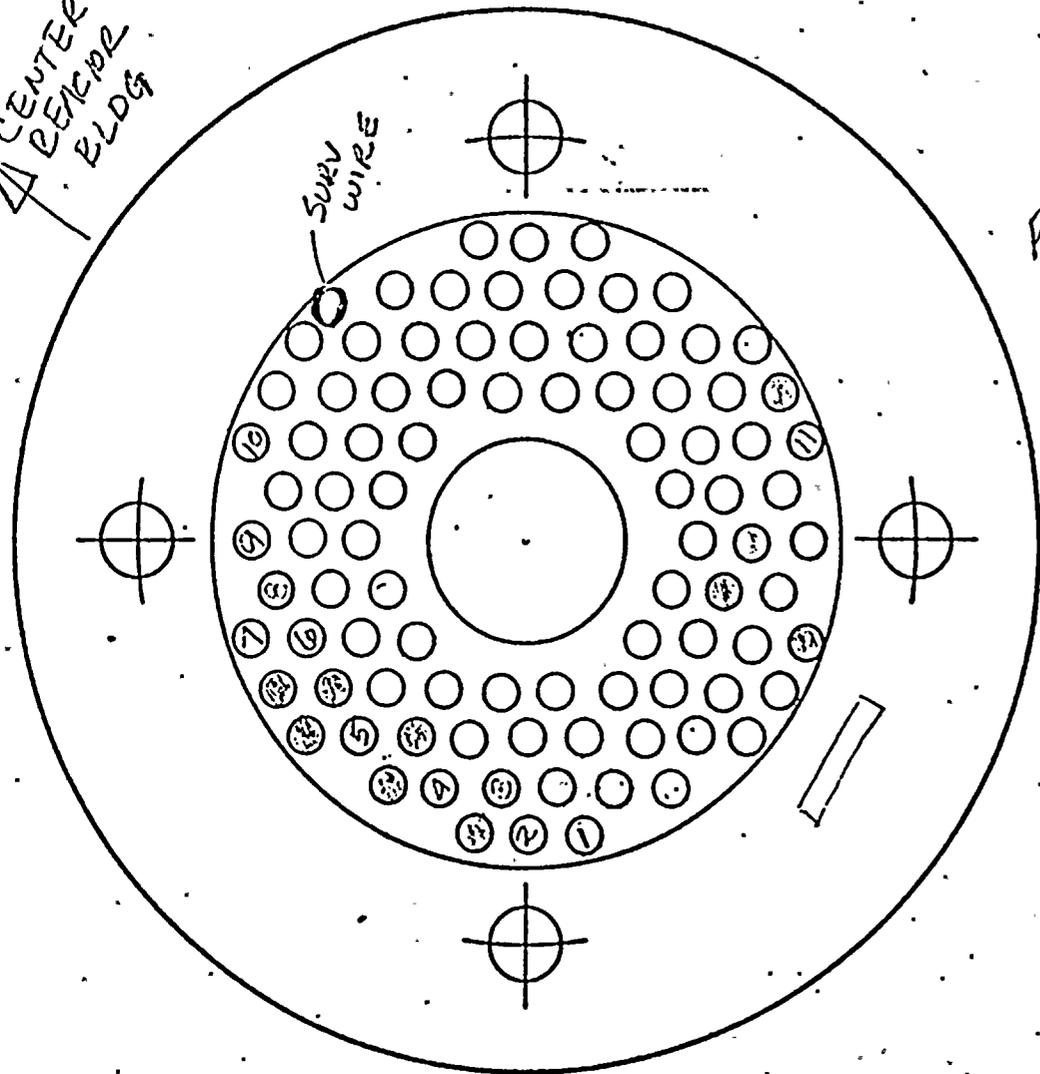
FIGURE 2.0

- 5) Wire and Buttonhead Inspection
 - a. Comments: Pulled the 11 ^{protruding} wires previously identified and marked - Found 1 additional wire which was broken + pulled it. See data sheet. Total of 22 broken wires removed as of 11:30 am. Photos taken: 11:45 AM; found 2 more broken (* on Data Sheet). - TOTAL 24 BROKEN AS OF 11:45 AM

▲ - Broken Wires
(C.A.F. 10/24/73)
