ACCESSION NBR: 8403280069 DOC. DATE: 84/03/23 NOTARIZED: NO DOCKET #
 FACIL: 50-244 Robert Emmet Ginna Nuclear Plant, Unit 1, Rochester G 05000244
 AUTH. NAME: AUTHOR AFFILIATION
 KOBER, R. Rochester Gas & Electric Corp.
 RECIP. NAME: RECIPIENT AFFILIATION:
 CRUTCHFIELD, R. Operating Reactors Branch 5

SUBJECT: Discusses installation & NDE of steam generator tubesheet sleeves. Approval to install 10 addl sleeves, based on insp results, requested.

Subject: Steam Generator Tubesheet Sleeves
R. E. Ginna Nuclear Power Plant
Docket No. 50-244

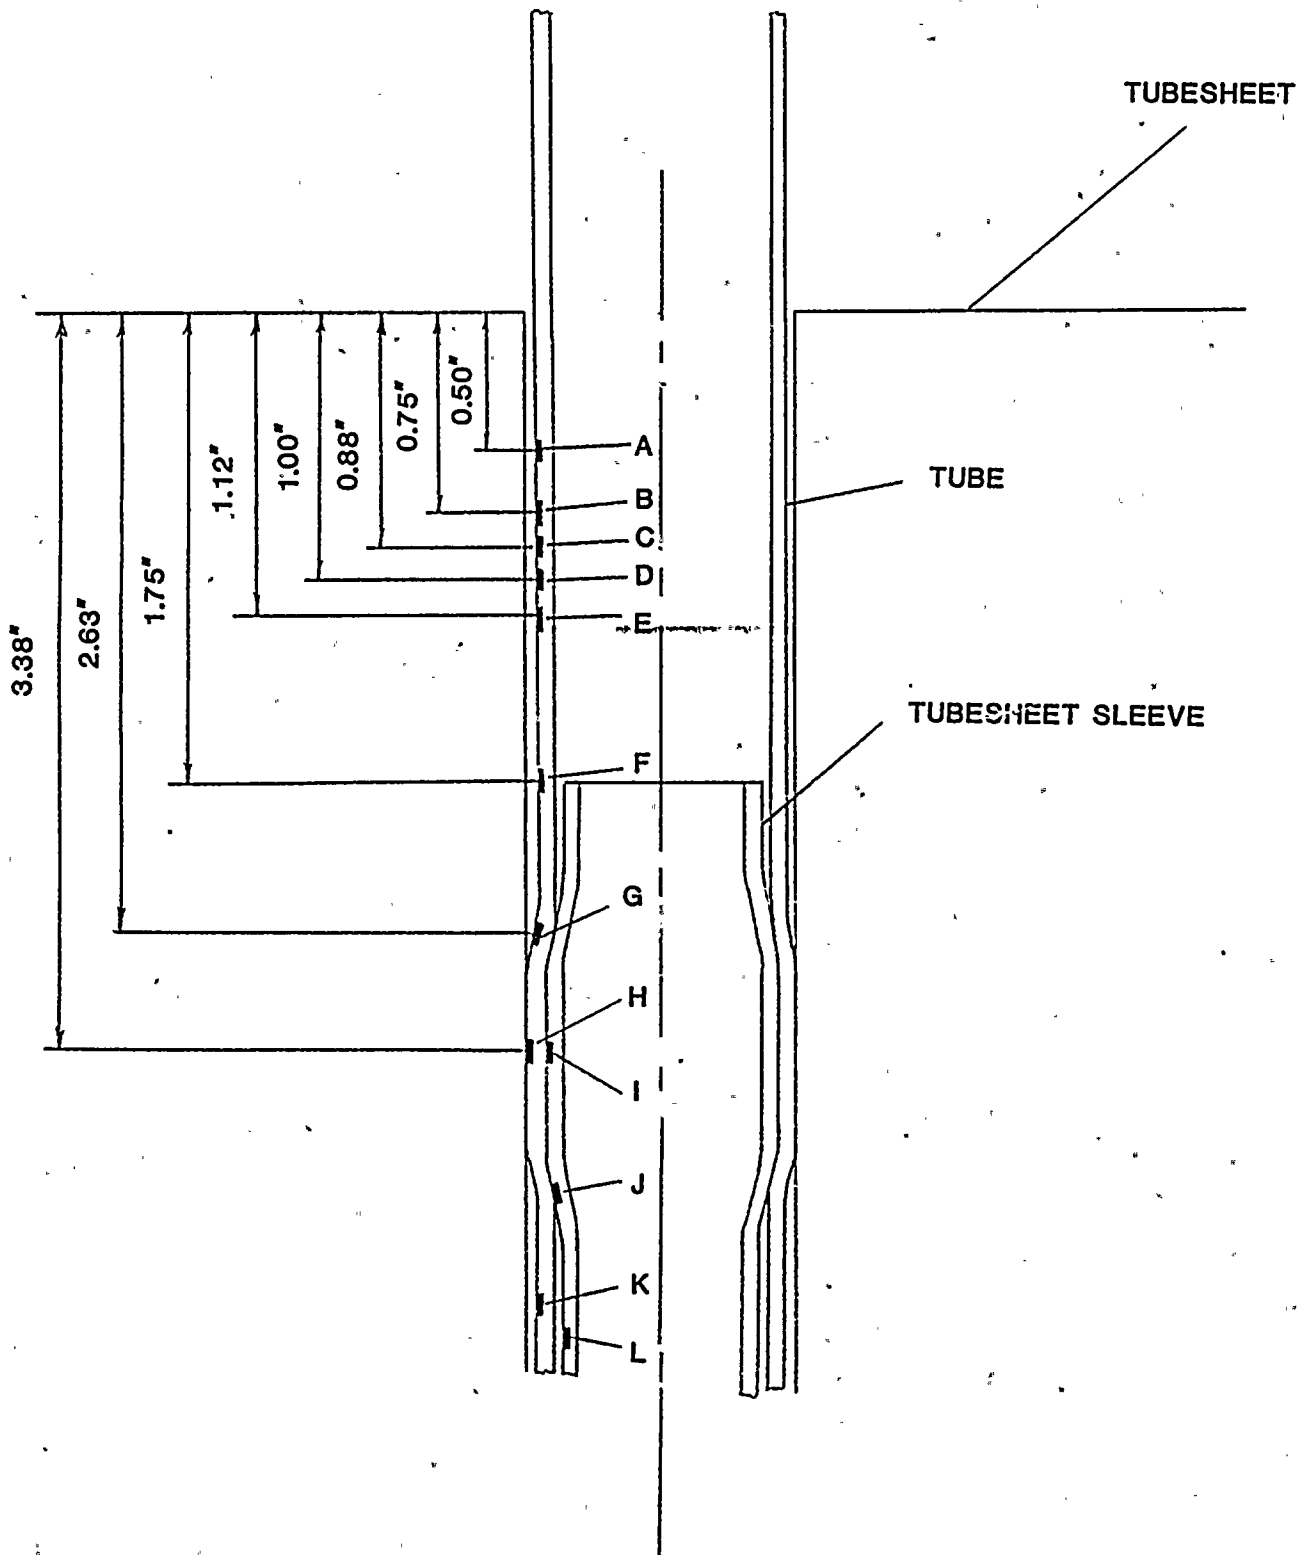
ATTACHMENT 1
TUBE / SLEEVE EDDY CURRENT
INSPECTION CAPABILITY

Although improvements have been made in the eddy current inspection techniques, there are still some areas of the tubesheet sleeve/tube combination where detection and sizing of defects at the 20% level is not possible. These areas are at the weld transitions and at the upper end of the sleeve. The eddy current coil now in use is an annular differential type with magnetic bias and operates on multiple frequencies including 50 and 150 kilo hertz. Use of the above coils will allow 20% thru wall defects to be seen 1 inch above the top of the tubesheet sleeve and at the lower transition as shown on Attachments 1 and 2. Larger defects can be seen at some intermediate locations.

Designation	Distance from Top of Tubesheet	Flow Detection Capability	Flow Signing Capability
A	0.50"	Yes	20%
B	0.75"	Yes	20%
C	0.88"	Yes	Marginal
D	1.00"	Yes	None
E	1.12"	Marginal	None
F	1.75"	None	None
G	2.63"	None	None
H	3.38"	Yes	40%
I	3.38"	Yes	40%
J	-	Yes	20%
K	-	Yes	20%
L	-	Yes	20%

To further minimize the consequences of potential defects, the tubesheet sleeves have been shortened approximately 1.25 inches. This will provide a minimum of 0.75 inches of tube within the tubesheet which can be inspected to the 20% thru wall criteria. A 0.75 inch length of tubing within the tubesheet will restrict the maximum achievable flow rate should a leak occur at this location. Even under postulated accident conditions, the tube will remain engaged in the tubesheet and the maximum flow rate would be well less than the capacity of one charging pump and, therefore, is acceptable.
