ROCHESTER GAS AND ELECTRIC CORPORATION
89 EAST AVENUE, ROCHESTER, NY 14649

SUMMARY EXAMINATION REPORT

1987 STEAM GENERATOR EDDY CURRENT INSPECTION

R.E. GINNA NUCLEAR POWER STATION

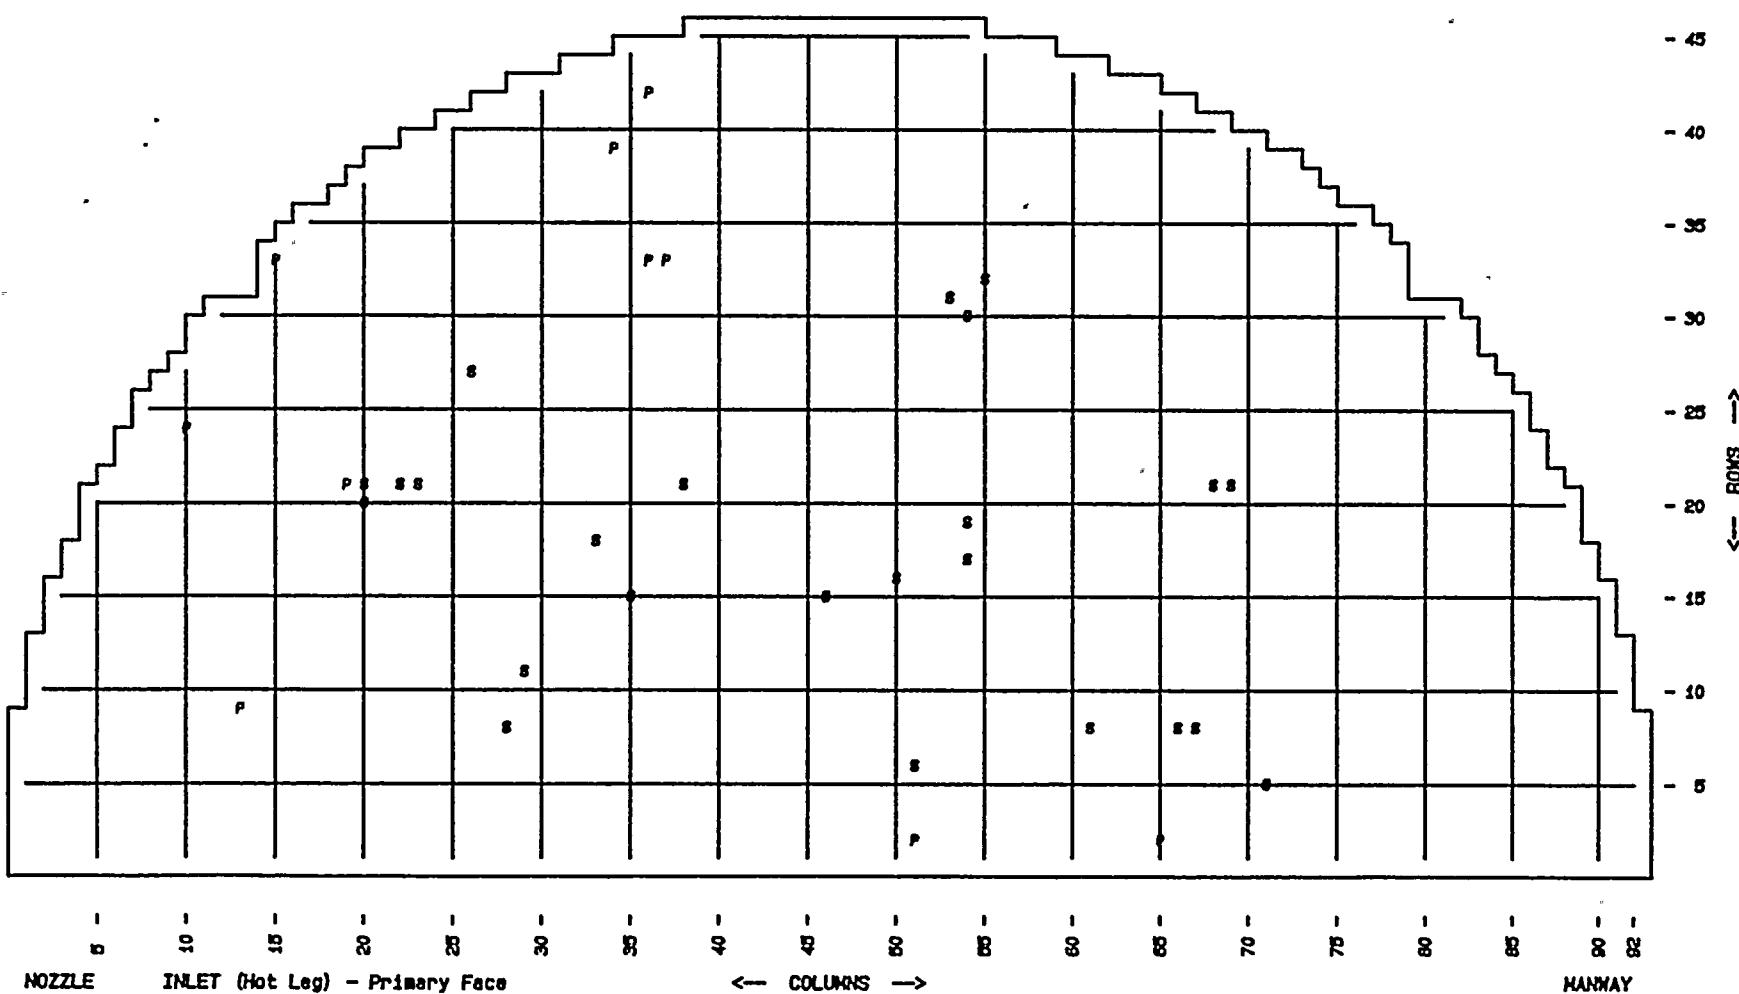
TABLE 5

STEAM GENERATOR "A" TUBES RECEIVING CORRECTIVE ACTION - FEBRUARY 1987

TOTAL TUBES: 3260

S = CE 27° SLEEVES (24)

P = CE PLUGS (10)

TOTAL TUBES ASSIGNED: 34

Table 5 has been generated to identify the tubes with crevice indications or with indications which exceed the repair criteria. This table also shows the location and axial extent of the indication and what corrective action was taken on these tubes. All tubes requiring repair had hot leg tubesheet crevice indications which were identified by an absolute drift signal of the Mix-2 Channel and/or quantifiable intergranular stress corrosion cracking (IGSCC) indications by the 400 kHz data. Several squirrel type (SQR) indications, multiple IGSCC, were also identified and have been placed on the list of tubes requiring corrective action. A total of 24 sleeves and 10 plugs were installed into the "A" steam generator. The "B" steam generator required a total of 80 sleeves and 73 plugs to be installed. One plug is attributed to a sleeve installed this outage which had to be removed from service due to unacceptable ultrasonic examination results of the upper weld.

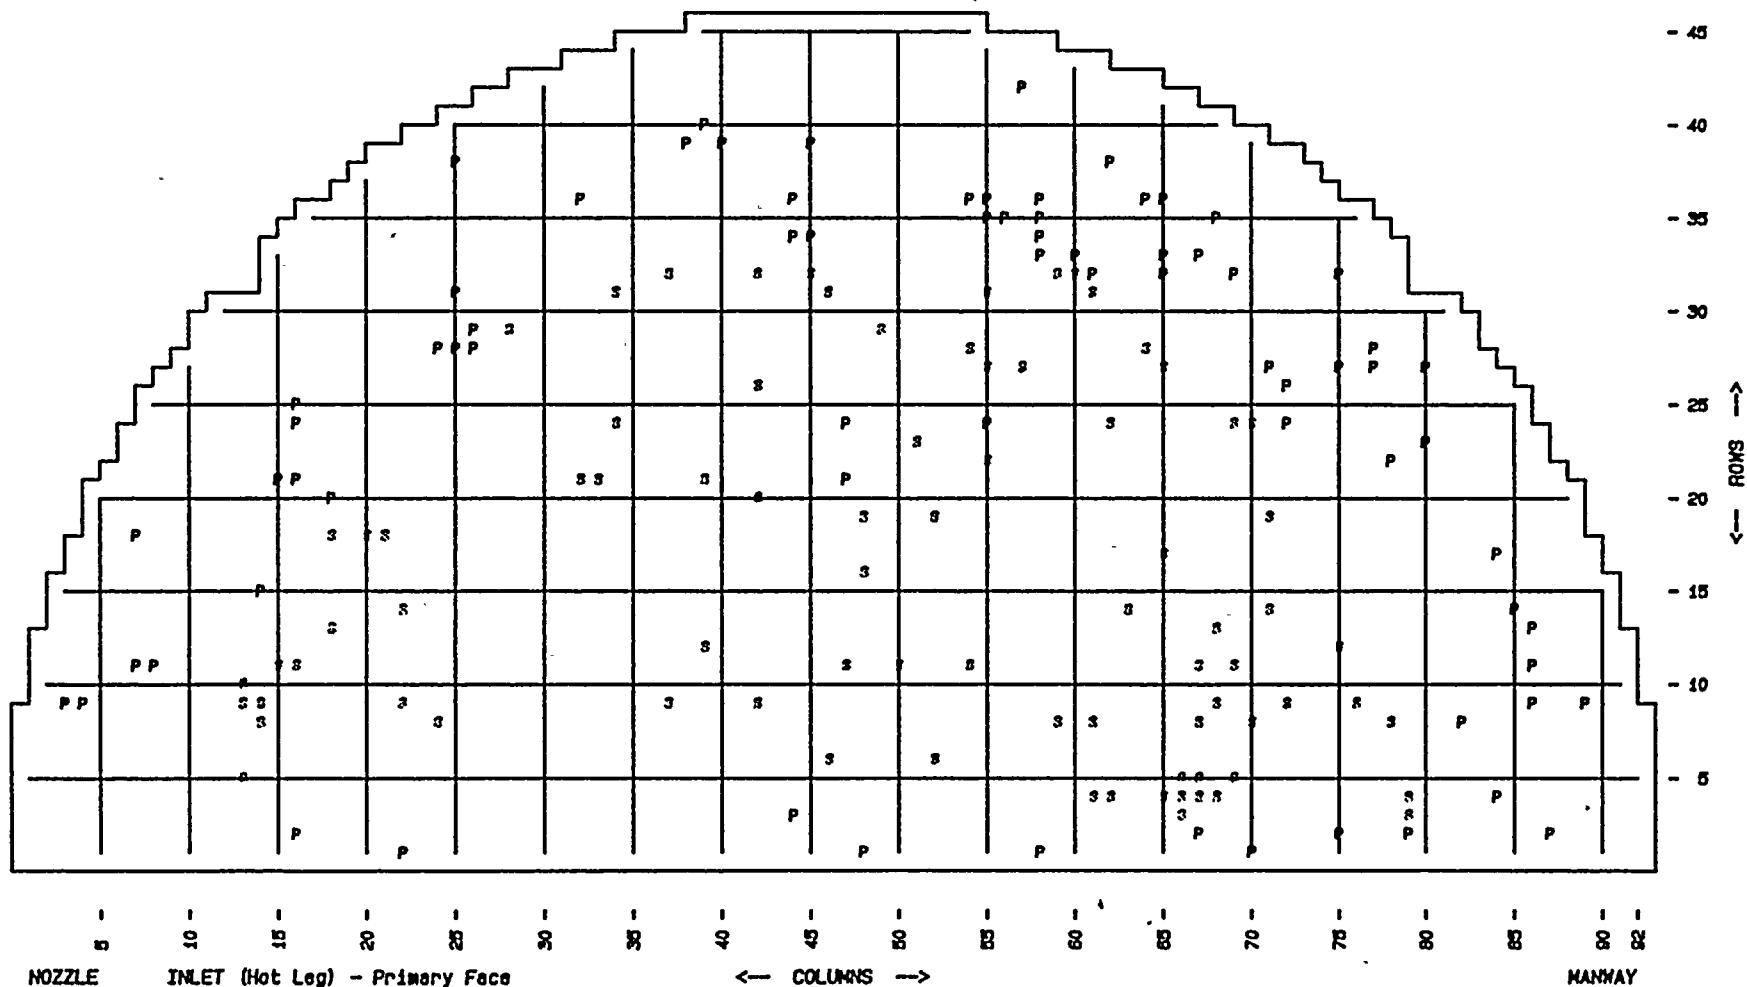
S = CE 27° SLEEVE (80)

TOTAL TUBES ASSIGNED: 155

The 153 tubes identified with crevice indications in the "B" steam generator inlet were repaired as follows:
