U. S. NUCLEAR REGULATORY COMMISSION
REGION I

Inspection Report 50-244/93-03

Facility: R. E. Ginna Nuclear Power Plant
Rochester Gas and Electric Corporation (RG&E)

Inspection: January 27 through March 9, 1993

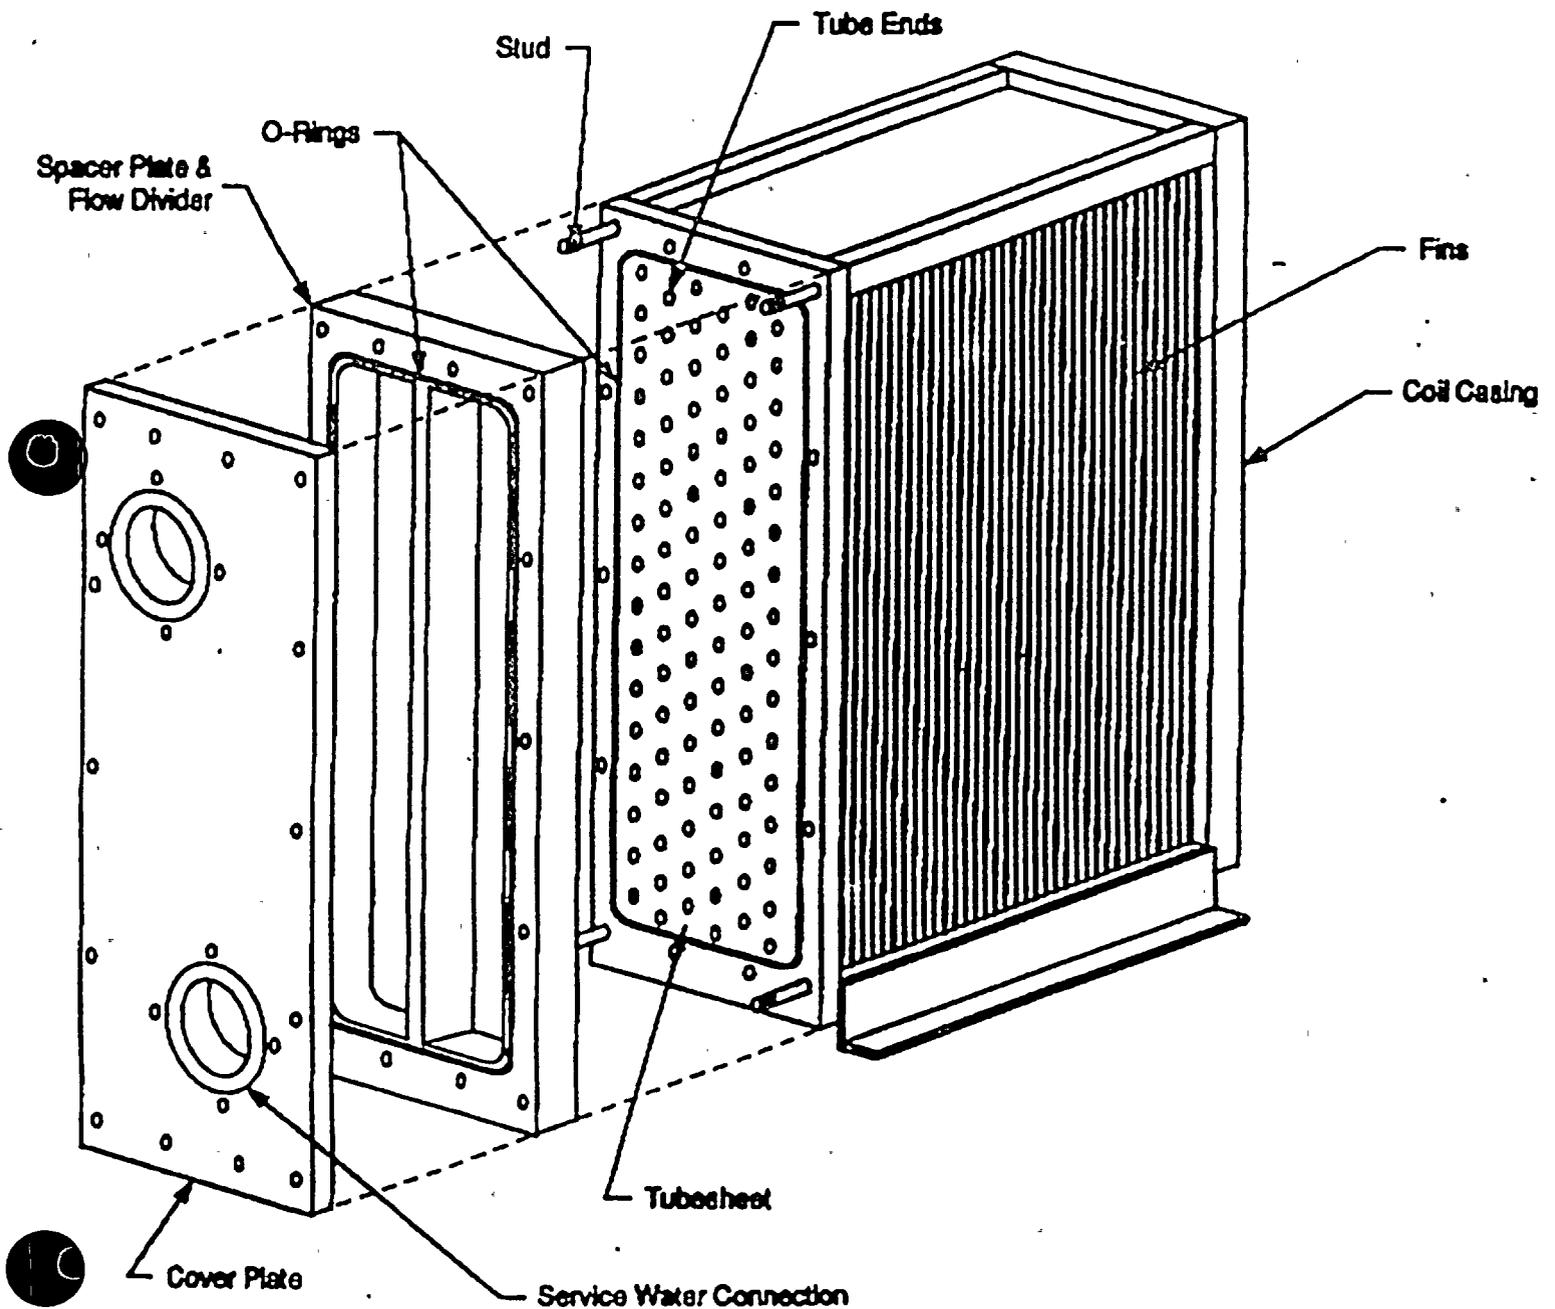
ENHANCED CRFC COIL DESIGN CONCEPT

- 17% Heat Transfer Margin
(Accident Conditions)
- AL-6XN Tube Material
- Resistant to Erosion and Corrosion
- Compatible with Velocities for Zebra Mussel Control
- Lower Water Velocity Reduces Potential for
Erosion/Corrosion
- Waterbox Design
- Water-Side Access for Inspection, Cleaning, and Repair
- Plugging Margin

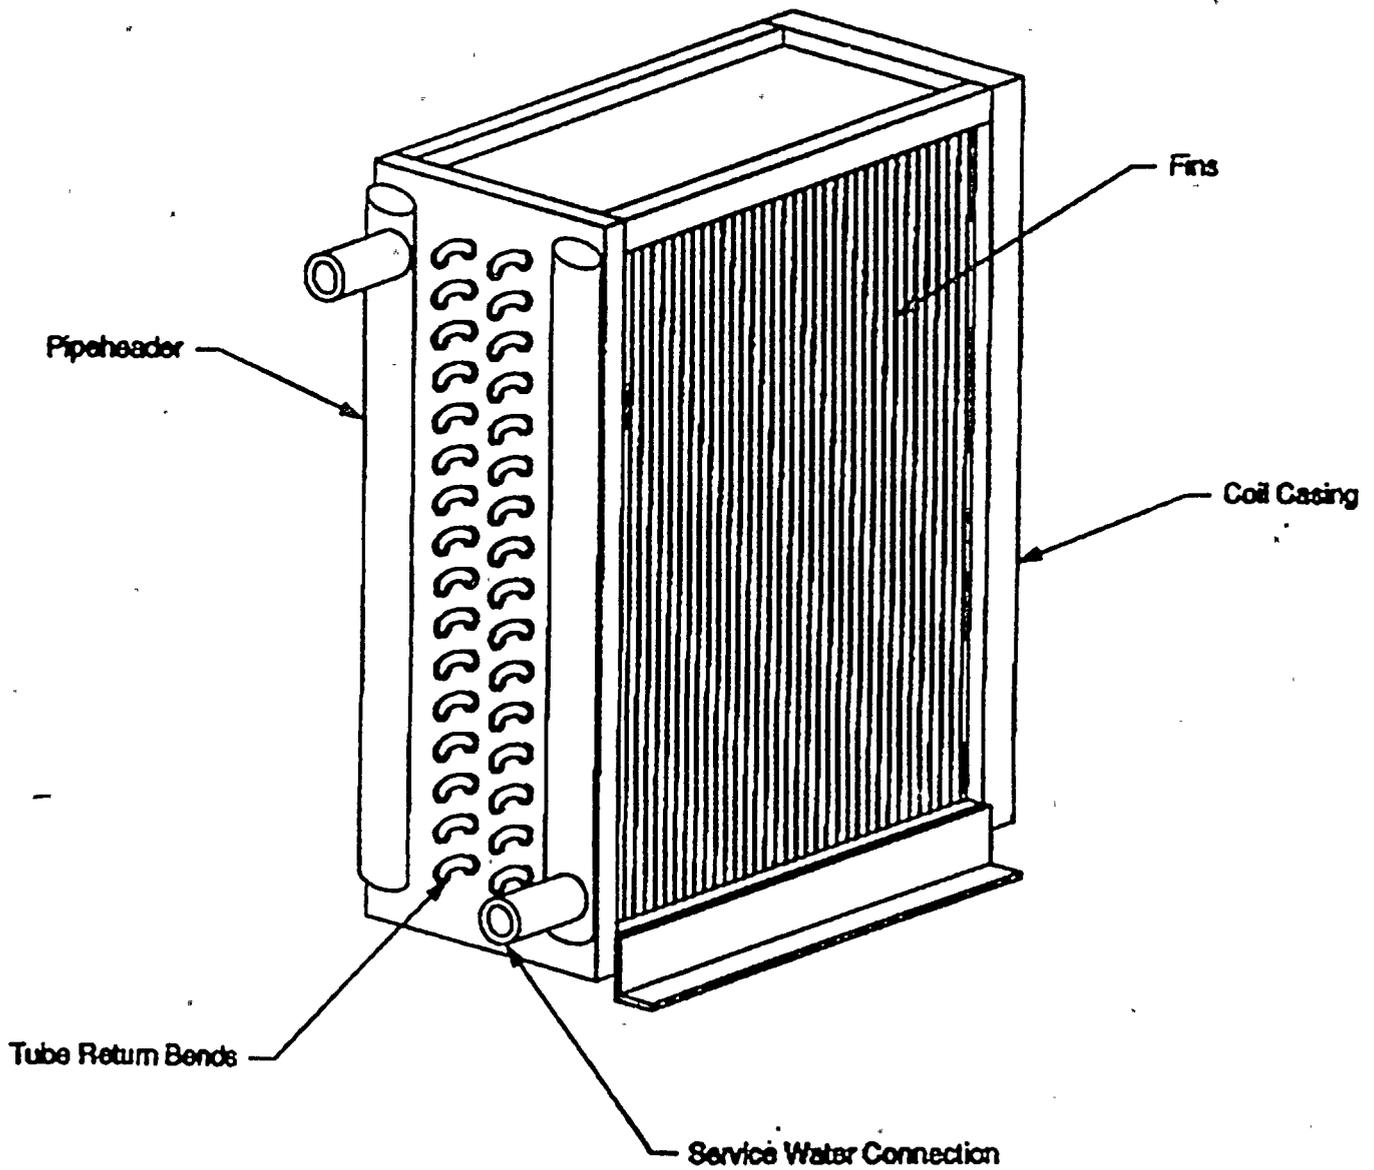
EXISTING CRFC COIL DESIGN CONCEPT

LEAKING COOLERS

RESTRICTIVE ACCESS FOR INSPECTION/REPAIR OF COOLERS

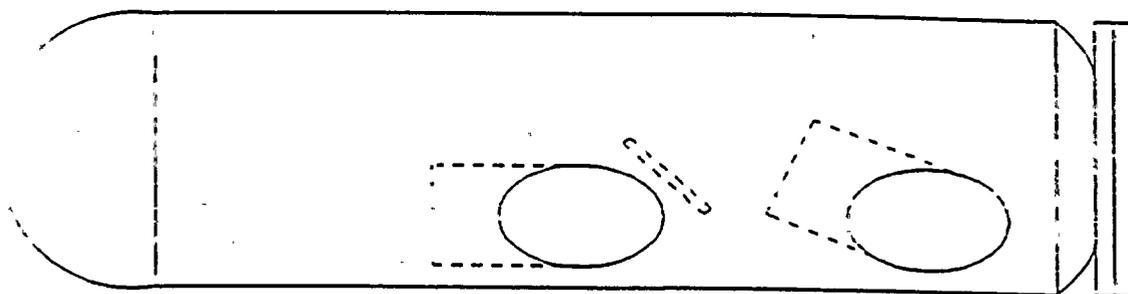
EXISTING "A" HEADER

June 1992 Fishmouth Rupture of "A" preseparator drain header. No injury resulted or damage to other equipment.

- Inspections were done on Both A & B preseparator drain headers.
- Engineering basis was established.
- A combination of A-36 plate & weld overlay in thinned area was used for repairs.
- Repair made was for the short term.
- The analysis was submitted to NRC.
- There were issues & questions raised in NRC Inspection report 50-244/92-09.
- RG&E has responded to questions raised in November 1992 response submittal.
