Rochester Gas & Electric Corporation
R. E. Ginna Nuclear Power Plant

GINNA STATION

ENFORCEMENT CONFERENCE

Inspection Report 93-08

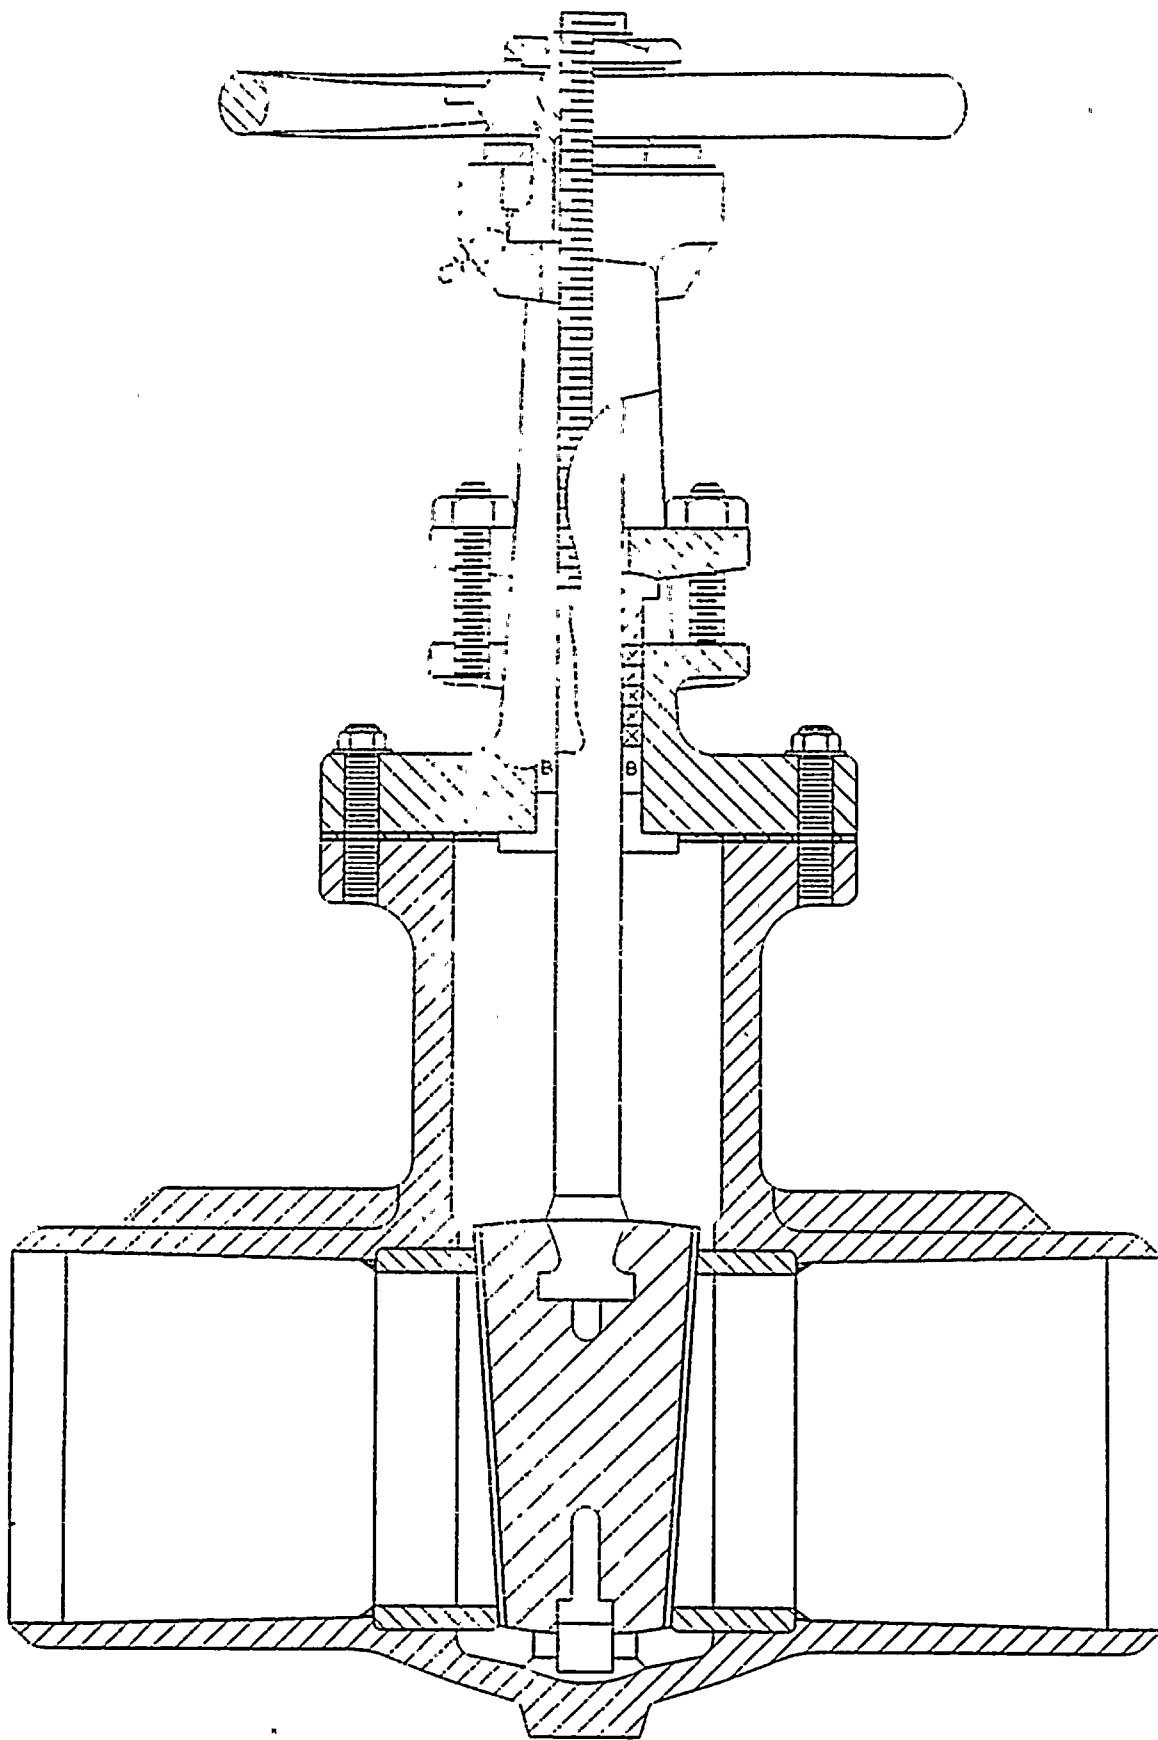
CRANE, GATE VALVE, MODEL NO. 101-XU

- First Failure - Valve V-4675
 - Valve V-4675 Inlet to Turbine Generator Seal Oil Heat Exchanger

Valve Material Condition

- Post-Maintenance Restoration
- Valve V-4675 Inspection
- Temporary Repair Performed
