ROCHESTER GAS AND ELECTRIC CORPORATION
89 East Avenue, Rochester, NY 14649

SUMMARY EXAMINATION REPORT

1995 STEAM GENERATOR EDDY CURRENT INSPECTION

R.E. GINNA NUCLEAR POWER STATION

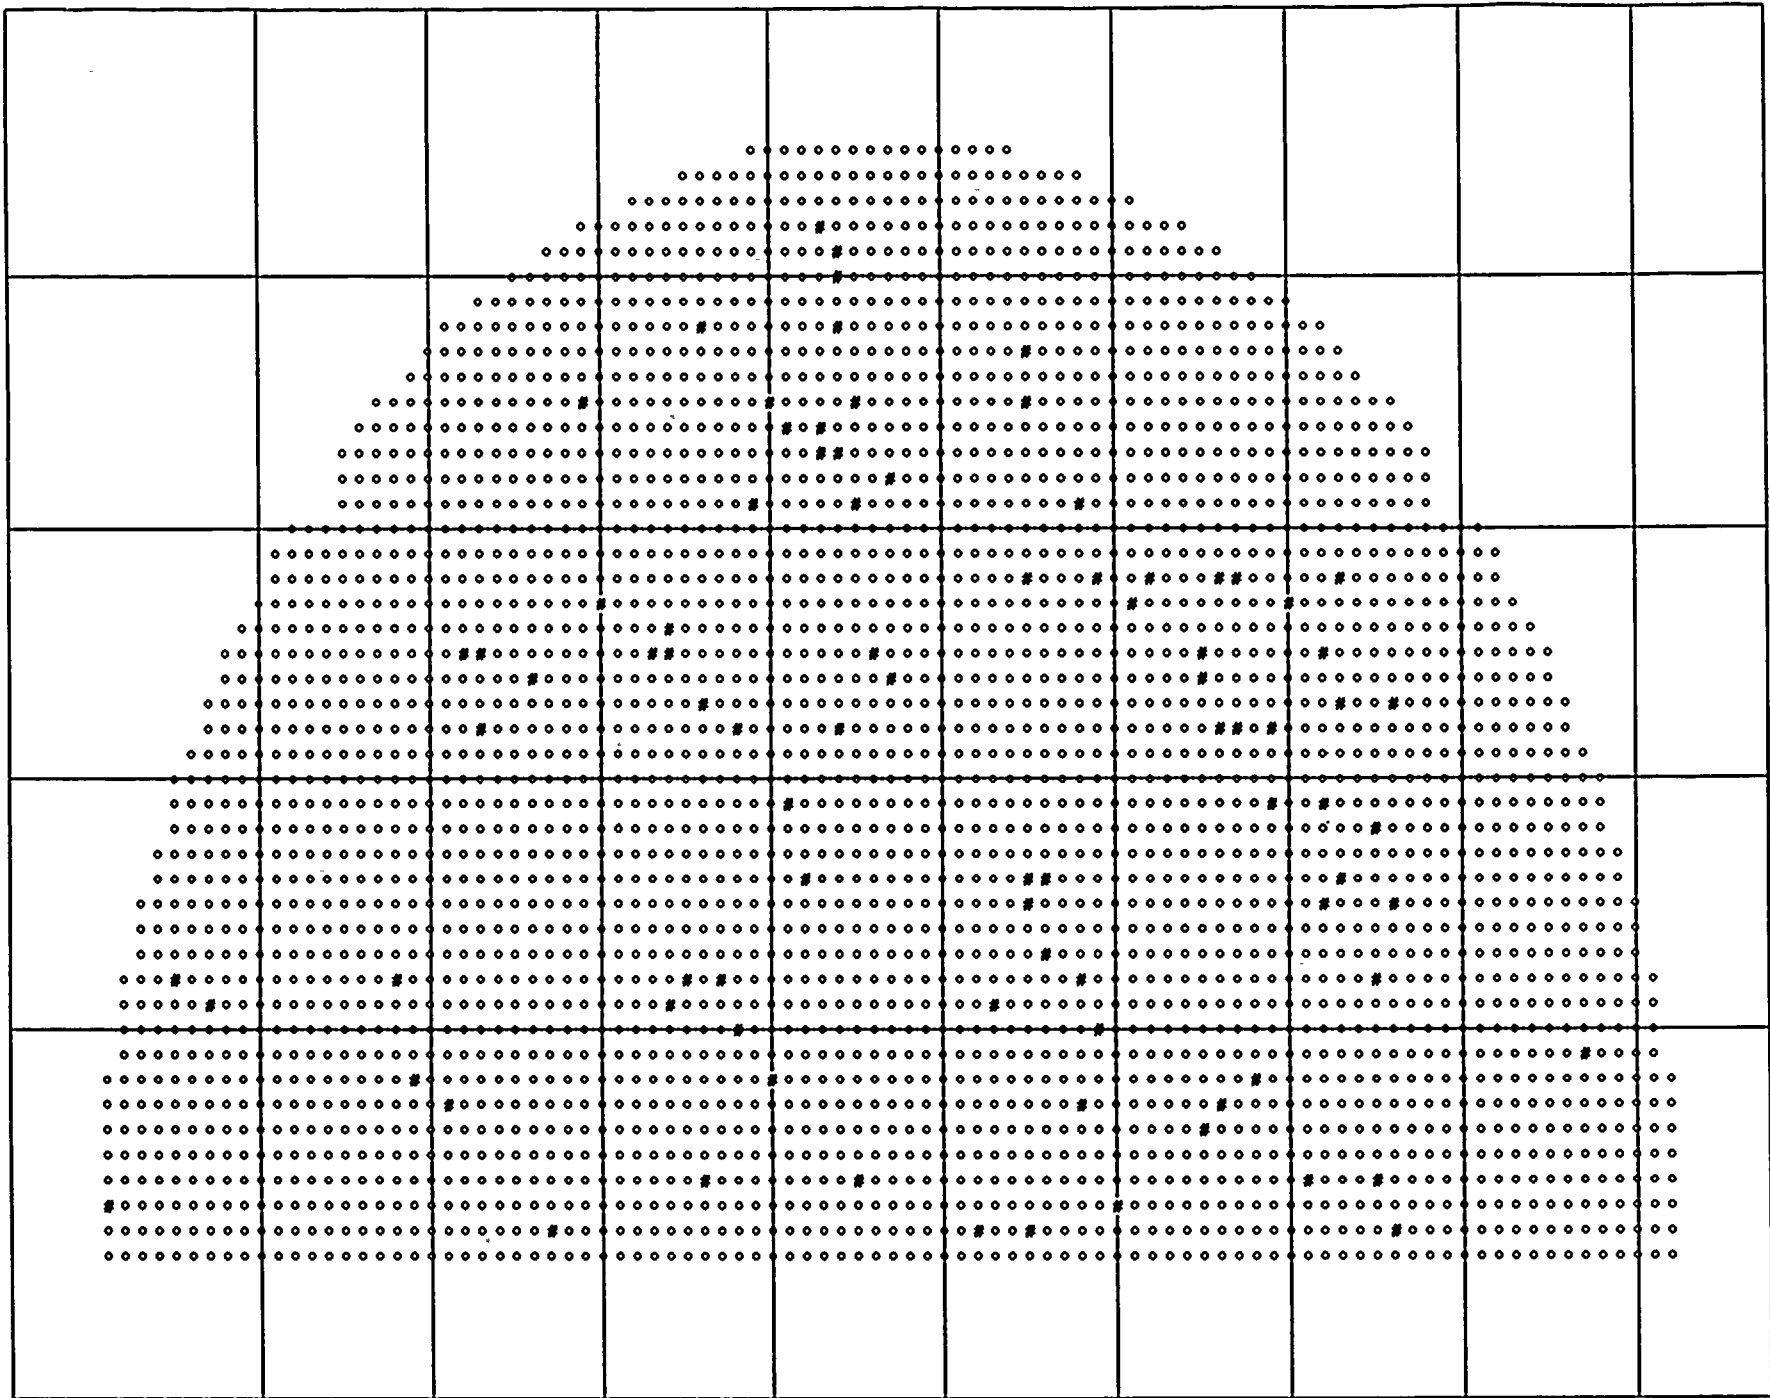
Rochester Gas & Electric Corp.
 Ginna Nuclear Power Station
 S/G - A 04/07/95 Inlet

#: 88: TUBES TO BE REPAIRED - 9SMAR OUTAGE

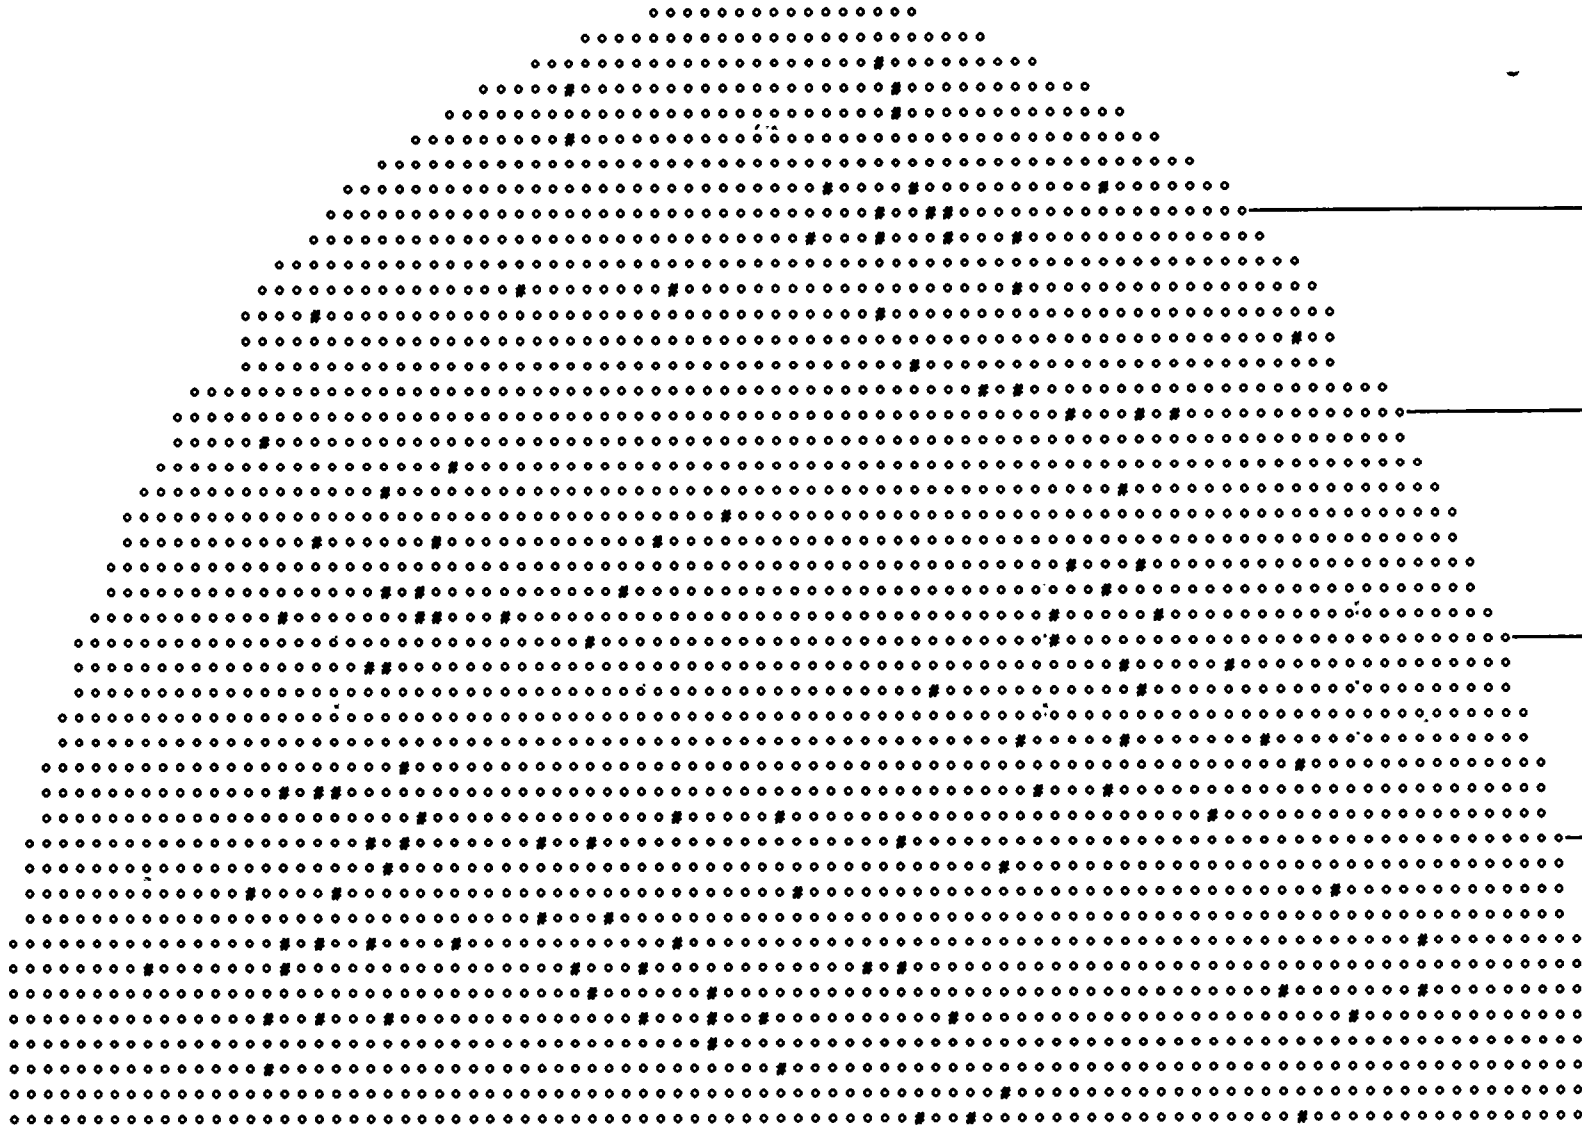
Rochester Gas & Electric Corp.
 Ginna Nuclear Power Station
 S/G - B 04/07/95 Inlet
 Applied Computer Resources, Inc.

#: 113: TUBES TO BE REPAIRED - 9SMAR OUTAGE
