Docket No. 05200046

Reply to NOV Report No.05200046/2016-202

September 2017

## **Reply to a Notice of Violation (NOV): NRC Inspection Report No.05200046/2016-202**

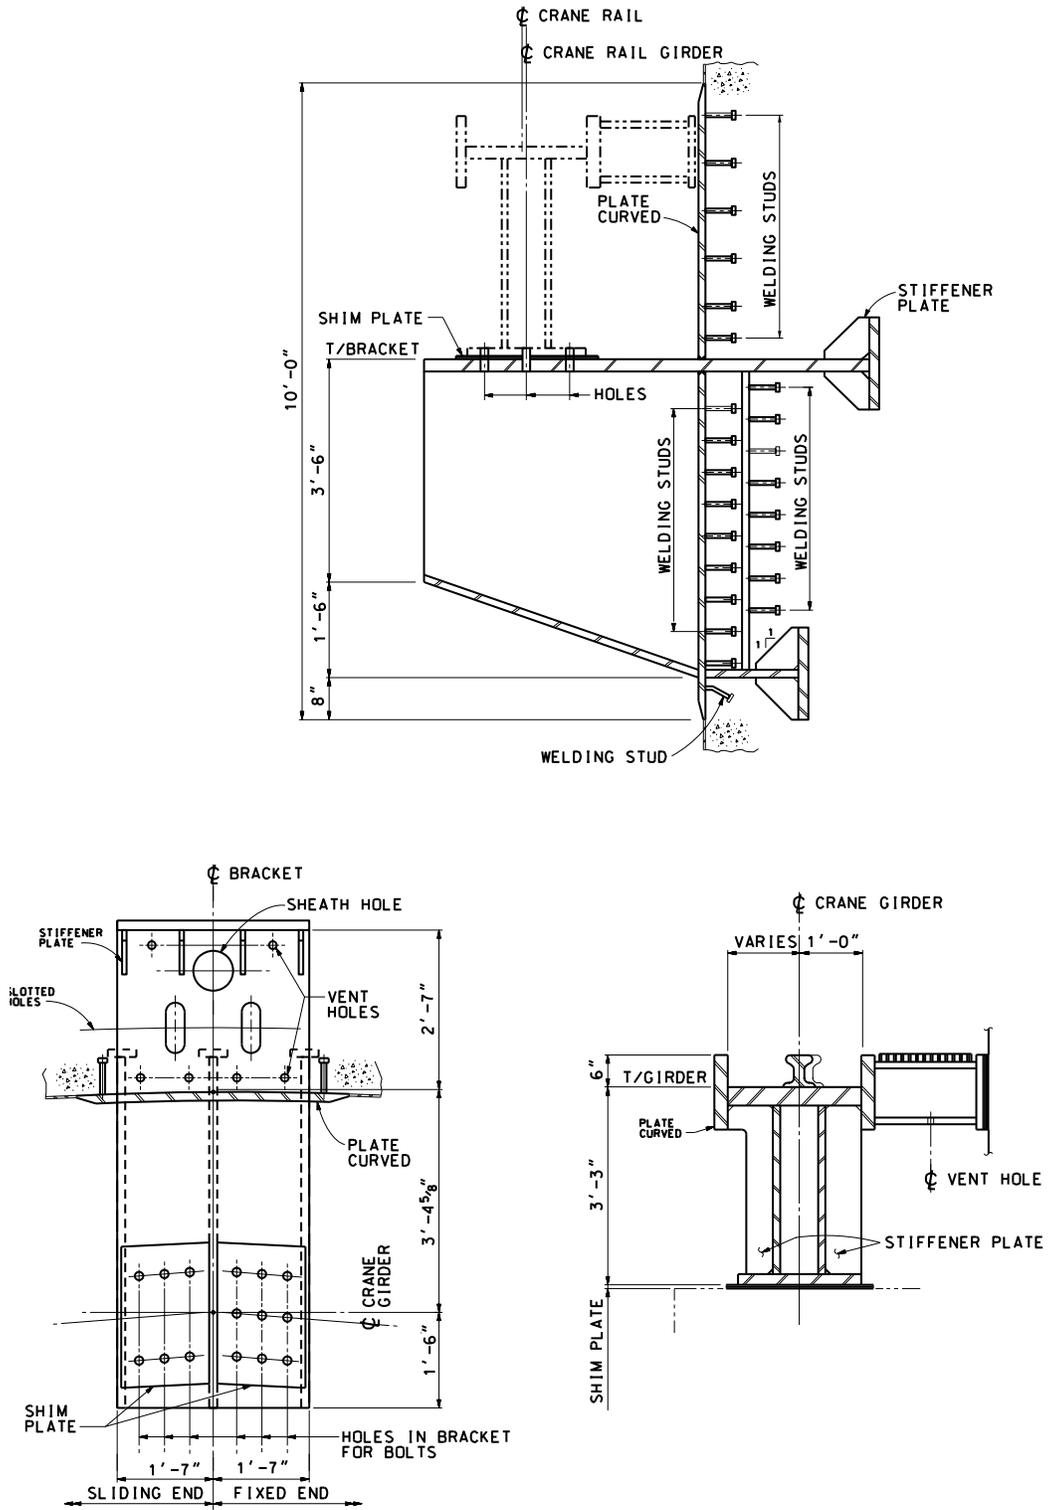
Figure 19.5-11 Polar Crane Bracket

The polar crane bracket and rail girder shown in Figure 19.5-11, are key design features to protect the safety system located inside containment from the drop of polar crane due to the impact of a large commercial aircraft. The polar crane brackets and girders shall be ASTM A588 Grade A or B and the bolts for the connection between polar crane bracket and rail girder shall be minimum 1.5" diameter ASTM A490X. The design of polar crane bracket and rail girder is performed to maintain adequate design margins. The summary of design results and material properties are shown in Table 19.5-1.

- 5) The polar crane support brackets and girders are added to Section 19.5.4.1 as a key design feature.
- 6) The auxiliary building interior and exterior walls are added to Section 19.5.4.2 as key design features.
