Supplement #3

THE FINAL SUPPLEMENT TO THE  
"ENGINEERING EVALUATION OF THE WNP-2  
SACRIFICIAL SHIELD WALL" SUBMITTED TO NRC  
IN AUGUST 1980

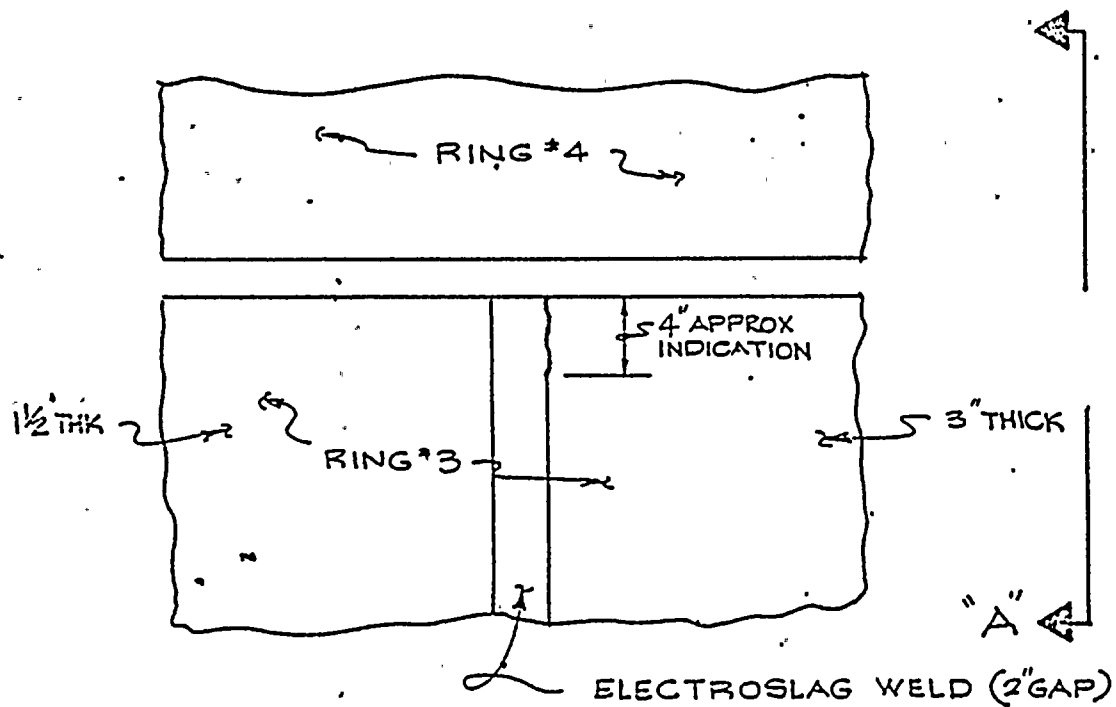
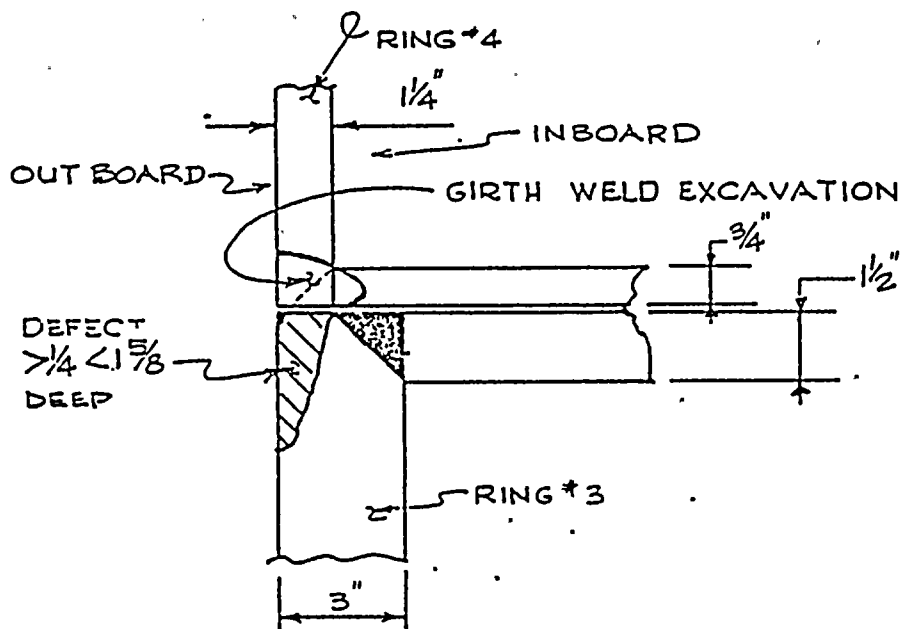
Fig 1. LINEAR INDICATION IN RING 3 AT 135°-150° AZ

- (i) Linear indications in electroslag welds were discovered adjacent to the girth weld. Details of this deficiency are given in Figures 1 and 2. This deficiency was detected in two of the thirty-two electroslag welds in ring #3 which intersect the girth weld.
- (ii) Linear indications, slag inclusions and porosity were discovered in guide plate welds (see Figure 3).
- (iii) Lack of penetration existed at the weld joint between the bottom flange of ring beam #4 and the exterior web plate. Details of this deficiency are shown in Figure 4. For further discussion and clarification see Part 5.
- (iv) Linear indications in the girth weld excavation probably resulted from the repair of deficiency (iii) above.

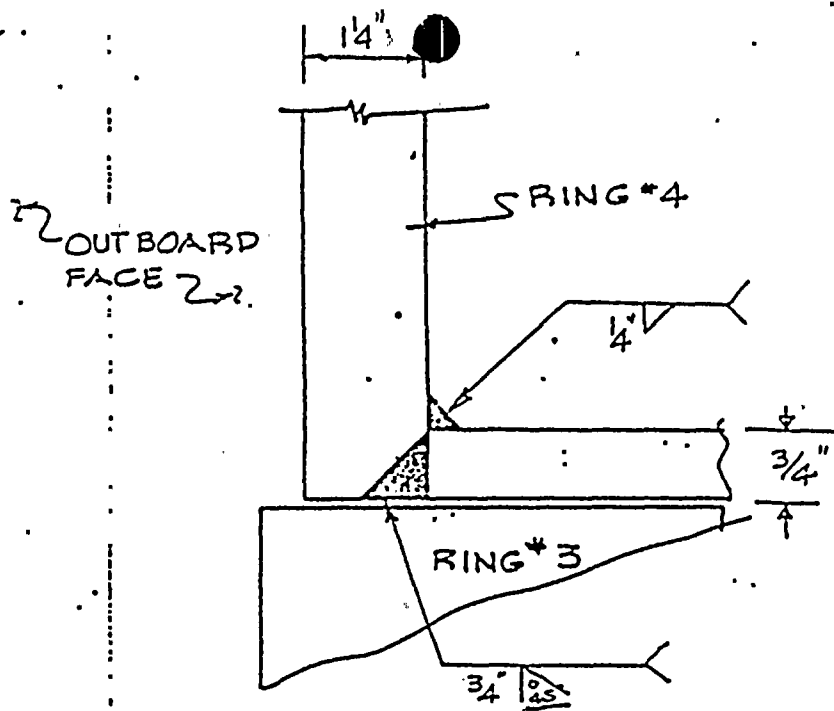
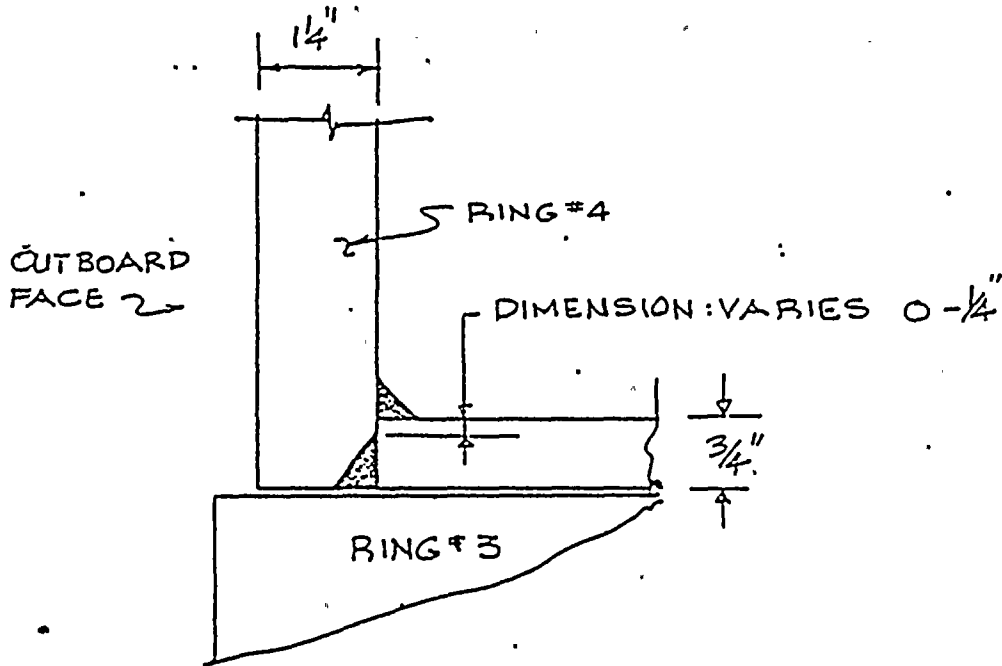
FIG. 4. LACK OF PENETRATION AT AZ. 90°-105°, 0°-15° AND 180°-195°.

B: AS-BUILT CONDITION AT AZ. 90°-105°, 0°-15°, AND 180°-195°.
