DESIGN ENGINEERING REPORT

WNP-2 FEEDWATER PIPING THERMAL DEFLECTION EVENTS

Washington Public Power Supply System Nuclear Plant No. 2

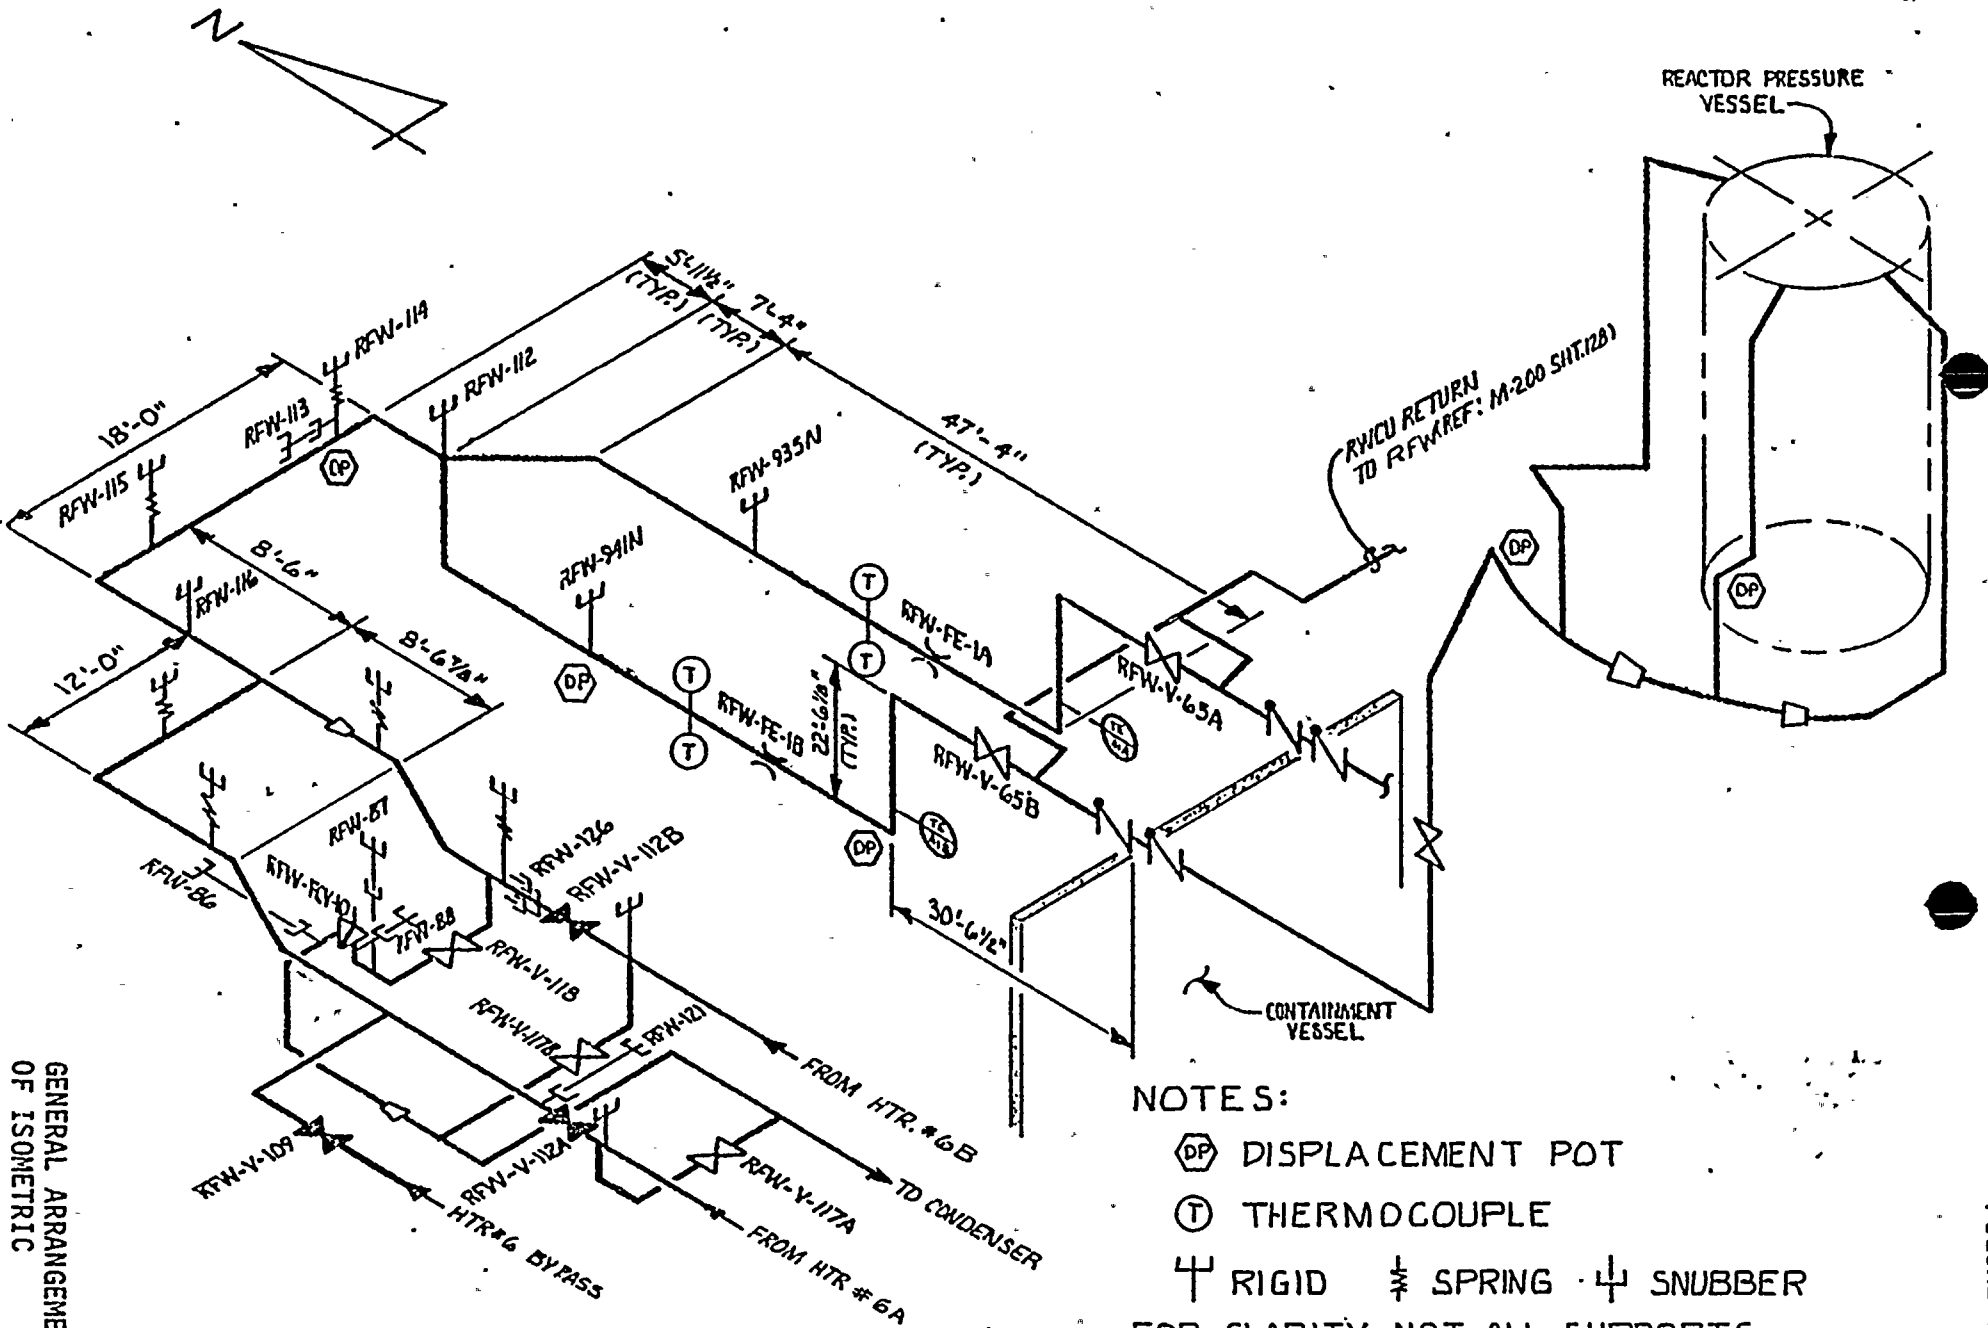
FIGURE 1

Refer to Figure 1 for the general piping system design. The major portion of the piping involved is between the the final stage of feedwater heaters, identified as heaters 6A and 6B, and the outboard containment isolation valves RFW-V-32A and 32B. During low power reactor operation, makeup water flows into this section of pipe through flow control valve RFW-FCV-10. During higher power operation RFW-FCV-10 is closed and flow is routed through valves RFW-V-112A and 112B. Flow continues into a section of 30 inch pipe, which is intended to provide mixing of the water leaving heaters 6A and 6B to assure uniform water temperature into the reactor. After the 30 inch section the flow branches at a wye into two-24 inch sections of pipe. These two long straight runs are flow straightening sections which provide uniform flow through reactor level control flow elements RFW-FE-1A and 1B. Flow is then directed upward and then back horizontally through the steam tunnel, and through the containment isolation valves on its way to the reactor. Immediately upstream of the outboard isolation valves, RWCU flow is injected into the RFW piping through a thermal sleeve branch connection in the upper portion of each RFW line.

GENERAL ARRANGEMENT OF ISOMETRIC

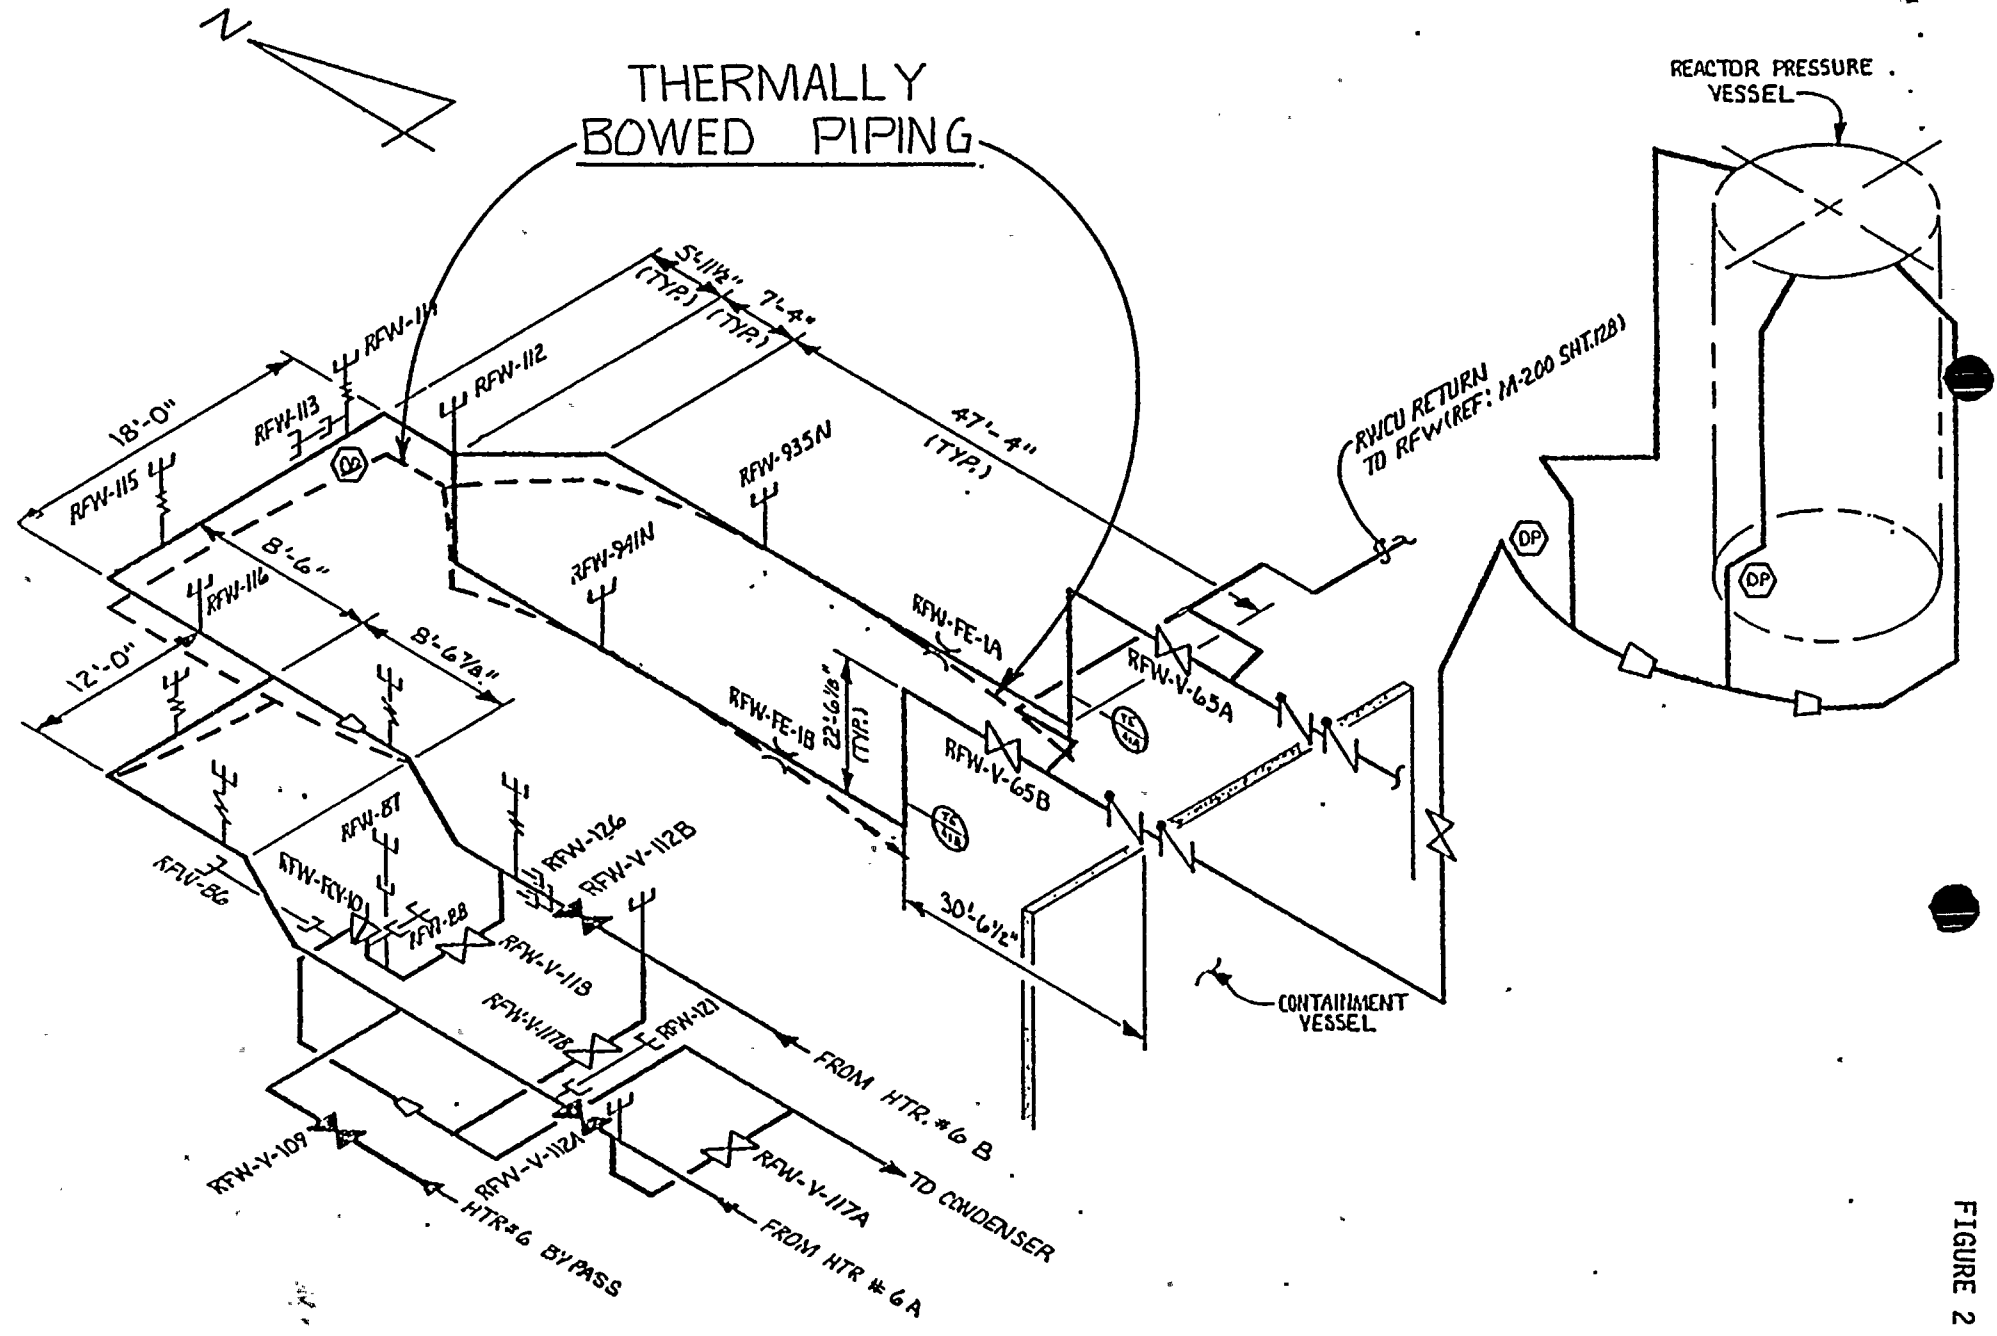
FIGURE 2

Pipe support damage was determined to have been the result of very high loads and displacements at the support locations. Traditional methods used to evaluate thermal expansion and/or water hammer effects do not predict sufficient displacement to cause the observed failures. Rather, it was found that large top to bottom temperature gradients in a long horizontal run of piping were the cause of the large displacements. Temperature differences of up to 200°F were measured between the top and bottom of the pipe with the higher temperature being on top. Thermal expansion of the top of the pipe exceeds that of the bottom resulting in the pipe assuming a bowed down shape with several inches of unrestrained vertical displacement at the endpoints of the horizontal run. Displacements in excess of support capability occurred at several locations. Figure 1 shows the general piping arrangement and Figure 2 illustrates the concept of bowing as described above.

THERMALLY BOWED PIPING

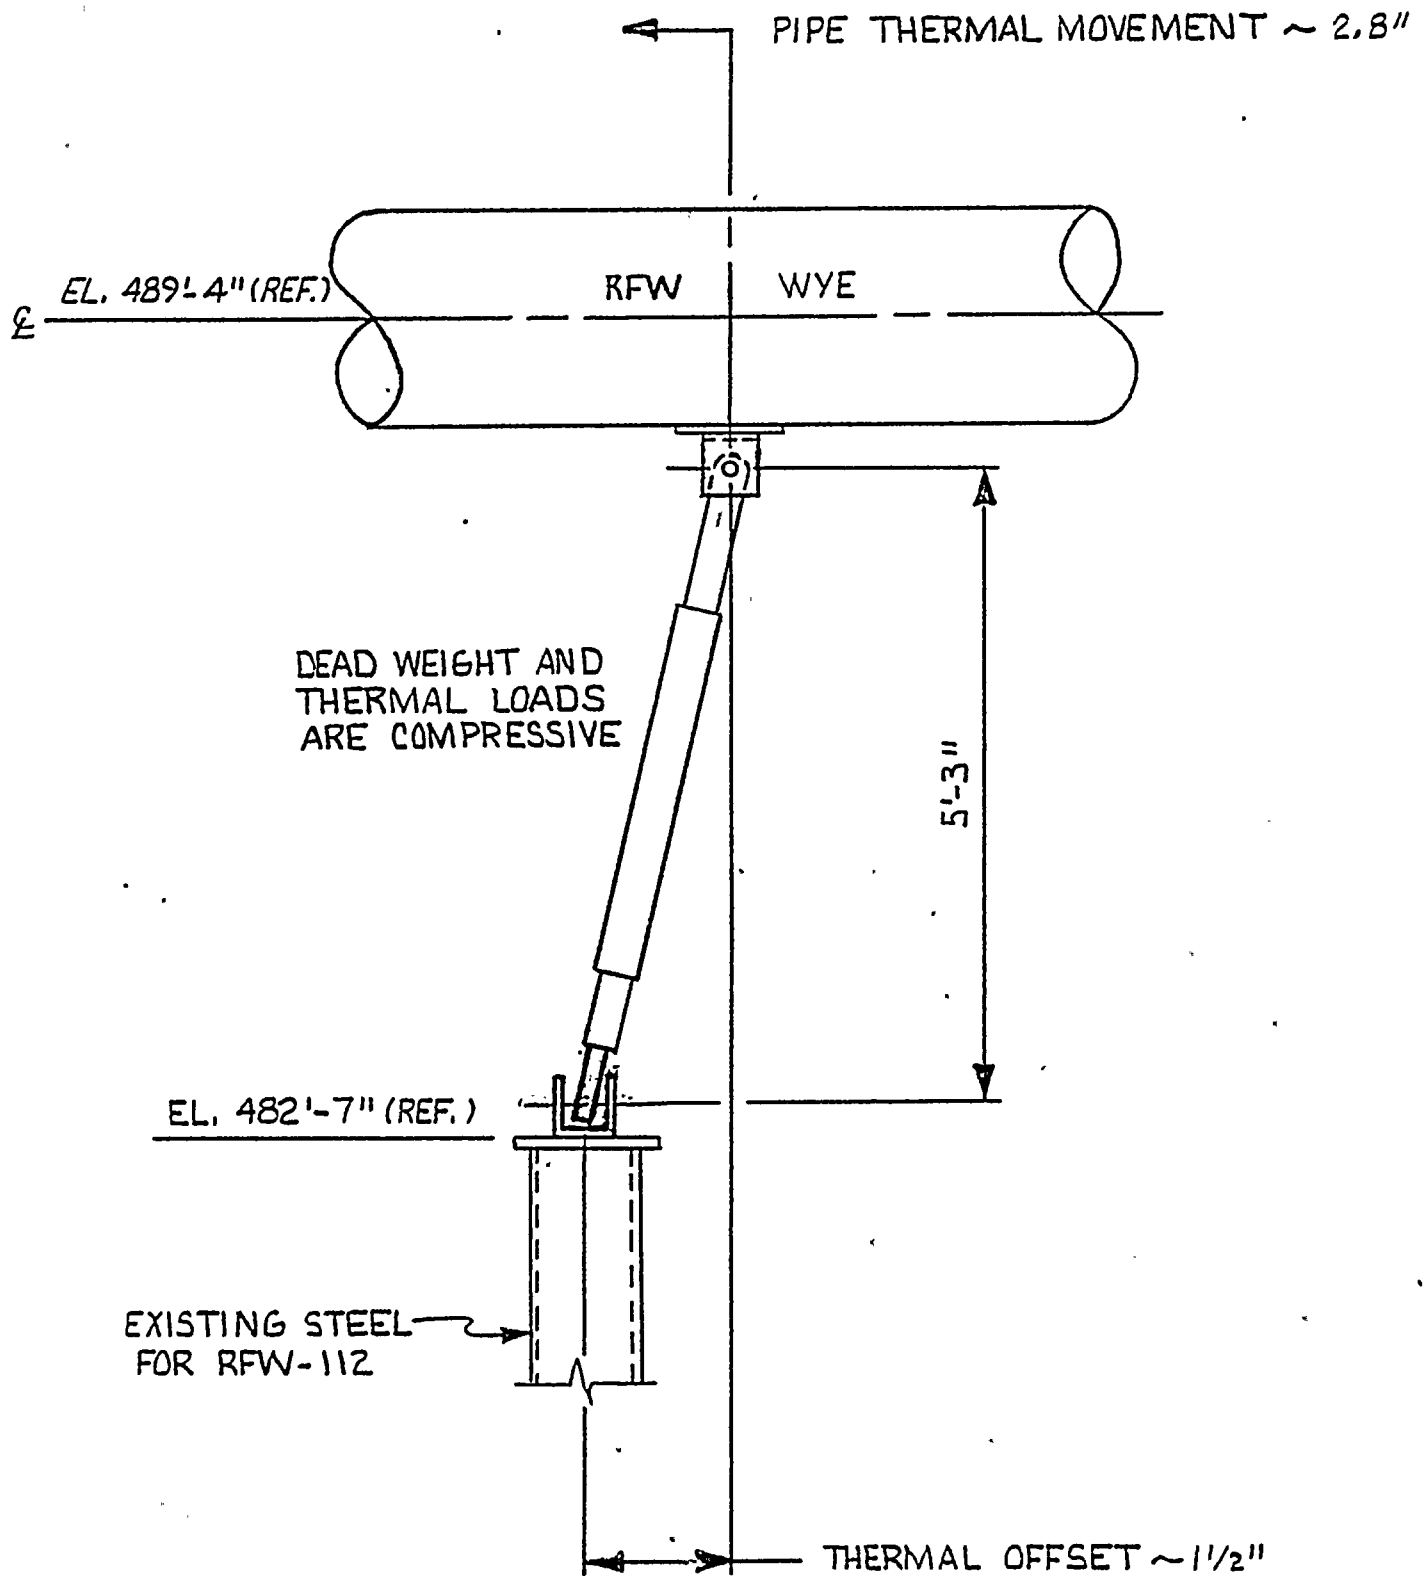
THERMAL OFFSET OF RFW-112

On June 20, with the reactor in hot standby, hanger RFW-112 was found buckled. The immediate cause of the failure was uncertain and a thorough inspection of adjacent hangers and piping was completed while looking for clues. No other damaged hangers or snubbers were found and no evidence of pipe movement could be found at points where the RFW piping insulation was in close proximity or touching adjacent structures or piping. Although initially suspected, it was therefore concluded that water hammer was not the mechanism which caused the failure. Further examination of the damaged strut revealed gouging marks on the attachment, or paddle ends. This evidence was combined with a review of the piping thermal movements, reactive loads, and the general design concept of hanger RFW-112. The conclusion was that failure resulted from excessive preload on the strut combined with paddle binding within its attachment end brackets as the piping system was thermally expanding in the plane of the long horizontal pipe runs. (See Figure 3) To help confirm this conclusion, motion detectors were installed in the vicinity of hanger RFW-112 and signals routed to a recorder.

As a result of the buckled strut, analyses were performed to verify the design basis analysis and pressure boundary integrity. These analyses found no anomalies and that the piping system was unaffected by the event. The buckled strut was removed and replaced with a similar strut. Re-alignment of the system to its original position was easily achieved, which supported analysis conclusions that the piping system (pressure boundary) was unaffected by the thermal transient. To preclude reoccurrence of hanger RFW-112 failure, the deadweight compressive load was relieved from the strut by minor adjustment of adjacent spring hangers. By removing the deadweight preload, the potential for strut binding was judged to be mitigated and enhanced freedom of movement for the large thermal movement (approximately 2.6 inches) would thus be attained. This action was considered adequate while the Supply System's Stress Group reanalyzed this anchor group in an effort to totally eliminate hanger RFW-112. This work was prompted by the analysis conclusion that hanger RFW-112, as originally designed, was a marginal concept for supporting the piping deadweight load. Specifically, utilization of a bottom mounted, compressively loaded, slender sway strut which incorporated large offsets to accommodate thermal movements was deemed not advisable, see Figure 3. Finally, it should be noted that it was not BRI's design practice to utilize sway struts as primary compressive elements with large imposed thermal movements, and as such hanger RFW-112 was essentially unique in the plant pipe support design.

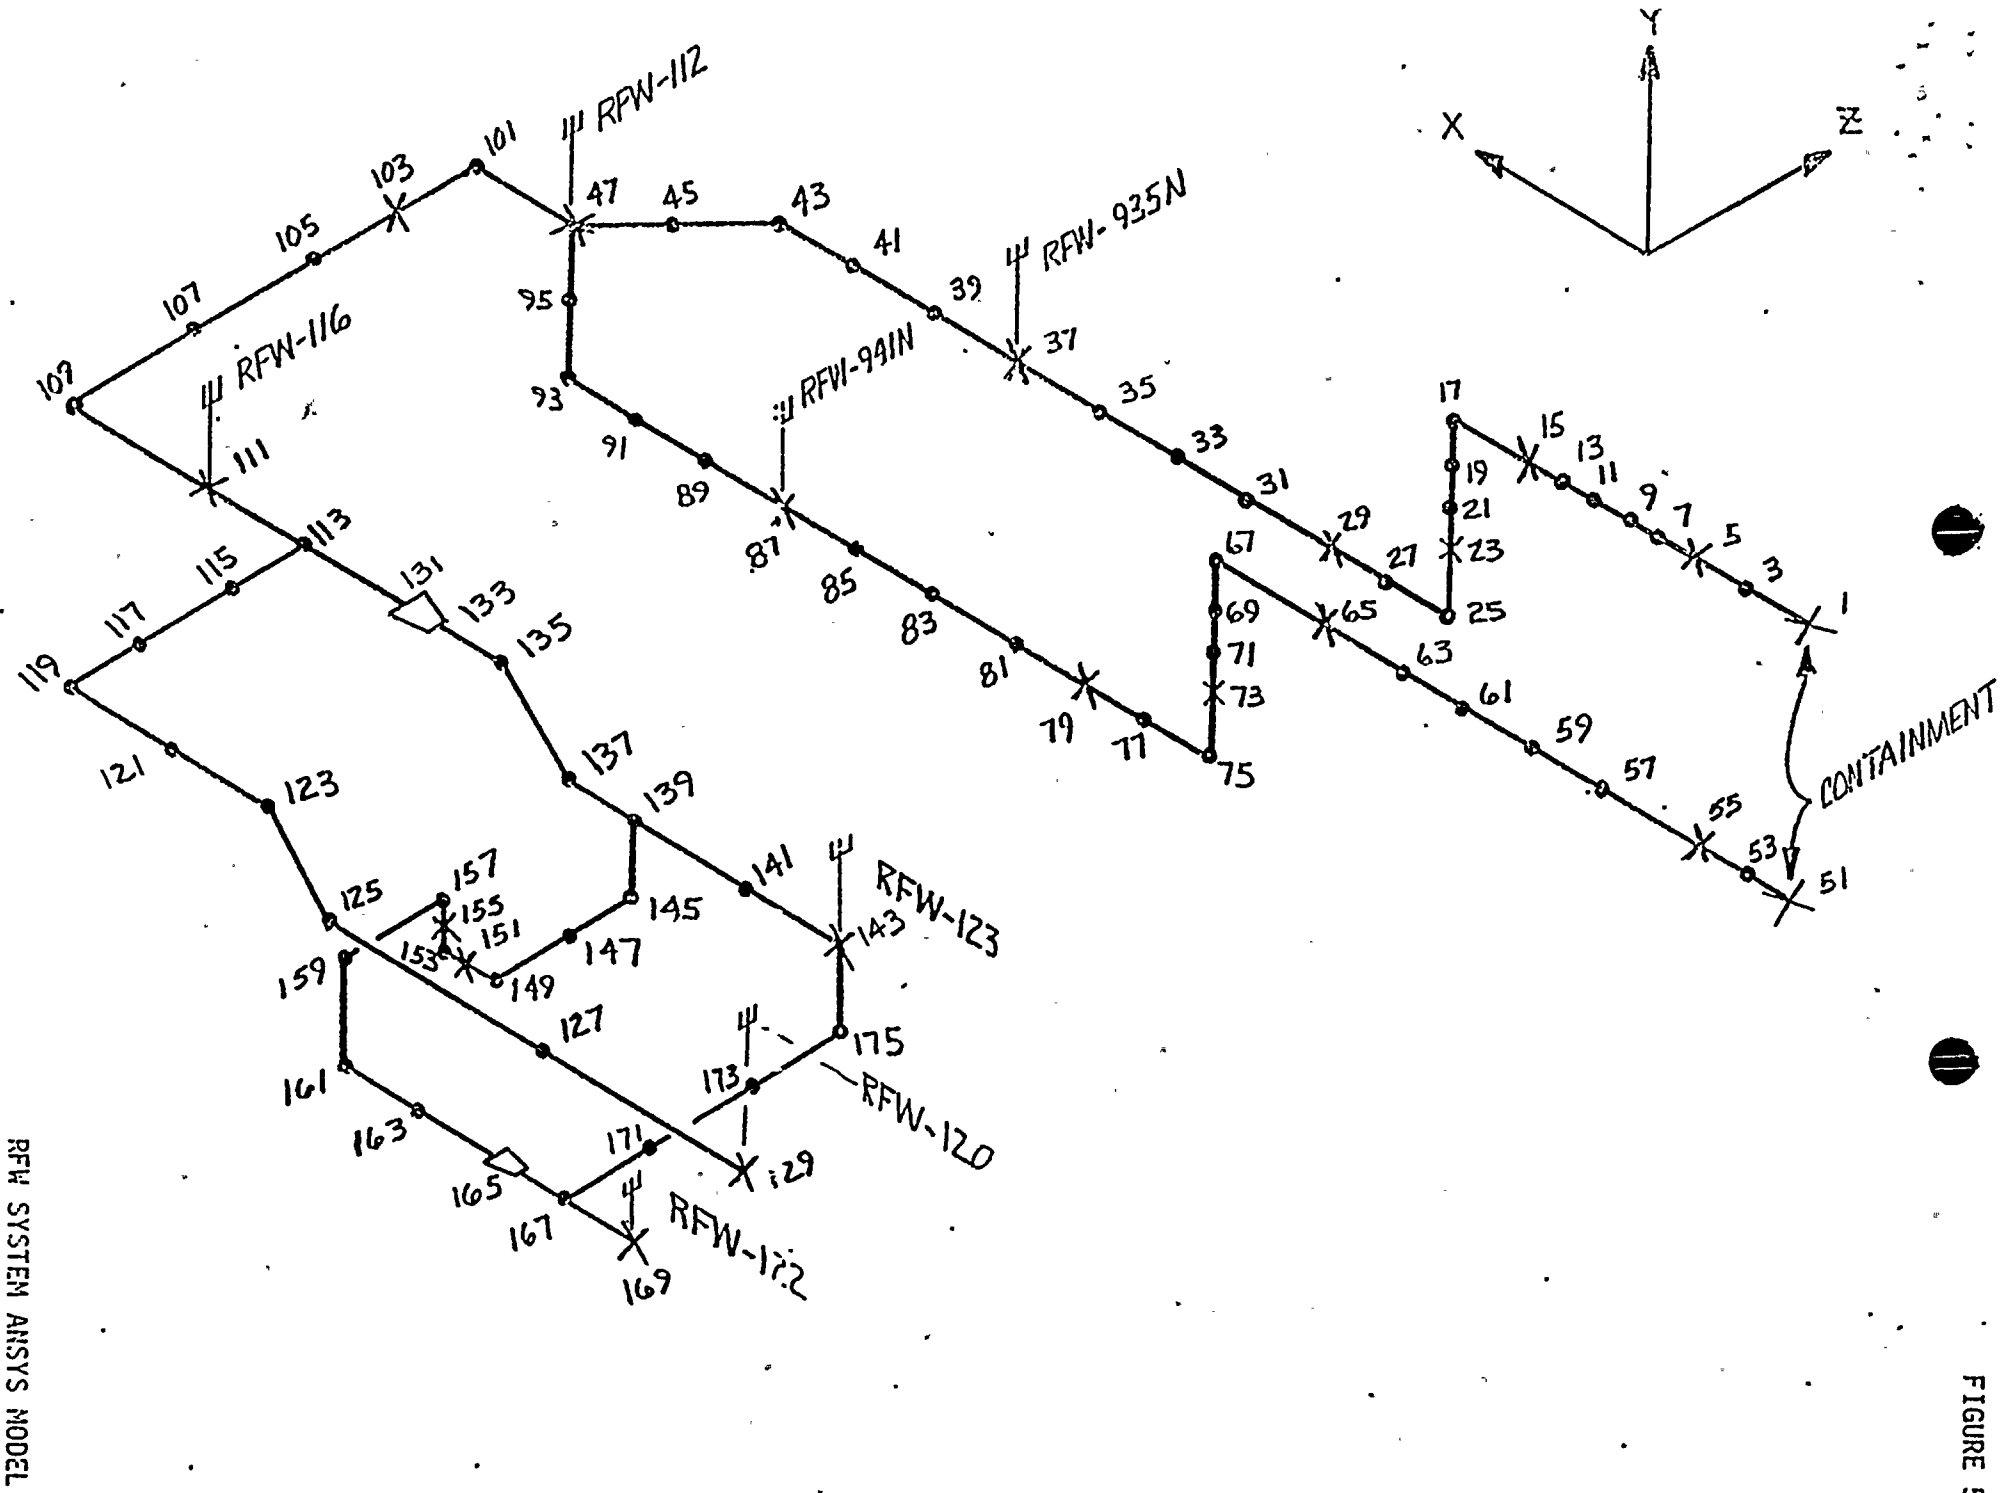
FIGURE 5

Since ADLPIPE cannot evaluate thermal bowing gradients an ANSYS finite element model was generated. The model utilizes ANSYS "Stiff-4" beam elements with equivalent piping section properties. The Stiff-4 element will accept cross sectional or top-to-bottom thermal variations. The piping system was nodalized into approximately five foot long sections and truncated at the rigid vertical supports upstream of RFW-116, see Figure 5. The ANSYS model was checked against the ADLPIPE model by repeating load Case A from Table 2. The reaction loads computed by ANSYS compared very favorably with the the ADLPIPE results. Therefore, the ANSYS model approximation was proved sufficiently accurate for the thermal bowing studies.

Table 3 summarizes the thermal bowing load cases. These results include no deadweight loads. However, the deadweight reactions can be obtained from the ADLPIPE analyses (e.g. 15 kips at RFW-112). A survey of the results revealed that load Case 5 yields thermal loads of sufficient magnitude to cause buckling of RFW-112. This load case imposed thermal gradients ($\Delta T = 300^{\circ}F$) over the region from the wye downstream to the elbows at the entrance to the steam tunnel (nodes 47 to 75 or 25, see Figure 5). Load Case 7 revealed that with RFW-112 removed (or failed) and the same worst case thermal loading imposed, sufficient load was then applied to cause failure of RFW-116 (i.e. 72 kips plus 17 kips dead load).

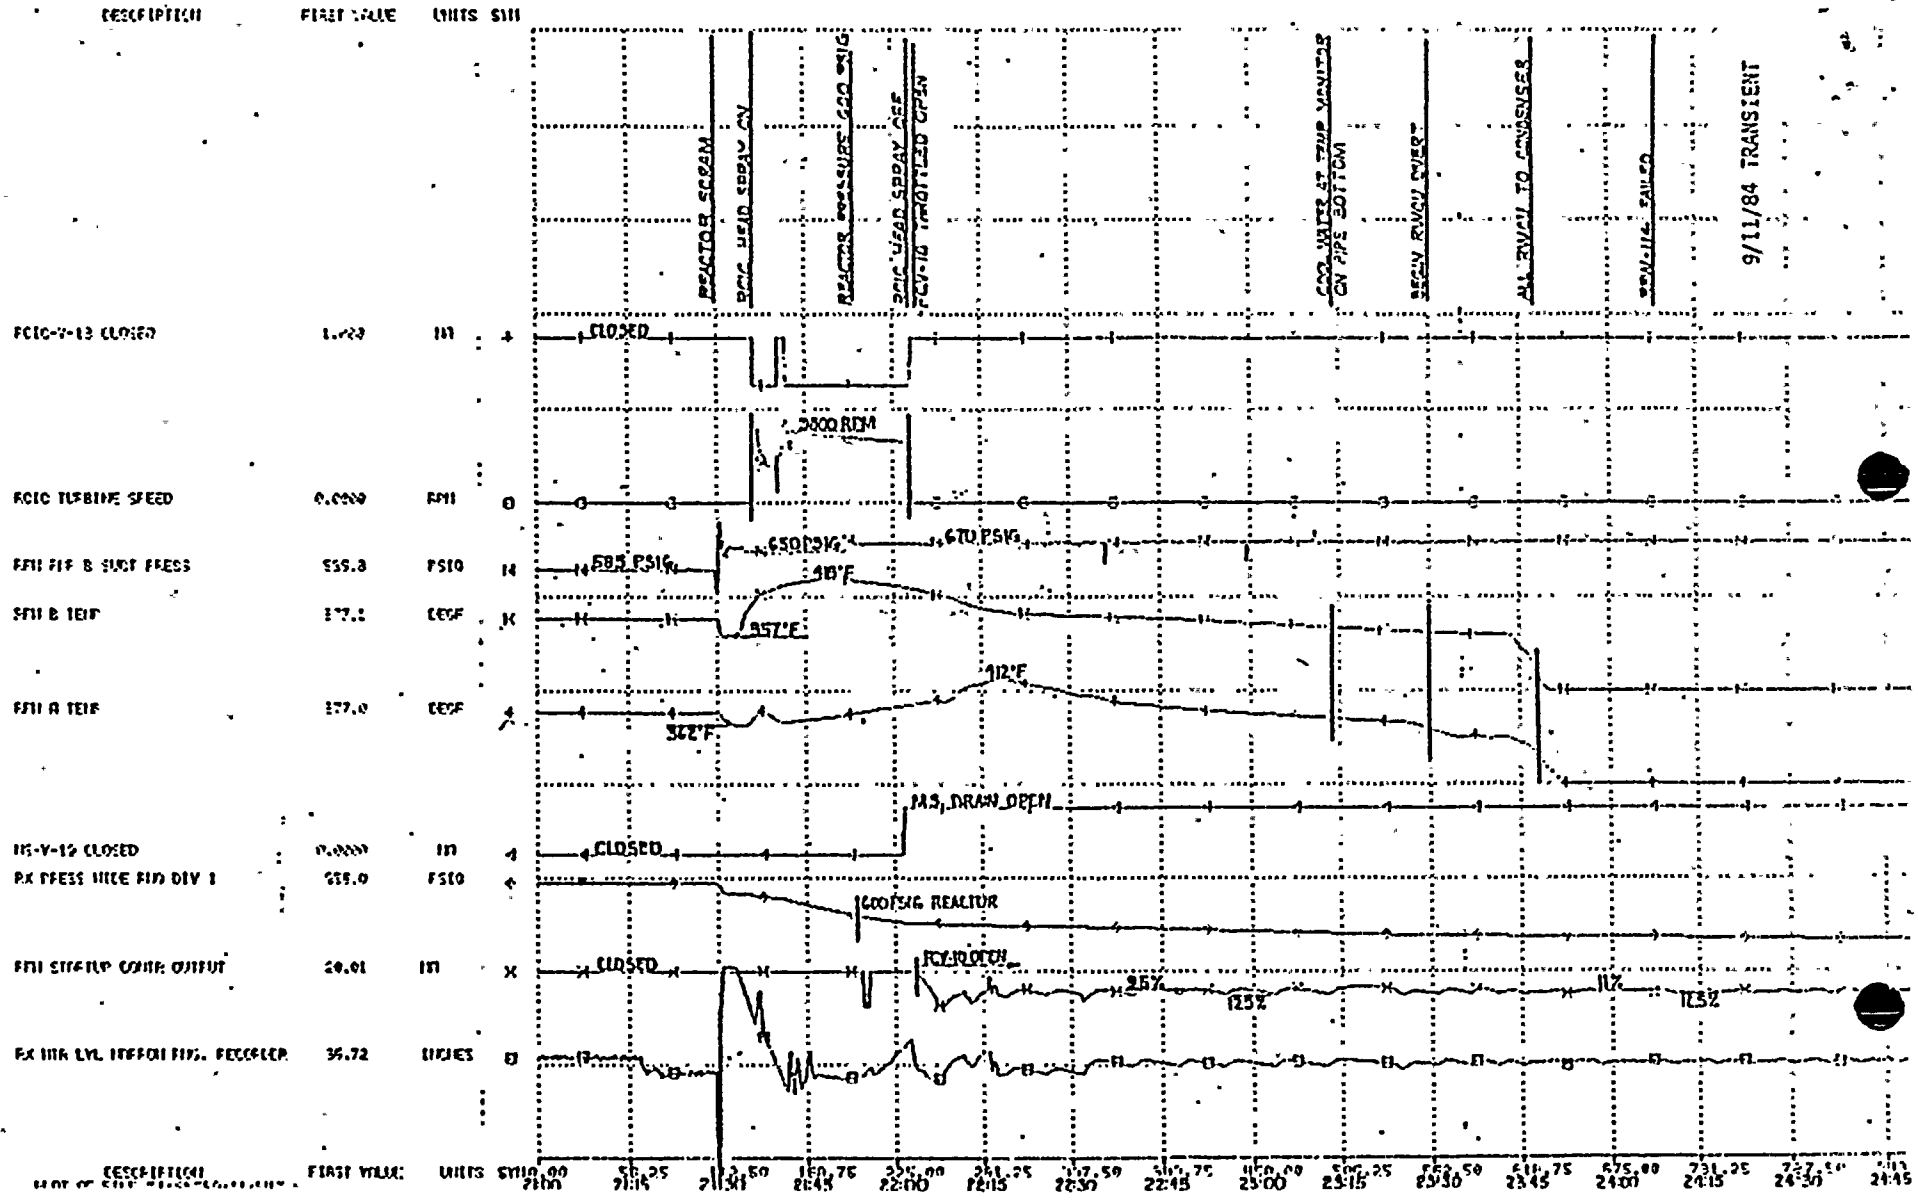
FIGURE 6

The following summarizes significant events leading up to and following the failure of feedwater piping support RFW-114. The plant had been running at approximately 75% power and the reactor was shutdown during testing. See Figure 6 for graphic representation of pertinent data.

<u>Date</u>	<u>Time</u>	<u>Event</u>
9/10/84	21:28	Reactor Feedwater 377.1°F Reactor Vessel Level 34 inches Reactor Pressure 958.0 psig
	21:29	Reactor Scram (Shutdown)
	21:31	Both reactor feedwater pumps tripped (one manually, one on high reactor water level).
	21:33	Feedwater temperature at RFW-TE-41A and 41B at approximately 360°F.
	21:35	RCIC Head Spray on
	21:50	Feedwater at RFW-TE-41B peaked at 418°F.
	21:53	Vessel pressure at 600 psig.
	22:02	Main Steam drains open.
	22:03	RCIC head spray off.
	22:04	RFW-FCV-10 open and controlling vessel level.
	22:20	Feedwater at RFW-TE-41A peaked at 412°F.
	23:13	Cool feedwater reached RFW piping bottom test thermocouples.
	23:30	RWCU diversion to condenser began.
	23:43	Sharp decrease in RFW temperature at RFW-TE-41A and 41B.
	23:48	RWCU diversion to condenser complete.
	24:08	RFW-114 failed.

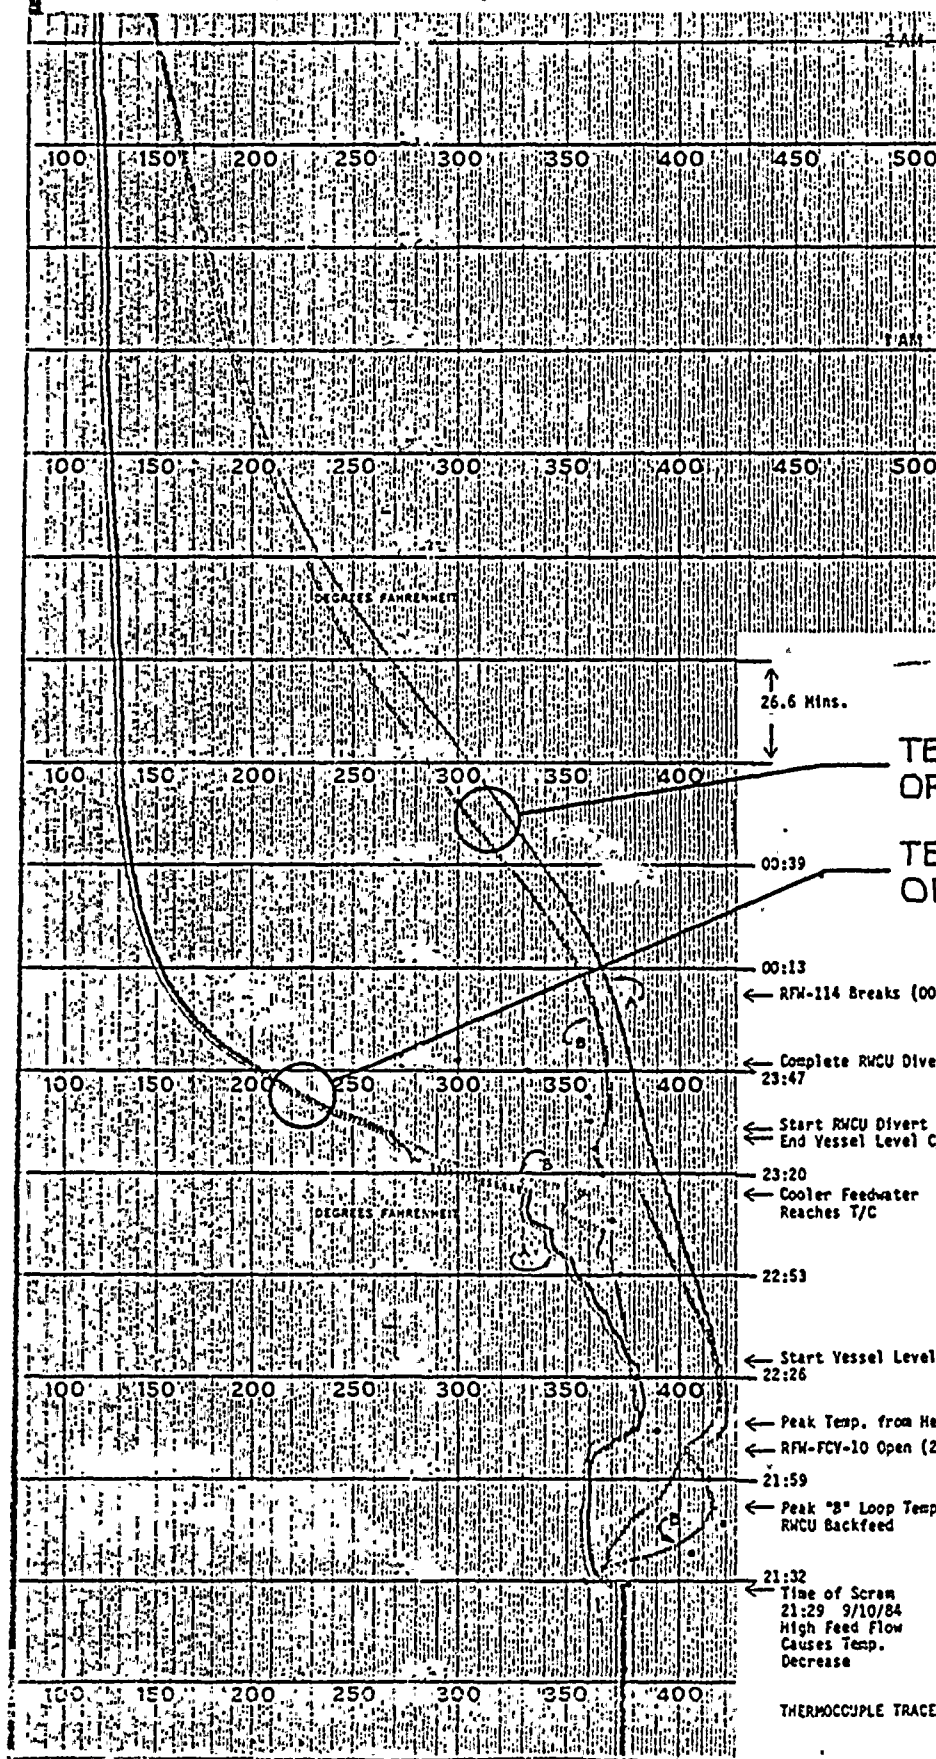
Although it was not predicted to occur on normal shutdown of the reactor, the mechanism for all the previous hanger failures became clearly understood as cold shutdown conditions were achieved. All the pipe monitoring instrumentation was working perfectly. Large top-to-bottom temperature differentials occurred in the flow straightening sections as the reactor was being cooled down. This resulted in large vertical displacements in the area of the previously failed hangers. The peak vertical displacement at hanger RFW-114 was 2.4 inches. The extension limit of the spring-can on RFW-116 was 1.6 inches and the attachment welds broke during the event. Refer to Figure 7 for piping displacements and Figure 8 for top-to-bottom temperature differentials.

← RFM-114 Breaks (00:08)

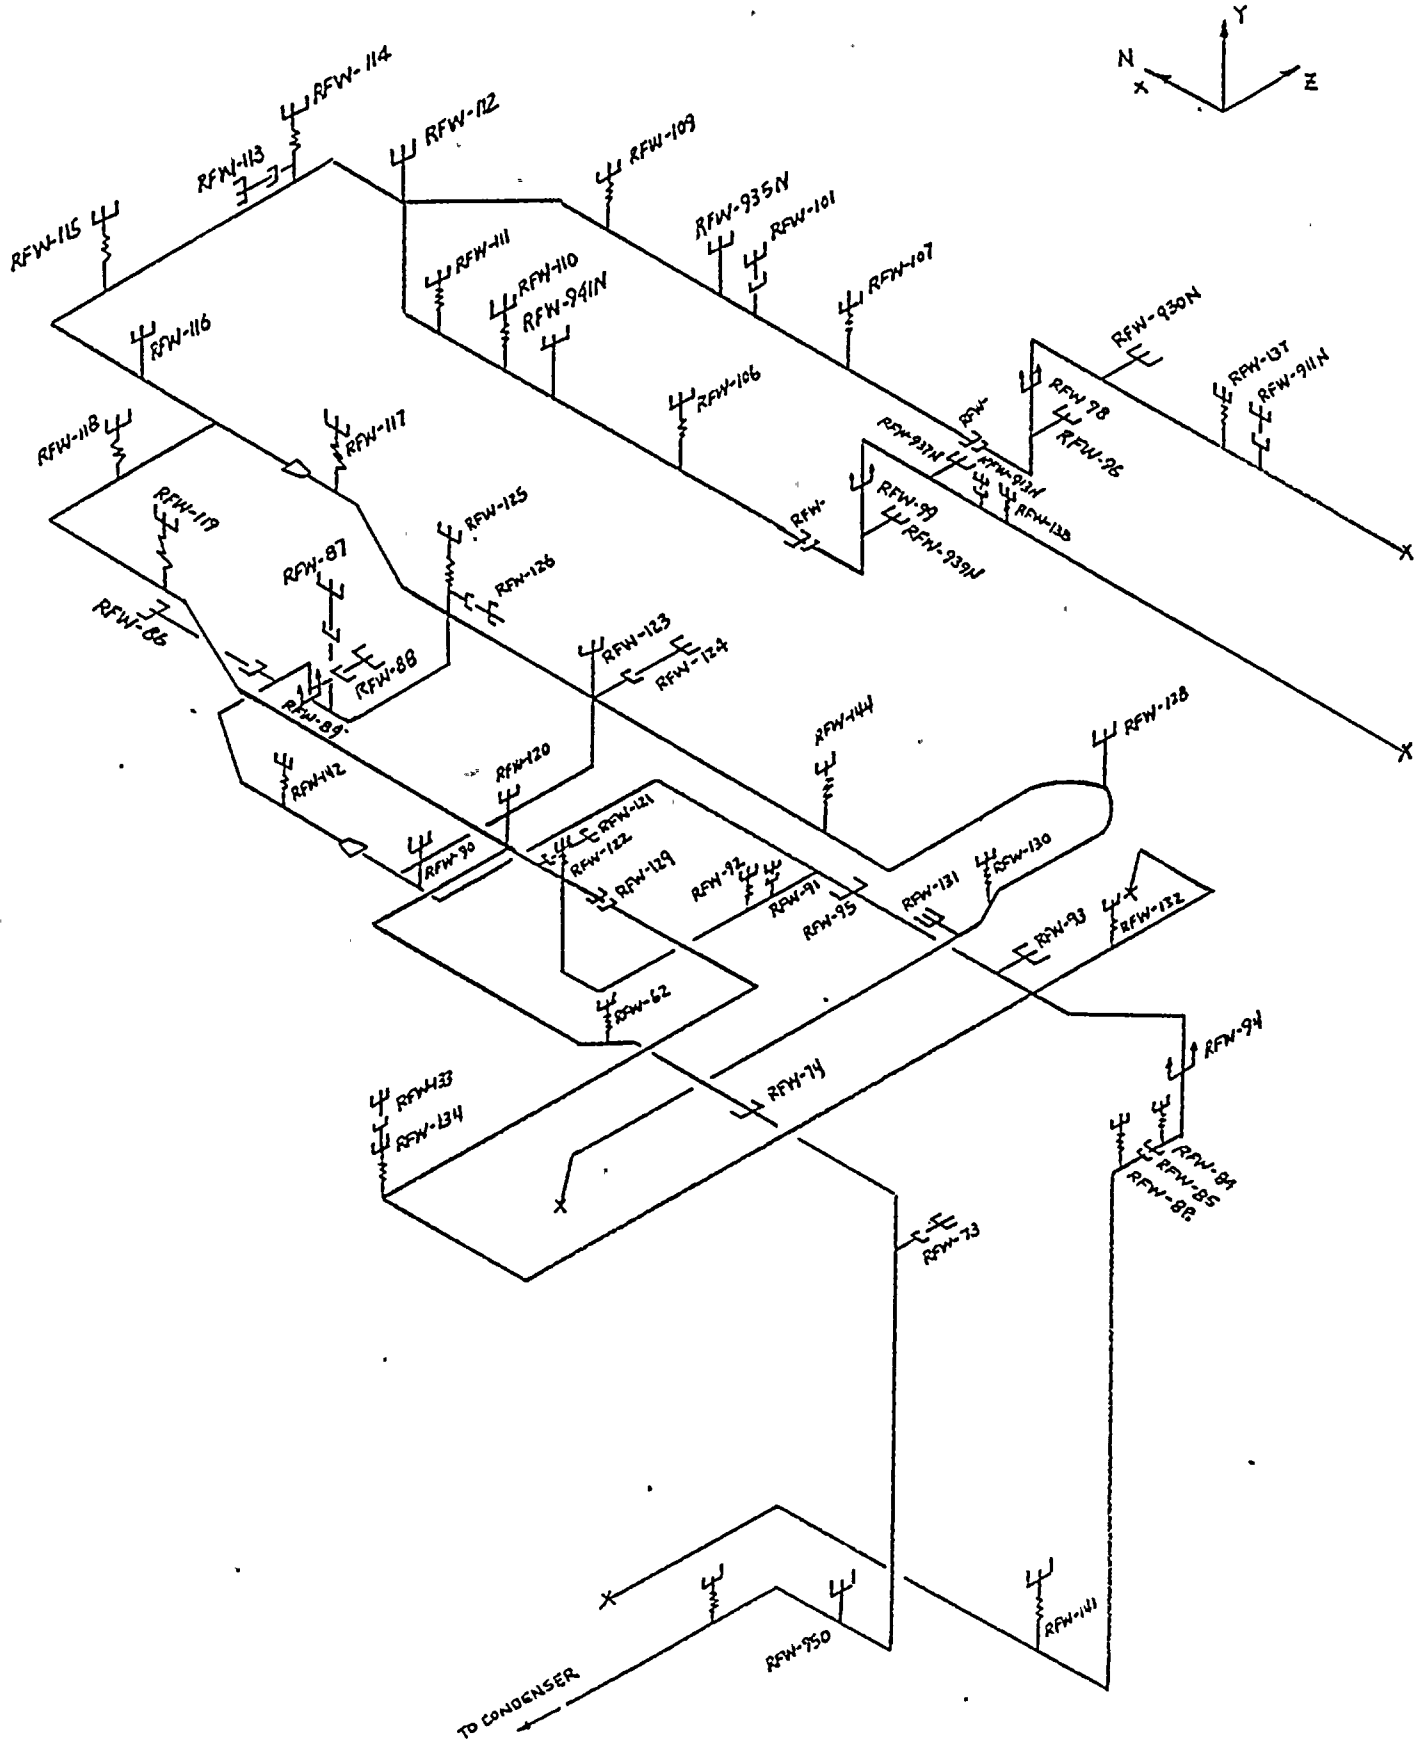
FIGURE 9

RFW SYSTEM ANSYS MODEL

The system modifications were implemented in the field and the system realigned and balanced. As noted in the August 22 Event, fatigue analyses of the ASME Class 1 portion of the system (isolation valves to containment) remains as a final task in closing out the design record file. This effort will be completed over the next few months as operating procedures, system line-up, and thermal analysis refinements are completed.
