SUBJECT: LER 88-012-00: on 880606, potential existence of unmonitored radiological effluent release path during certain emergency conditions determined. Cause unknown. Fan disabled. W/880606 ltr.

LICENSEE EVENT REPORT (LER)

FACILITY NAME (1) Washington Nuclear Plant - Unit 2 DOCKET NUMBER (2) 050008197 PAGE (3) 1 OF 15

TITLE (4) Potential Unmonitored Effluent Release Path Due To Design Error By Architect/Engineer Cause Unknown

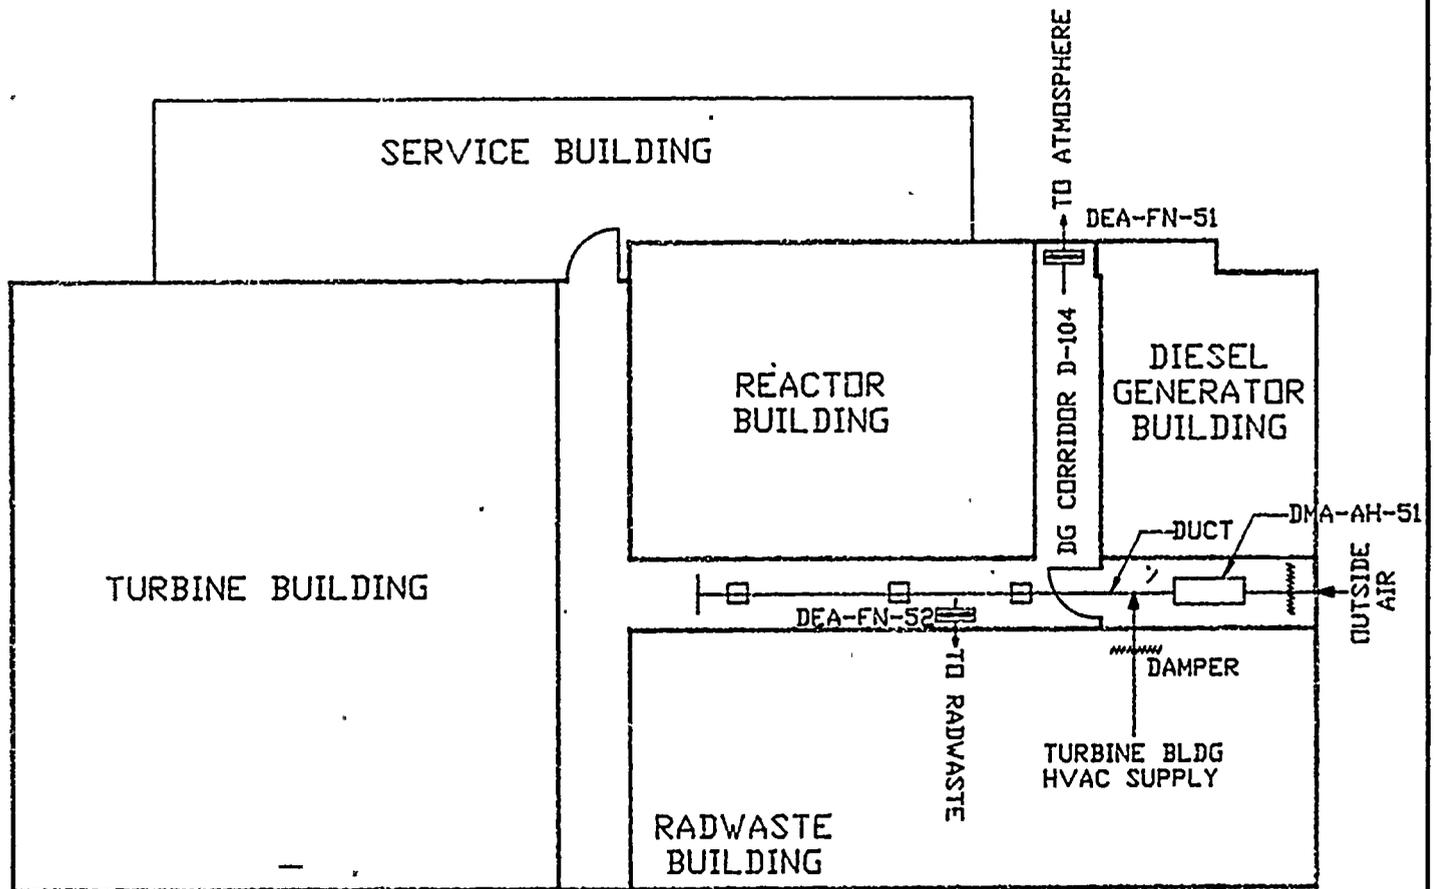
FIGURE 1

During normal Plant operations DEA-FN-51 draws clean air down the diesel generator corridor (D104) which is supplied by the Turbine Building HVAC System. During some emergency conditions DEA-FN-51 and DEA-FN-52 are supplied outside air by the supply air handling unit (DMA-AH-51) when the outside air temperature is greater than 40°F or recirculated room air when the temperature is less than 40°F. However, if during these emergency conditions DMA-AH-51 is not operable, air from the Turbine Building could be drawn in by DEA-FN-51 and exhausted to the atmosphere. A main steamline break in the Turbine Building would result in a source whose maximum concentration is  $3.312 \times 10^{-4}$  uCi/cc. (The source concentration was calculated by dividing the total main steamline break source by 10% of the volume of the Turbine Building.) The above concentration level is within the range specified in Regulatory Guide 1.97 Table 2 (between  $10^{-6}$  uCi/cc and  $10^2$  uCi/cc) and, therefore, this release path should have been monitored.

The cause of this event is a design error. This fan was part of the original Plant design done by Burns & Roe Inc., the Architect/Engineer for WNP-2, and should have been evaluated in accordance with Regulatory Guide 1.97. The root cause of this event can not be determined.

An Engineering Assessment determined that DEA-FN-51 was not required for cable cooling during normal or emergency conditions. The fan was disabled by removing its power fuses and by closing the back draft damper.

A Plant Modification Request is being processed to remove DEA-FN-51 and its associated accessories and to seal the opening created by the removal of the fan.
