SUBJECT: LER 88-014-00: on 880512, voluntary rept of RWCU sys resin tank spill due to RWCU valves being open. W/8 ltr.

FACILITY NAME (1) Washington Nuclear Plant - Unit 2	DOCKET NUMBER (2) 0 5 0 0 0 3 1 9 1 7	PAGE (3) 1 OF 0 8
---	---	-----------------------------

TITLE (4) **Voluntary Report of Reactor Water Cleanup (RWCU) System Resin Tank Spill Due To RWCU Valves Being Open - Cause Unknown**

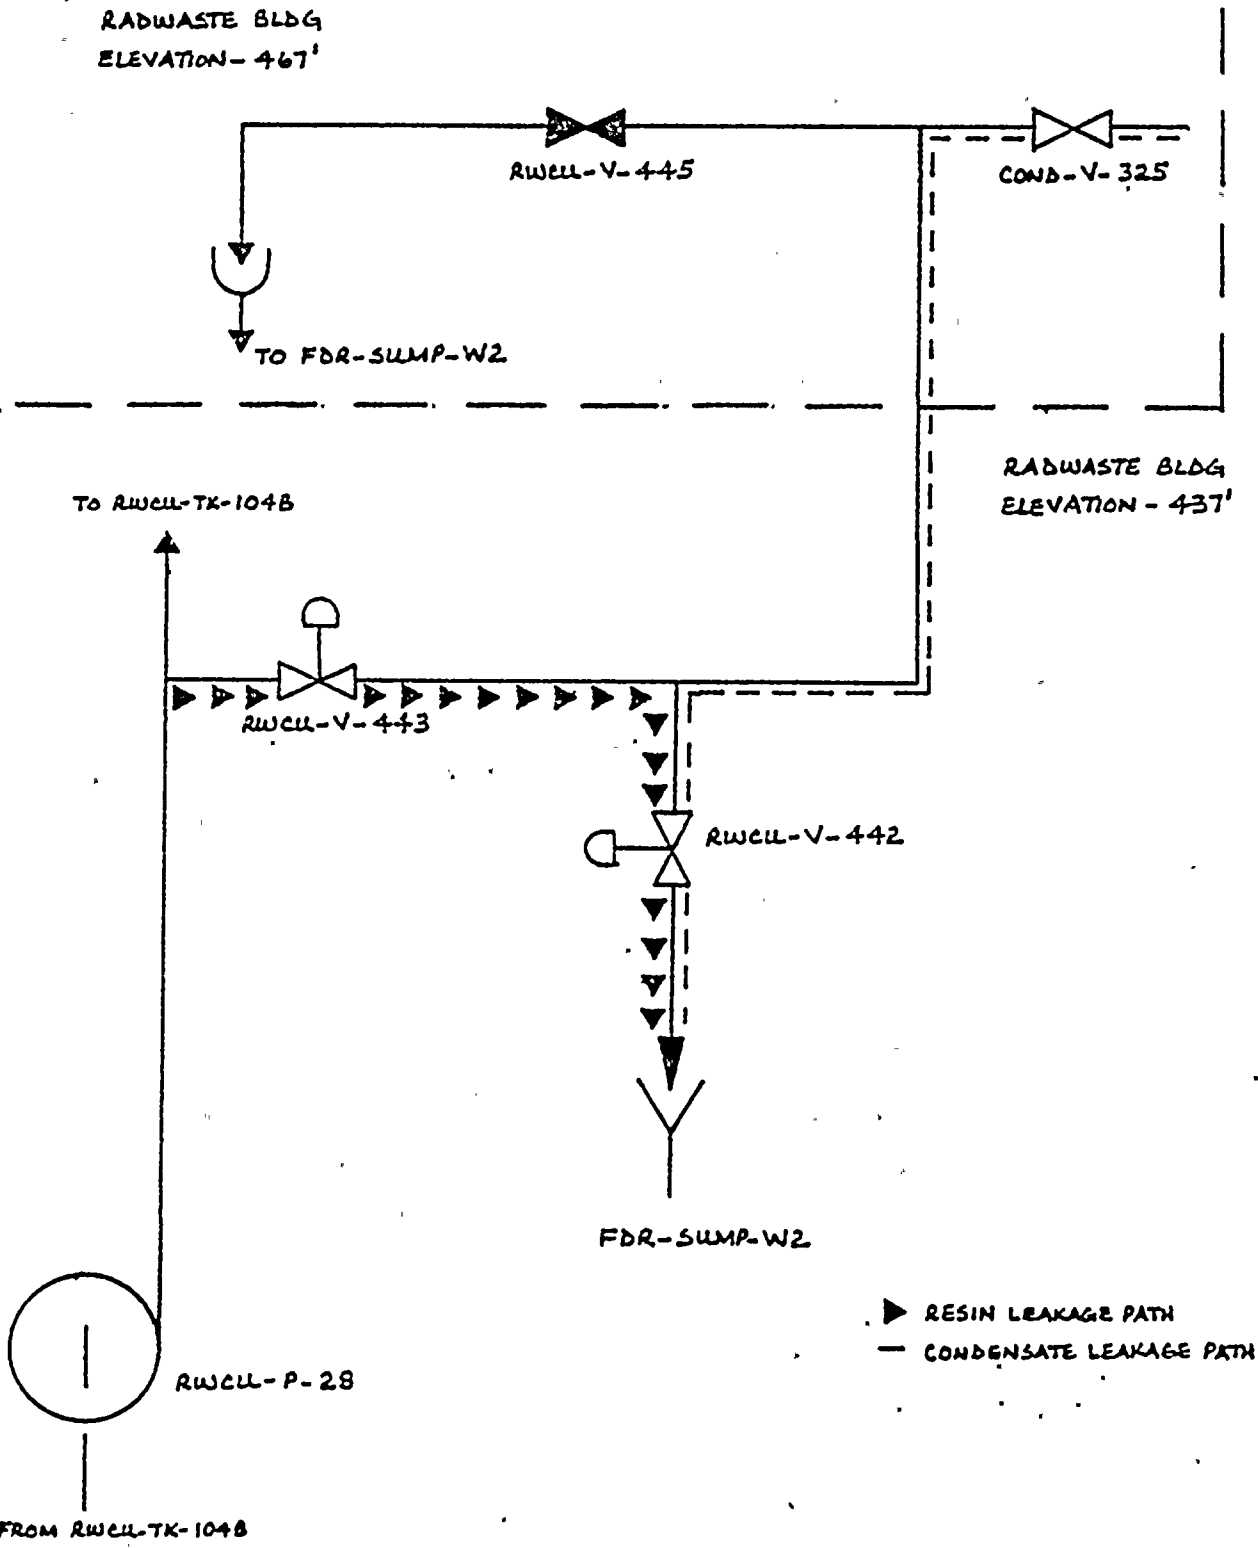
FIGURE 1

1. The immediate cause of this event was valves RWCU-V-442 and RWCU-V-443 being open. The root cause for the valves being open is indeterminate. As shown in Figure 1, this configuration created the following unknown leakage paths:

- o RWCU-V-442 and RWCU-V-443 Open (Resin Leakage Path)

With both valves open, and the start of RWCU-P-28, RWCU resin slurry was pumped through the valves to the drain system. As a result of RWCU-TK-104B level changes, it is estimated that 1,000 gallons was inadvertently drained from the tank. This equates to a resin loss of approximately 25-30 cubic feet. The bulk of the resin was contained in the liquid radwaste processing system.

o RWCU-V-442 Open (Condensate Leakage Path)

Condensate water was supplied through COND-V-325, down a 1/2" pipe and through RWCU-V-442 to the drain. It is estimated that the leakage through this flow path was 3.4 gpm.

1. RWCU-V-442 and 443 were tagged shut and de-energized.
2. PPM 2.11.1 was deviated to include RWCU-V-442 on the valve checklist. The required condition for both RWCU-442 and 443 on the valve checklist is "closed."
3. The RWO involved in this event was counseled on the importance of monitoring the status of operational tasks, including procedural compliance and believing Plant instrumentation unless proven otherwise.
