SUBJECT: LER 88-031-00: on 880902, found that due to single failure control room HVAC sys could operate in recirculation mode.
 W/8 ltr.

LICENSEE EVENT REPORT (LER)

FACILITY NAME (1) Washington Nuclear Plant - Unit 2	DOCKET NUMBER (2) 0 5 0 0 0 3 9 7	PAGE (3) 1 OF 0 7
--	--------------------------------------	----------------------

TITLE (4) Single Failure Could Cause Control Room HVAC to Operate in an Unanalyzed Operation Mode Due to Design

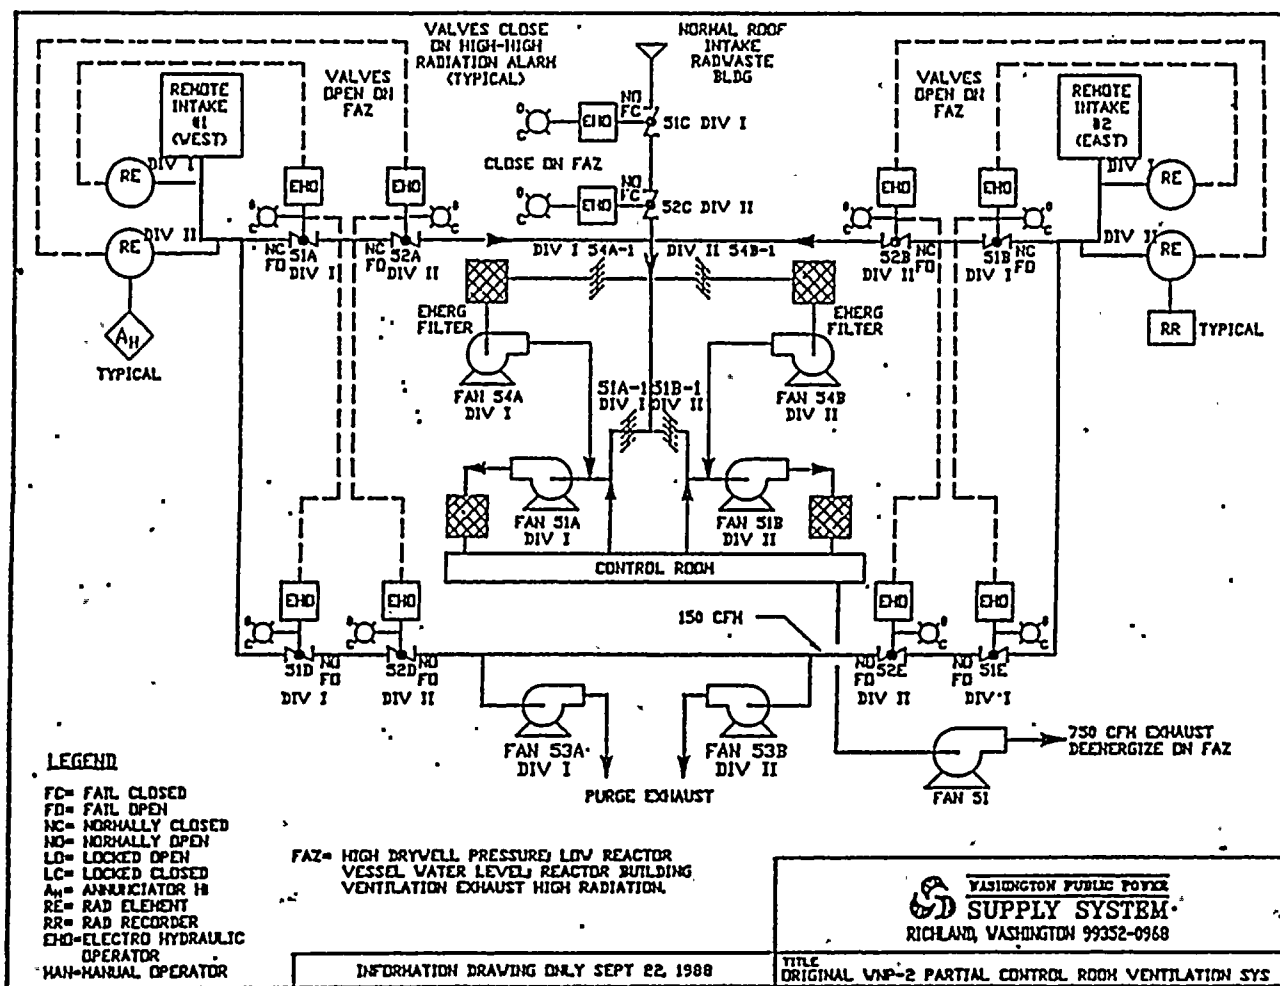
Figure 1 Pre-Event Control Room HVAC

The following brief description of the Control Room HVAC System (before modification) for normal operation and emergency operation during a Loss of Coolant Accident (LOCA) is presented to aid in understanding the event and the changes made to the system. Figure 1 is a partial diagram of the Control Room HVAC System prior to the event. The Control Room HVAC System consists of two redundant systems for both normal and emergency operation. During normal operation, 1000cfm of fresh air from the normal roof intake Radwaste Building is mixed with 20,000cfm of recirculated air (through fan 51A or 51B). Seven hundred and fifty (750) cfm is exhausted from the control room through fan 51 and the remaining 250cfm pressurizes the control room and is exfiltrated. Also during normal operation, the remote air intake isolation valves (51A and B and 52A and B) are closed and the radiation monitor purge line valves (51D and E and 52D and E) are open with radiation monitor purge line fans 53A and B operating. During a LOCA when any of the following trip levels are reached 1) High drywell pressure ("F" signal), 2) Low low reactor water level ("A" signal) or 3) Reactor building ventilation exhaust high radiation ("Z" signal) the following actions occur:

- a) The normal roof intake Radwaste Building is isolated by closing valves 51C and 52C.

- b) The 750cfm control room exhaust fan (51) de-energizes.
- c) The remote air intake isolation valves (51A, 51B, 52A, and 52B) open and the radiation monitor purge line isolation valves (51D, 51E, 52D and 52E) close. The remote air intake isolation valves and the radiation monitor purge line isolation valves are interlocked so when an intake line is opened the associated purge line is isolated.
- d) The control room emergency filtration system is automatically started and draws 1000cfm of fresh air through the remote air intakes. This additional air, when added to the recirculated air, pressurizes the control room.

The event described in LER 88-005 was for leakage around the emergency filters in excess of the technical specification allowable limit. During the engineering evaluation committed to in LER 88-005 to determine the effect of the excess leakage on control room habitability, a design engineer determined that postulated single failures could cause some combination of remote air intake line isolation valves to fail to open or to re-isolate and; thus, isolate both remote air intake lines. If this condition existed during LOCA conditions, the Control Room HVAC would be running in a recirculation mode only since the normal roof intake is also isolated. In the recirculation mode the 20,000cfm would continue to be drawn from the control room and recirculated back to the control room; however, without the fresh air input the control room would not be pressurized. In a neutral pressure condition the inleakage to the control room would increase and this condition is not analyzed.

The cause of this event was the failure of the Plant Architect/Engineer (Burns & Roe Inc.) to provide a system design for which a single failure could not isolate both remote air intakes and cause the Control Room HVAC System to operate in the recirculation mode, or to analyze the recirculation mode of operation. The root cause of this event is a lack of communication between the Architect/Engineer design groups.
