U.S. NUCLEAR REGULATORY COMMISSION  
REGION IV

Docket No.: 50-397  
License No.: NPF-21  
Report No.: 50-397/98-13  
Licensee: Washington Public Power Supply System  
Facility: Washington Nuclear Project-2  
Location: Richland, Washington  
Dates: June 7 through July 18, 1998  
Inspector(s): S. A. Boynton, Senior Resident Inspector  
S. C. Burton, Resident Inspector, Arkansas Nuclear One  
D. F. Kirsch, Acting Director, Walnut Creek Field Office, Region IV  
C. Poslusny, Project Manager, Office of Nuclear Reactor Regulation  
J. J. Russell, Resident Inspector, San Onofre Nuclear Generating  
Station  
B. A. Smalldridge, Resident Inspector, Wolf Creek Station  
J. E. Spets, Resident Inspector

### Washington Nuclear Project-2 NRC Inspection Report 50-397/98-13

FIRE MAIN RUPTURE  
AND  
PUMP ROOM FLOODING  
RECOVERY

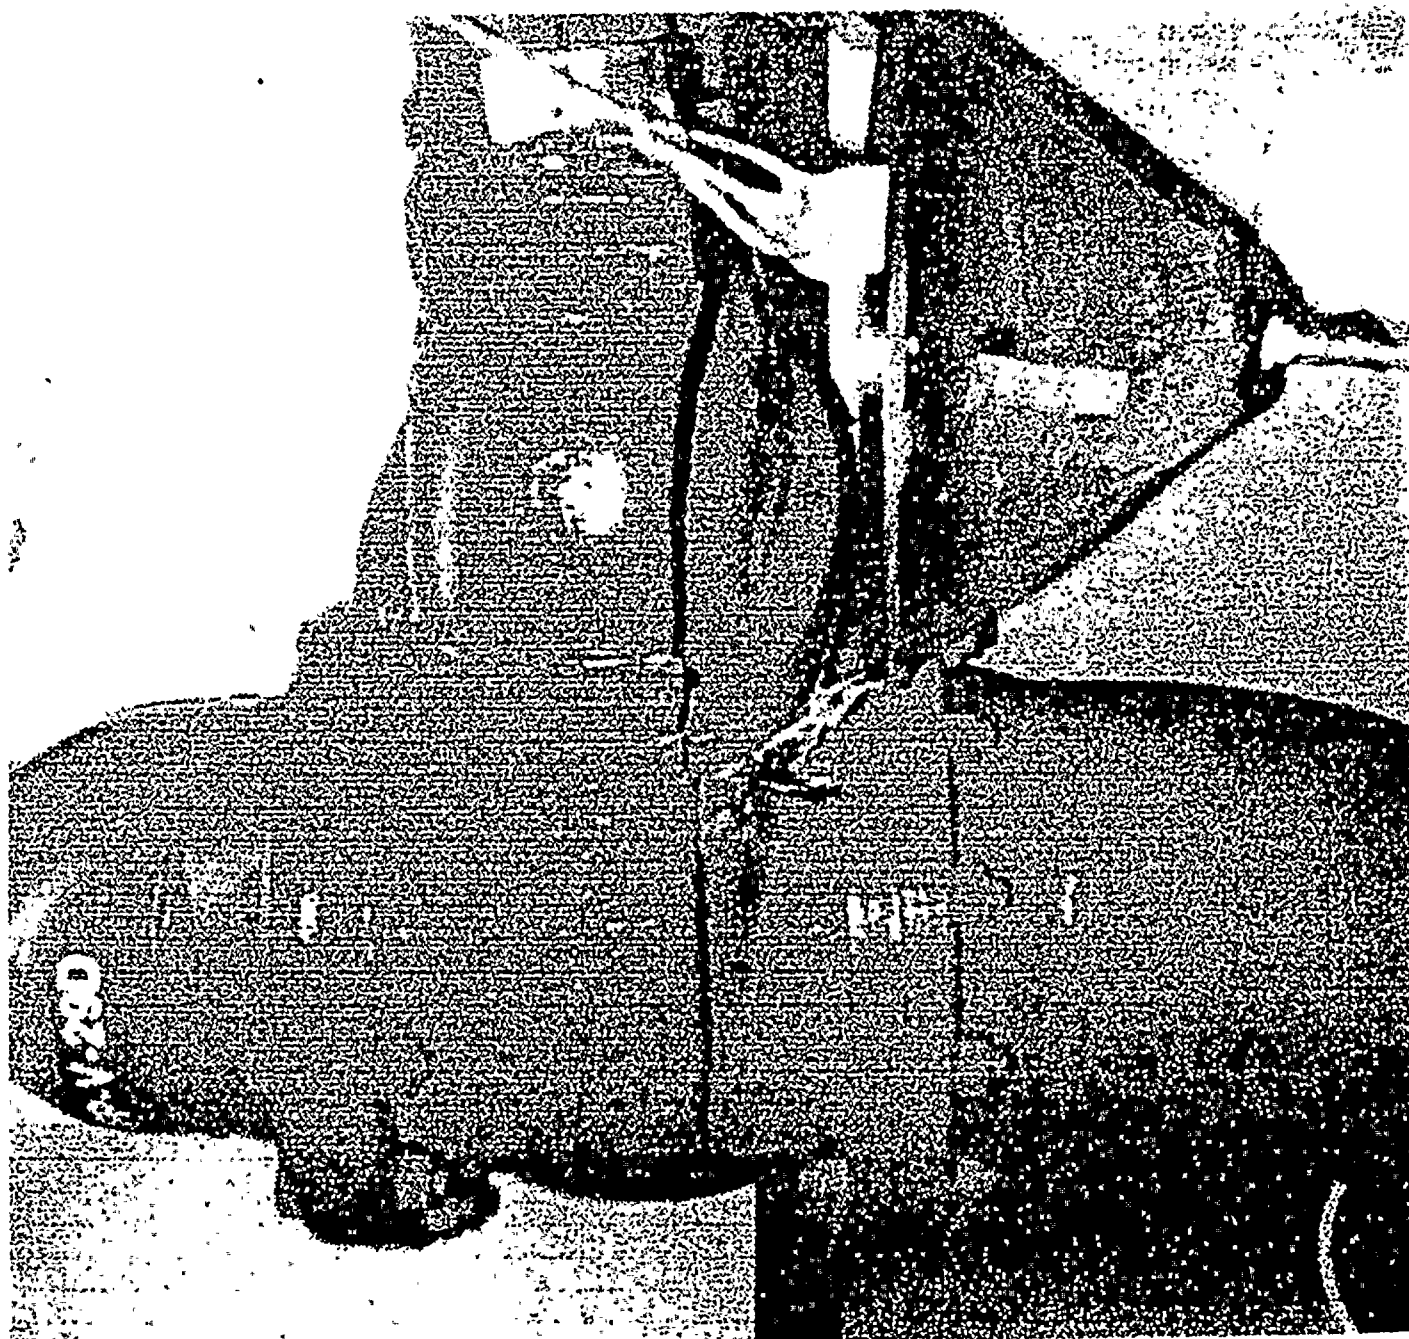
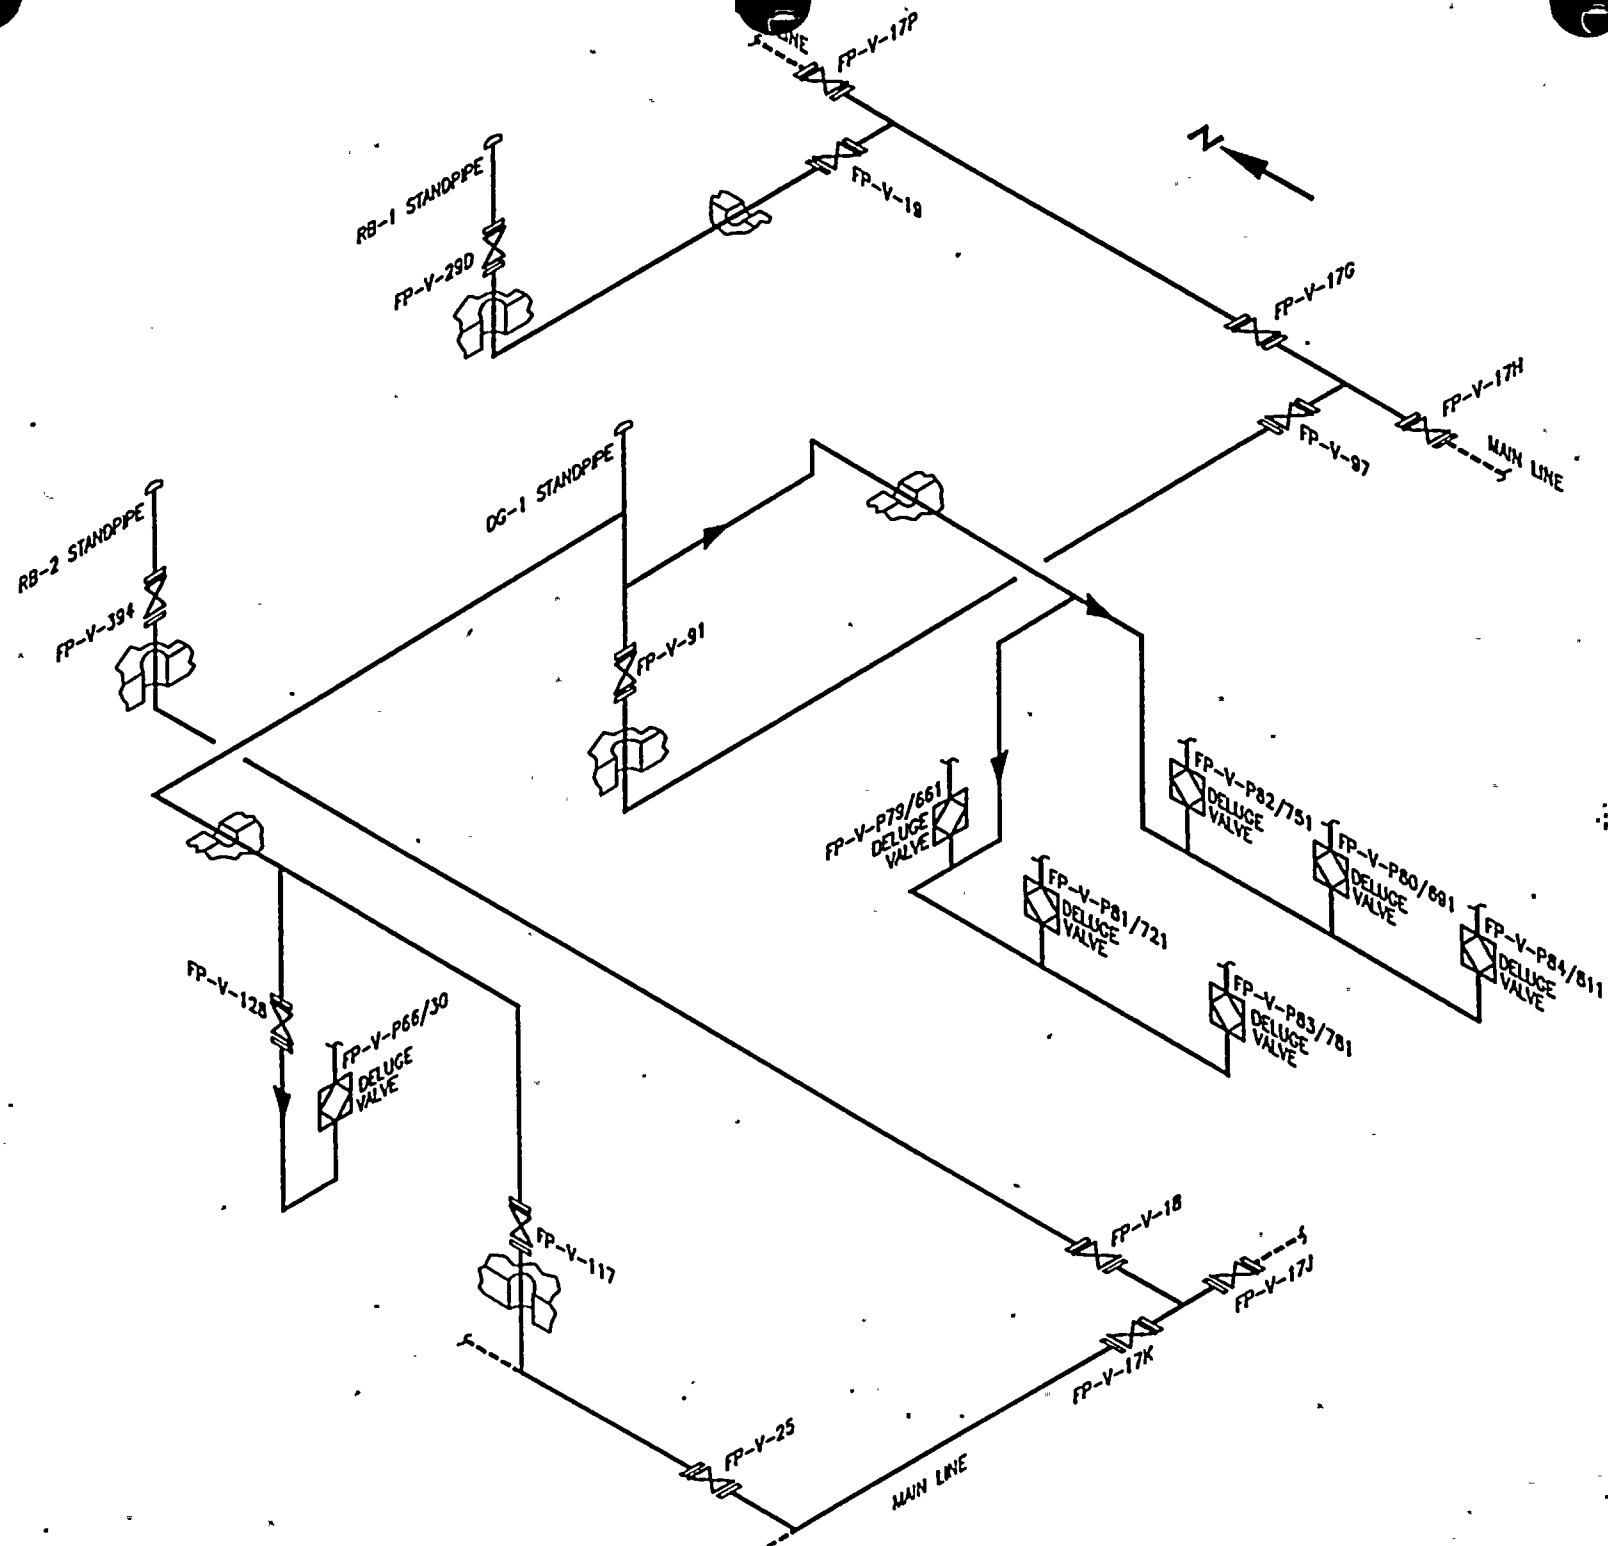
- As the fire main pressure is restored, a water hammer is created that ruptures a 12” isolation valve near the bottom of the reactor building Northeast stairwell (and fire zone 81 pre-action valve opens “sympathetically”).

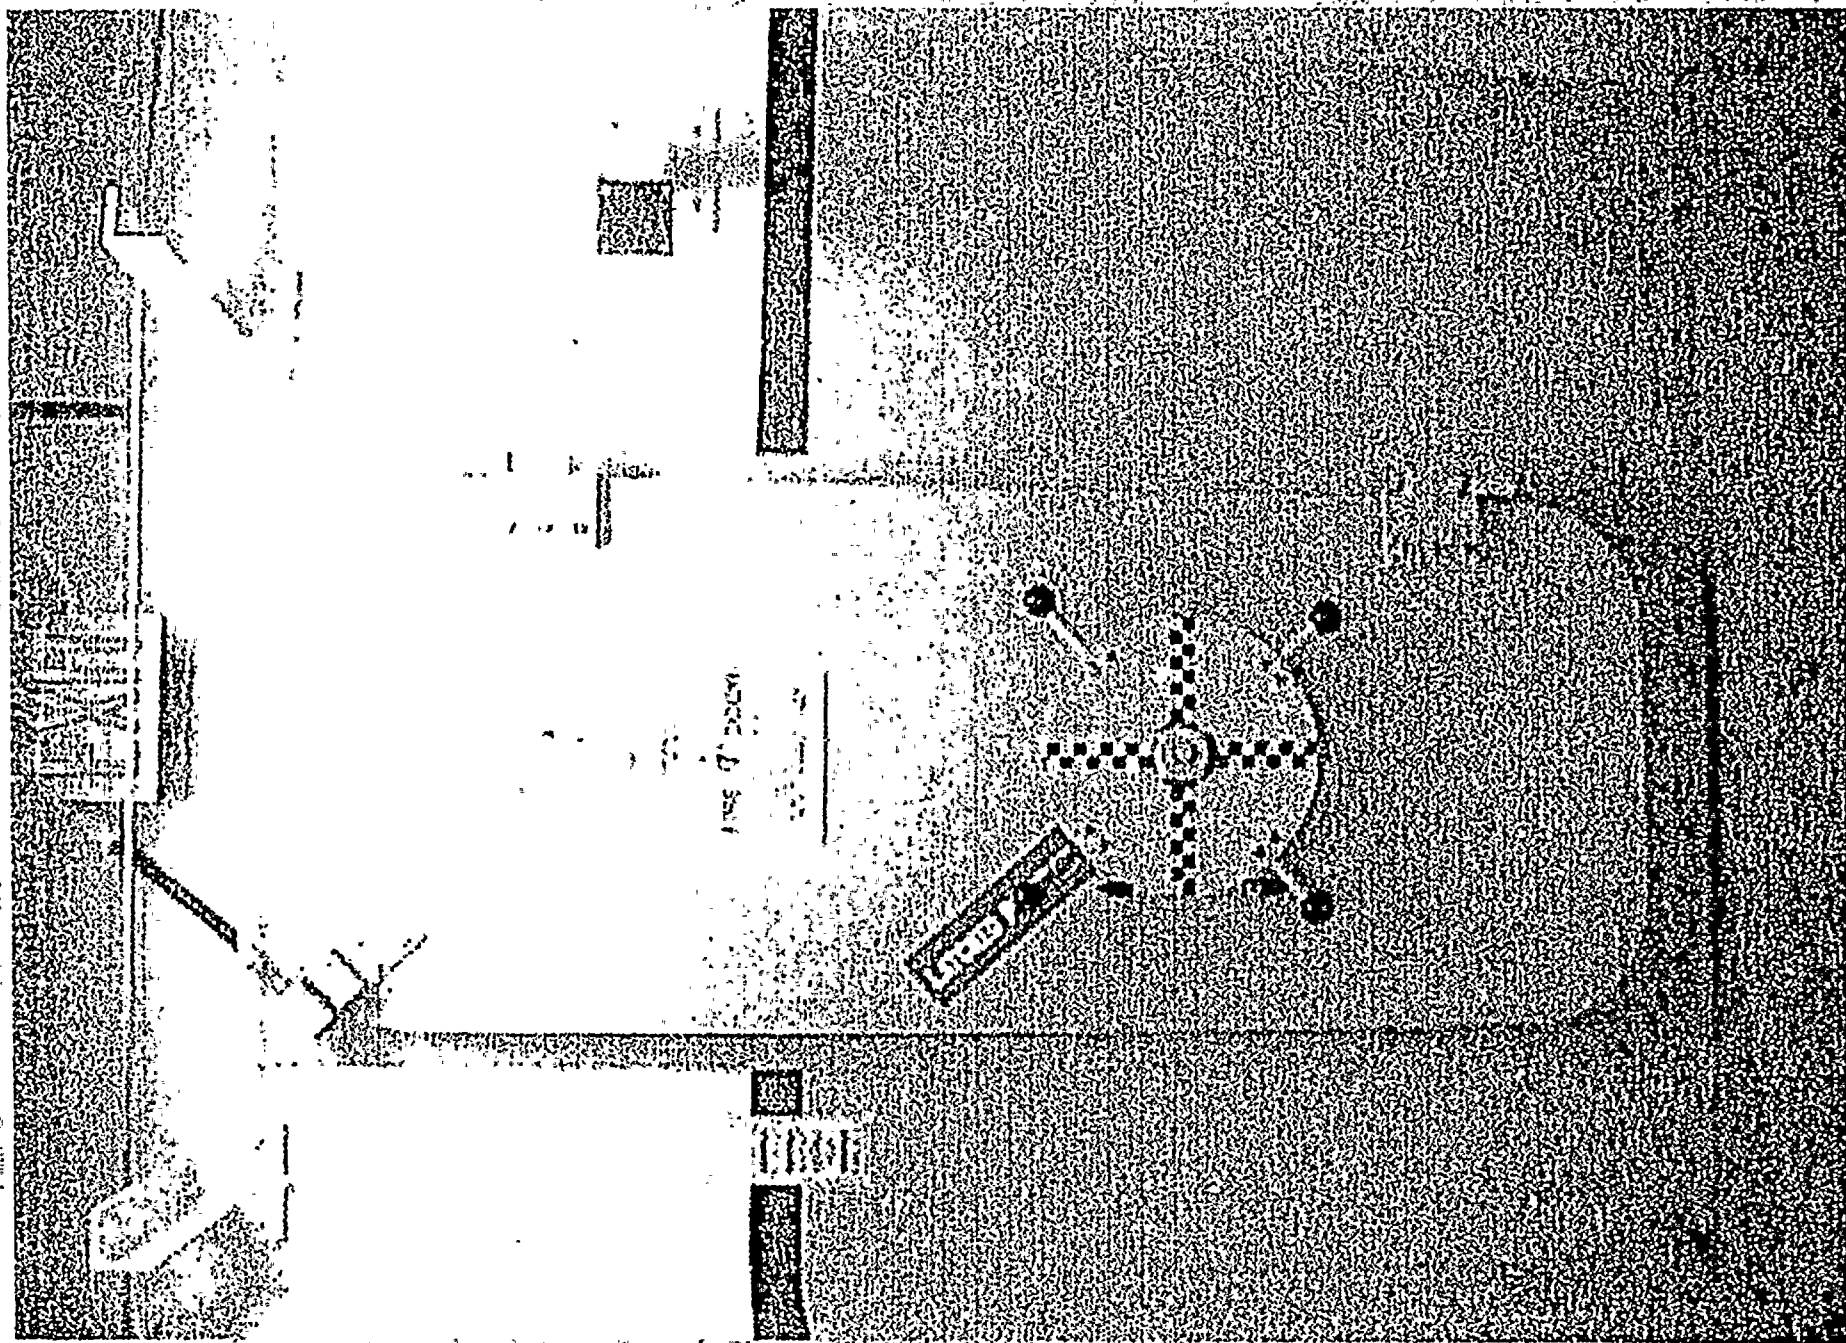
- Comparison of Flooding Event to Licensing & Design Basis
- Safety Basis for Sump Isolation Valves & Their Configuration
  - Close FDR-V-607, 608, & 609 Until Analyzed or Modified
