SUBJECT: LER 89-005-00: on 890311, multiple control rod drifts caused  
 by momentary low scram air header pressure due to trips..  
 W/8    ltr.

Subject: NUCLEAR PLANT NO. 2  
LICENSEE EVENT REPORT NO. 89-005

TITLE (4) Multiple Control Rod Drifts Caused by Momentary Low Scram Air Header Pressure Due to Multiple Rapid Half-Scram Trips and Resets

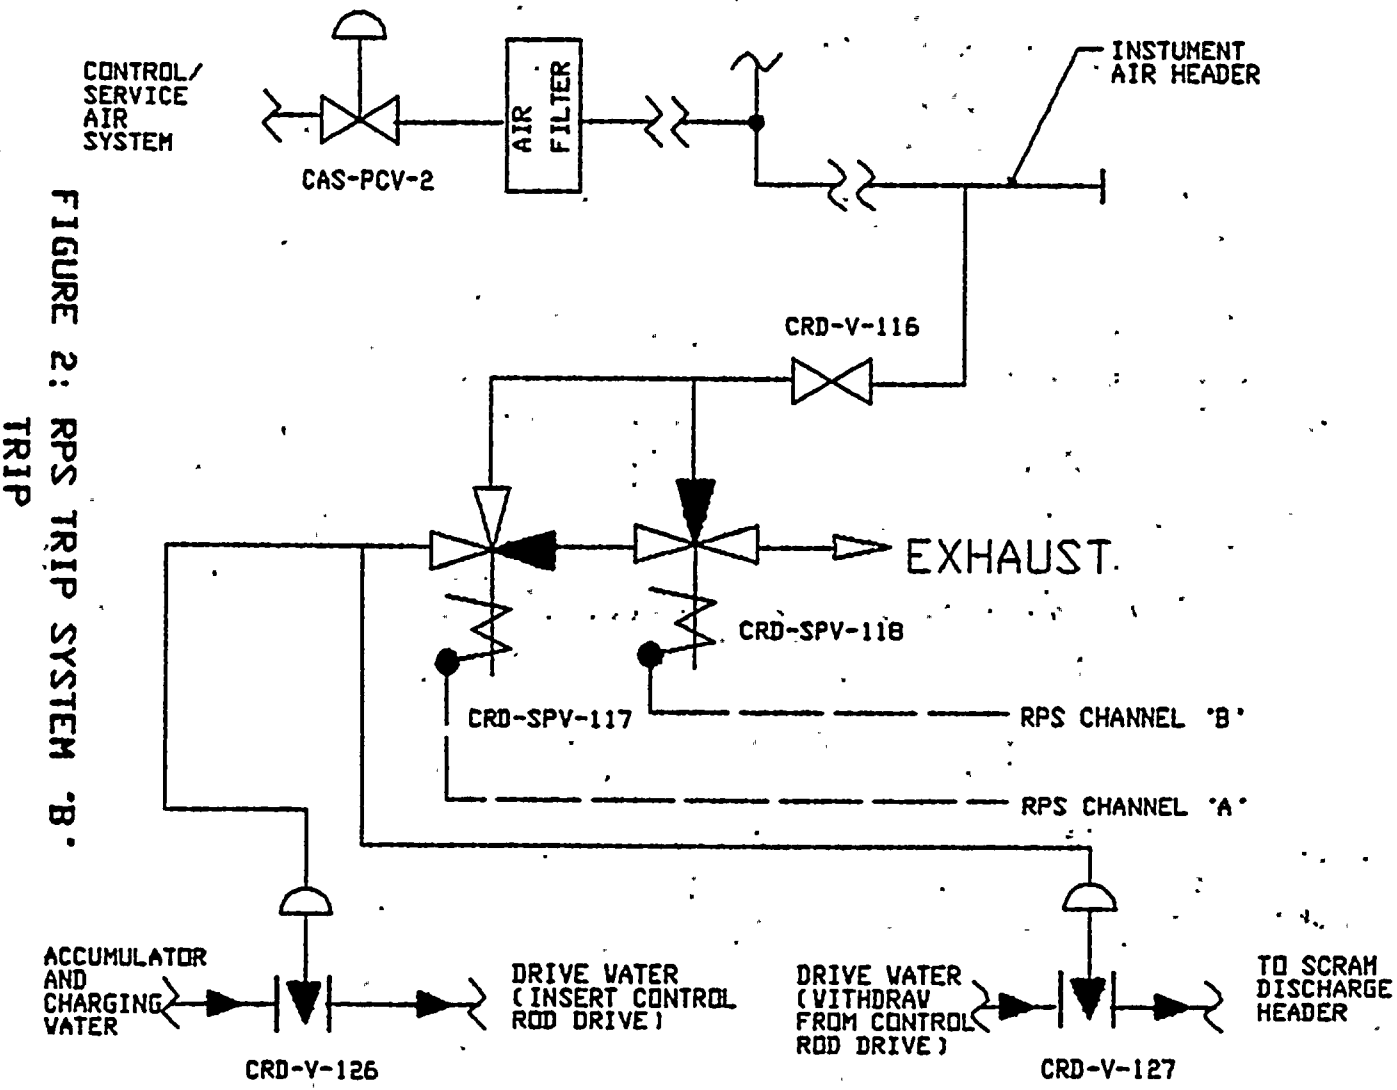
FIGURE 2: RPS TRIP SYSTEM 'B' TRIP

The RPS scram contactor (K14 relay) de-energizes when the radiation monitor trips. The RPS reset pushbutton re-energizes the scram contactor when no trip signal exists. While the reset pushbutton is depressed, the tripping and resetting of the radiation monitor also cycles the scram contactor. Cycling of the scram contactor cycles the CRD scram air pilot valve (CRD-SPV-118) on each HCU. See Figure 1 for piping schematic of the scram pilot valves and the scram valves for one HCU in the normal operation configuration and Figure 2 for the RPS Trip System "B" half-scam configuration. Energizing the CRD-SPV-118 to the vent position vents a small portion of the instrument air piping between the scram air pilot valves (CRD-SPV-117 and CRD-SPV-118) to atmosphere. While the solenoid valve is rapidly changing position, a scram air header vent path is also established for a short time.

The cause of the rod drift event was the rapid cycling of the RPS relays/solenoids during the period of time the RPS reset pushbuttons were depressed, thus allowing the scram air header (local effect only) to vent to atmosphere.
