SUBJECT: LER 91-017-00:on 910708,ground fault occurred in off-site
 500 kV sys.Caused by substation personnel error & substation
 equipment design deficiency.Plant operators returned unit to
 startup power source.W/910807 ltr.

Subject: NUCLEAR PLANT NO. 2
LICENSEE EVENT REPORT NO. 91-017

FACILITY NAME (1) Washington Nuclear Plant - Unit 2										DOCKET NUMBER (2) 0 5 0 0 0 3 9 1 7										PAGE (3) 1 OF 0 6																													
TITLE (4) AUTO START OF EMERGENCY DIESEL GENERATORS WHILE ON BACKFEED. UNDERVOLTAGE WAS INITIATED BY A 500KV GRID DISTURBANCE. ROOT CAUSES ARE PERSONNEL ERROR AND EQUIPMENT DESIGN																																																	
EVENT DATE (5)										LER NUMBER (6)										REPORT DATE (7)										OTHER FACILITIES INVOLVED (8)																			
MONTH			DAY			YEAR			YEAR			SEQUENTIAL NUMBER			REVISION NUMBER			MONTH			DAY			YEAR			FACILITY NAMES										DOCKET NUMBER(S)												
0 7			0 8			9 1			9 1			0 1			7 0			0 0			0 8			0 7			9 1													0 5 0 0 0 0 0 0 0 0									
OPERATING MODE (9)										THIS REPORT IS SUBMITTED PURSUANT TO THE REQUIREMENTS OF 10 CFR §: (Check one or more of the following) (11)

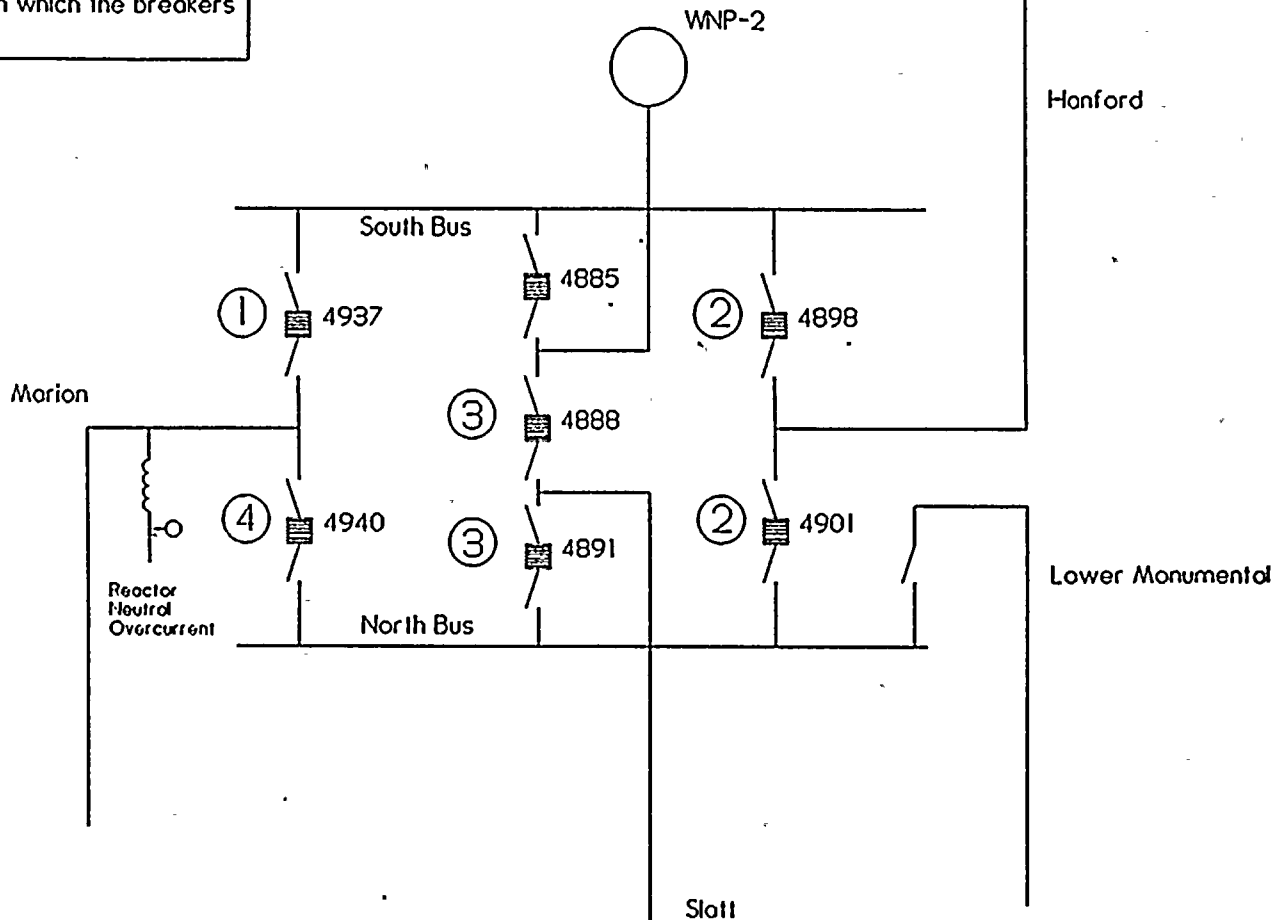
Ashe Substation

The disturbance was a ground fault on the Marion line feeding the substation. (See Figure 1 for schematic drawing of Ashe substation. The numbers in circles indicate the opening sequence for the substation breakers.) Misalignment of two protective relay selector switches at the substation precluded the BPA primary relays from immediately isolating the faulted line. The switches allowed breaker 4937 to open but not breaker 4940. Backup relaying (line relays) isolated the Hanford line (by opening breakers 4898 and 4901) and then the Slatt line (via breakers 4888 and 4891). Finally the fault was cleared when a neutral overcurrent relay timed out and opened breaker 4940. The fault was completely isolated in less than one second.

WNP-2 backfeed de-energized when the Slatt line isolated by opening breakers 4891 and 4888. Since the Hanford, Slatt and Marion line relays are not designed to trip breaker 4885, WNP-2 was left connected to the de-energized South bus through 4885. Breaker 4885 was not required to open to isolate the fault and did not open. However, for automatic transfer of station power from the 500KV backfeed configuration to the 230KV Startup transformer (TRS) to function, both 4885 and 4888 must open. As a result, auto-transfer to the Startup source did not occur. The resultant loss of power to critical plant buses was detected by undervoltage protective relays. The loss of voltage relay scheme then transferred Division 1 and 2 critical bus power to the Backup transformer (TRB) within four seconds. Concurrently, the loss of voltage relays started the Division 1 and 2 Diesel Generators. The High Pressure Core Spray Diesel Generator was out of service for maintenance at the time of the event.

The Root Causes of this event are personnel error on the part of substation operations personnel and equipment design deficiency. These root causes are confirmed by both substation operator (BPA) and Supply System investigations. It is believed the selector switches remained misaligned after planned breaker work. Substation personnel failed to use procedurally prescribed methods for changing component status and logging such actions. Since the relay selector switches had been out of service for approximately 19 days, the BPA investigation specifically addressed their procedural controls over substation activities and log keeping. The controls were found to be satisfactory.

Equipment design is less than adequate since there was no indication in the substation control room that the switches were out of its normal position. Further there were no features of the switch which would obviously indicate, locally, that it was out of position.

BPA will implement modifications to 1) automatically record relay selector switch activity; 2) annunciate and alert the substation operator if a relay selector switch are out of its normal position; and color coding the selector switches to facilitate visual determination of their position.
