August 31, 1992
G02-92-0207

SUBJECT: NUCLEAR PLANT WNP-2, OPERATING LICENSE NPF-21
LICENSEE EVENT REPORT NO. 92-032-01

LICENSEE EVENT REPORT (LER)

TITLE (4)
UNPLANNED MANUAL ACTUATION OF ESF COMPONENT DUE TO DECREASE IN REACTOR WATER LEVEL RESULTING FROM VOIDED FEEDWATER PIPING

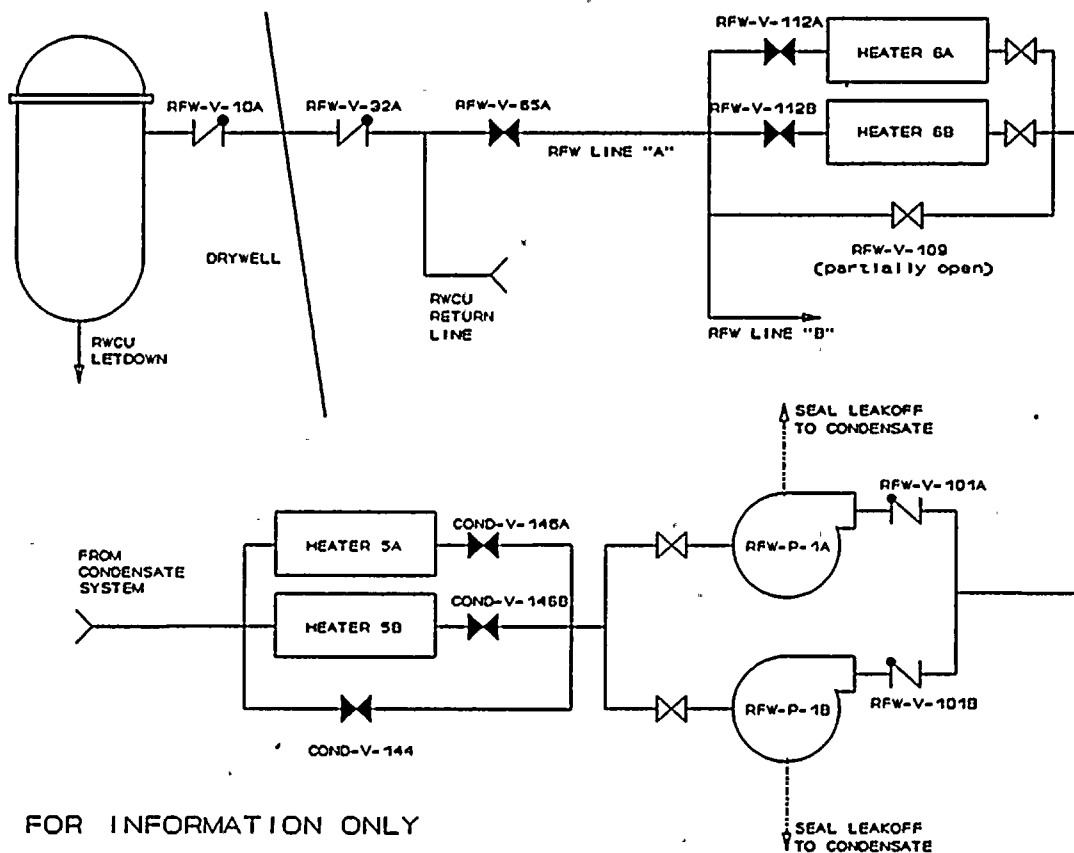
Feedwater System Valve Lineup

At the time of the event, a boundary had been established for work being performed on valve RFW-V-65A by closing valves located on the suction side of the feedwater pumps (COND-V-146A, COND-V-146B, COND-V-144). The boundary had been previously established at valves located closer to RFW-V-65A (RFW-V-112A, RFW-V-112B, RFW-V-109), but was expanded approximately 13 hours prior to the event as a result of unexpected, small reactor water level increases that were noted when RFW-V-65A was opened during the previous control room shift.

With the plant in the configuration previously described, it was possible for water trapped between RFW-V-65A and boundary valves located on the suction side of the feedwater pumps to drain into the condensate system via a flow path that existed through RFW-V-109, the feedwater pump discharge check valves (RFW-V-101A, and RFW-V-101B), and the feedwater pump seals.

The decrease in reactor vessel water level that occurred during this event was initiated when valve RFW-V-65A was opened. Opening RFW-V-65A caused RWCU return flow to be diverted from the reactor and into the voided section of feedwater piping. This resulted in annunciation of the RWCU high differential flow alarm, and caused reactor vessel level to decrease because RWCU letdown was still in progress.

At the time of the event, operators believed that RFW-V-109 was closed. It is standard practice when closing motor operated throttle valves, such as RFW-V-109, for operators to hold the control switch for an additional 10 seconds after closed indication is received in order to assure the valve is fully seated. In accordance with this policy, when boundaries were initially established for work on RFW-V-65A the operator held the control switch for RFW-V-109 for an additional 10 seconds after the closed indication was received.

During post-event investigation it was observed that RFW-V-109 required approximately 33 seconds to achieve full closure after displaying closed position indication. This is in excess of the 10 seconds assumed under the standard practice for throttle valve closure, and as a result, RFW-V-109 remained partially open when closed in this manner. Post-event examination of positioning for the closed limit switch on RFW-V-109 verified that it was set in accordance with motor operator data sheet specifications.

The root cause of this event was incorrect plant/system operation resulting from inaccurate valve position indication that was obtained by implementing the standard practice for throttle valve closure. Although limit switches for RFW-V-109 were set in accordance with data sheet specifications, the valve remained partially open when closed in accordance with the standard practice. This event was contributed to by inadequate self-checking of expected equipment response by the crew that observed vessel water level increases on the shift prior to this event during operation of RFW-V-65A.

As further corrective action, the closed limit switch for RFW-V-109 was examined and verified to be set in accordance with data sheet specifications, and a caution tag has been placed on the handswitch for RFW-V-109 in order to advise operators that it requires more than 10 seconds to seat following receipt of closed position indication. Additionally, limit switch positions for motor operated valves with long stroke times that do not have a seal-in feature will be evaluated with respect to Operations practices. These valves will be provided with caution tags, as necessary, until the results of this evaluation can be implemented. Also, a description of this event will be incorporated into required reading for licensed operators. Stroke time evaluations and required reading are scheduled for completion by December 31, 1992.
