U.S. NUCLEAR REGULATORY COMMISSION

AUGMENTED INSPECTION TEAM (AIT) REPORT

Report No. 50-397/92-30

Areas Inspected: Augmented Inspection Team (AIT) review of a power
oscillation event at WNP-2 on August 15, 1992.

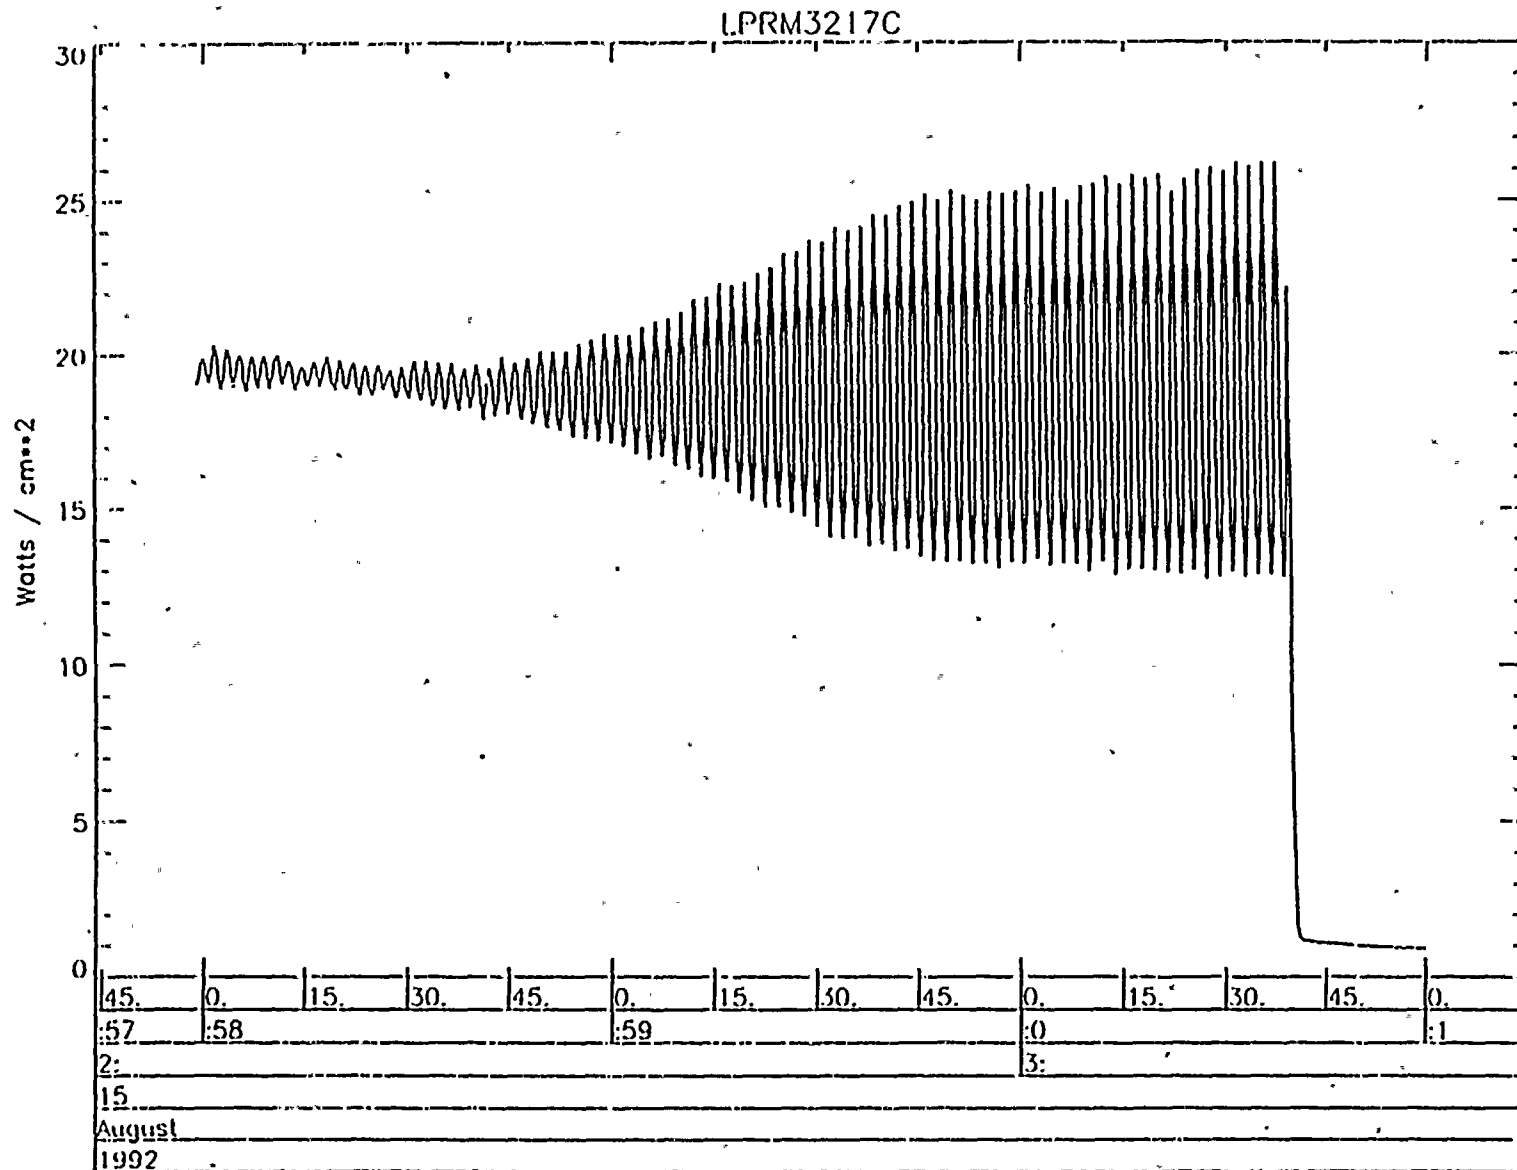
Figure 1 shows a time trace for LPRM 32-17C during the event. On this trace, the oscillations started approximately at 02:58:45 and grew for about one minute with a decay ratio of approximately 1.06 until the amplitude saturated to a peak-to-peak value that is approximately 80 % of the average local power. The oscillation frequency was approximately 0.5 Hz (2 second period). The decay ratio (DR) is a measure of the relative stability of the reactor; DR values less than 1.0 indicate stable operation, while DRs greater than 1.0 indicate an instability.

Figure 1. Time trace of LPRM 32-17-C during the 8/15 event. This LPRM was not filtered by the 0.3 Hz low-pass filter.

At 0300:00, the oscillations seemed to have reached a stable limit cycle (i.e., decay ratio of 1.0), and their amplitude was not growing significantly. A slight trend towards increased amplitude, however, can be observed in Figure 1 even at the moment of scram. This small increase is attributed to nonstationary reactor conditions, such as nonequilibrium feedwater temperature and nonequilibrium xenon.

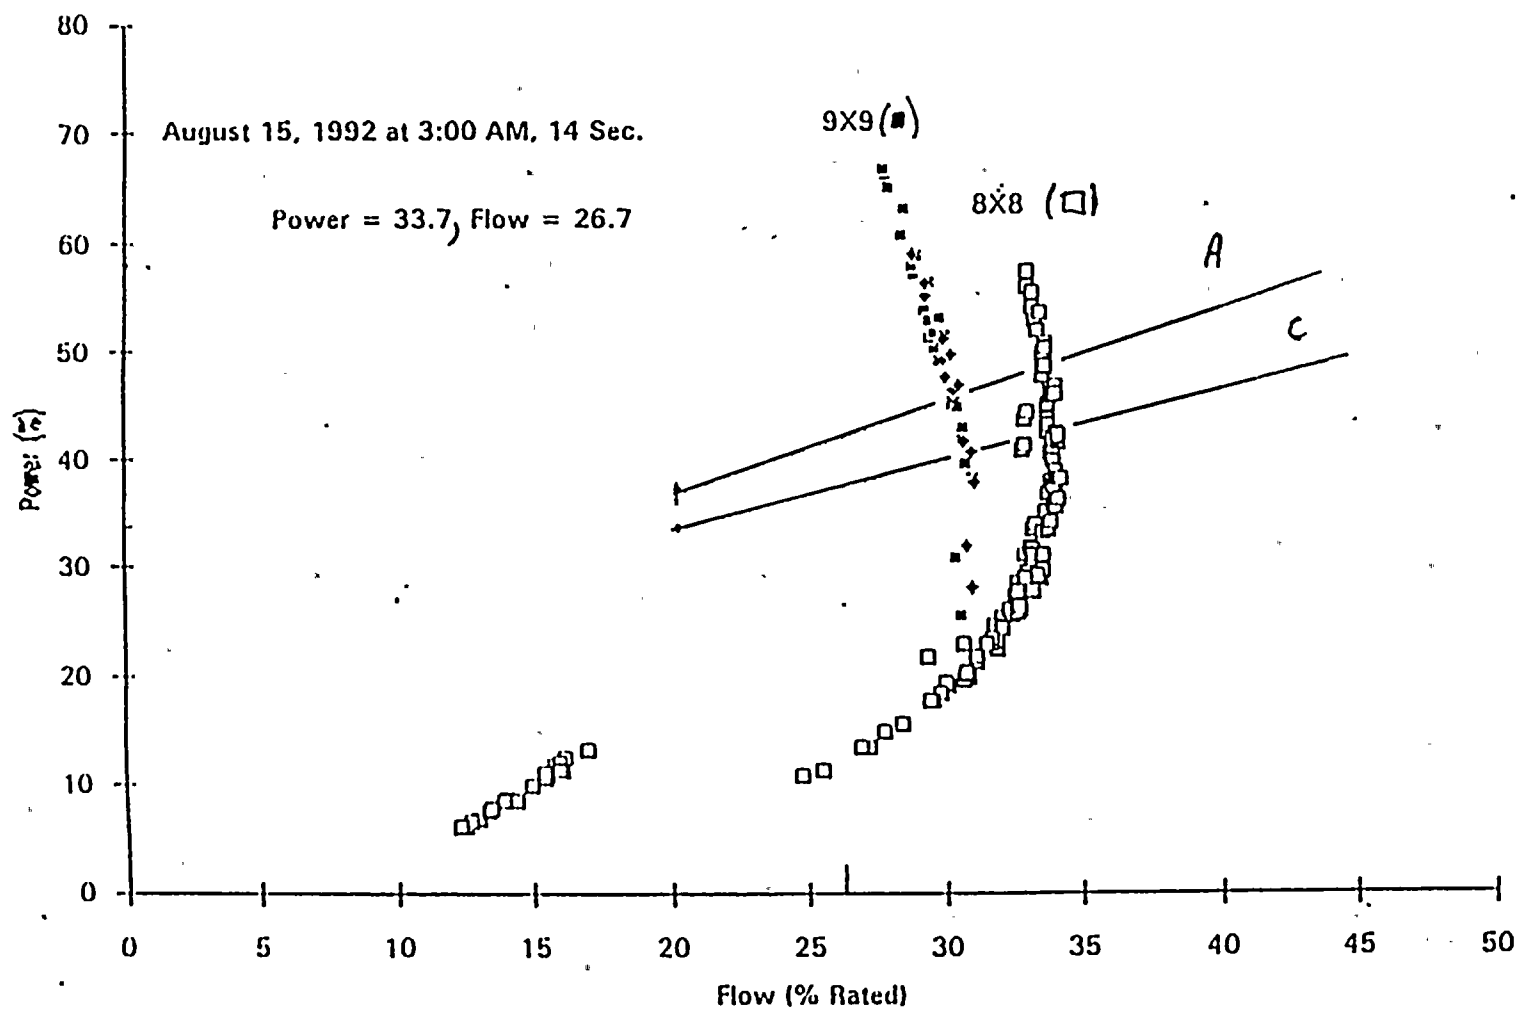
The AIT also found by analyses that a contributor to the instability of Cycle 8 in WNP-2 was a mixed core with unbalanced flow characteristics between the new 9x9-9X fuel and the old 8x8 assemblies. Under these conditions, the low-power and low resistance 8x8 bundles were starving the flow from the high-power and high friction 9x9-9X bundles; this effect can be observed in Figure 2, which shows the relative power and flow of all the channels in the core at the time of the event. LAPUR calculations (Appendix D) indicated that if the whole core had been loaded with 8x8 fuel, the decay ratio would have been 20 % lower and the instability would have been avoided, even with the power distributions which were in use on August 15. Noticeably, if the whole core had been loaded with 9x9-9X instead of being a mixed core, the decay ratio would be lower by 10 % and the instability may have also been avoided.

Figure 2. Relative power and flow of all channels just before the 8/15 WNP-2 event.
The reduced flow area of the 9x9-9X fuel compared to 8x8 results in a lower flow.

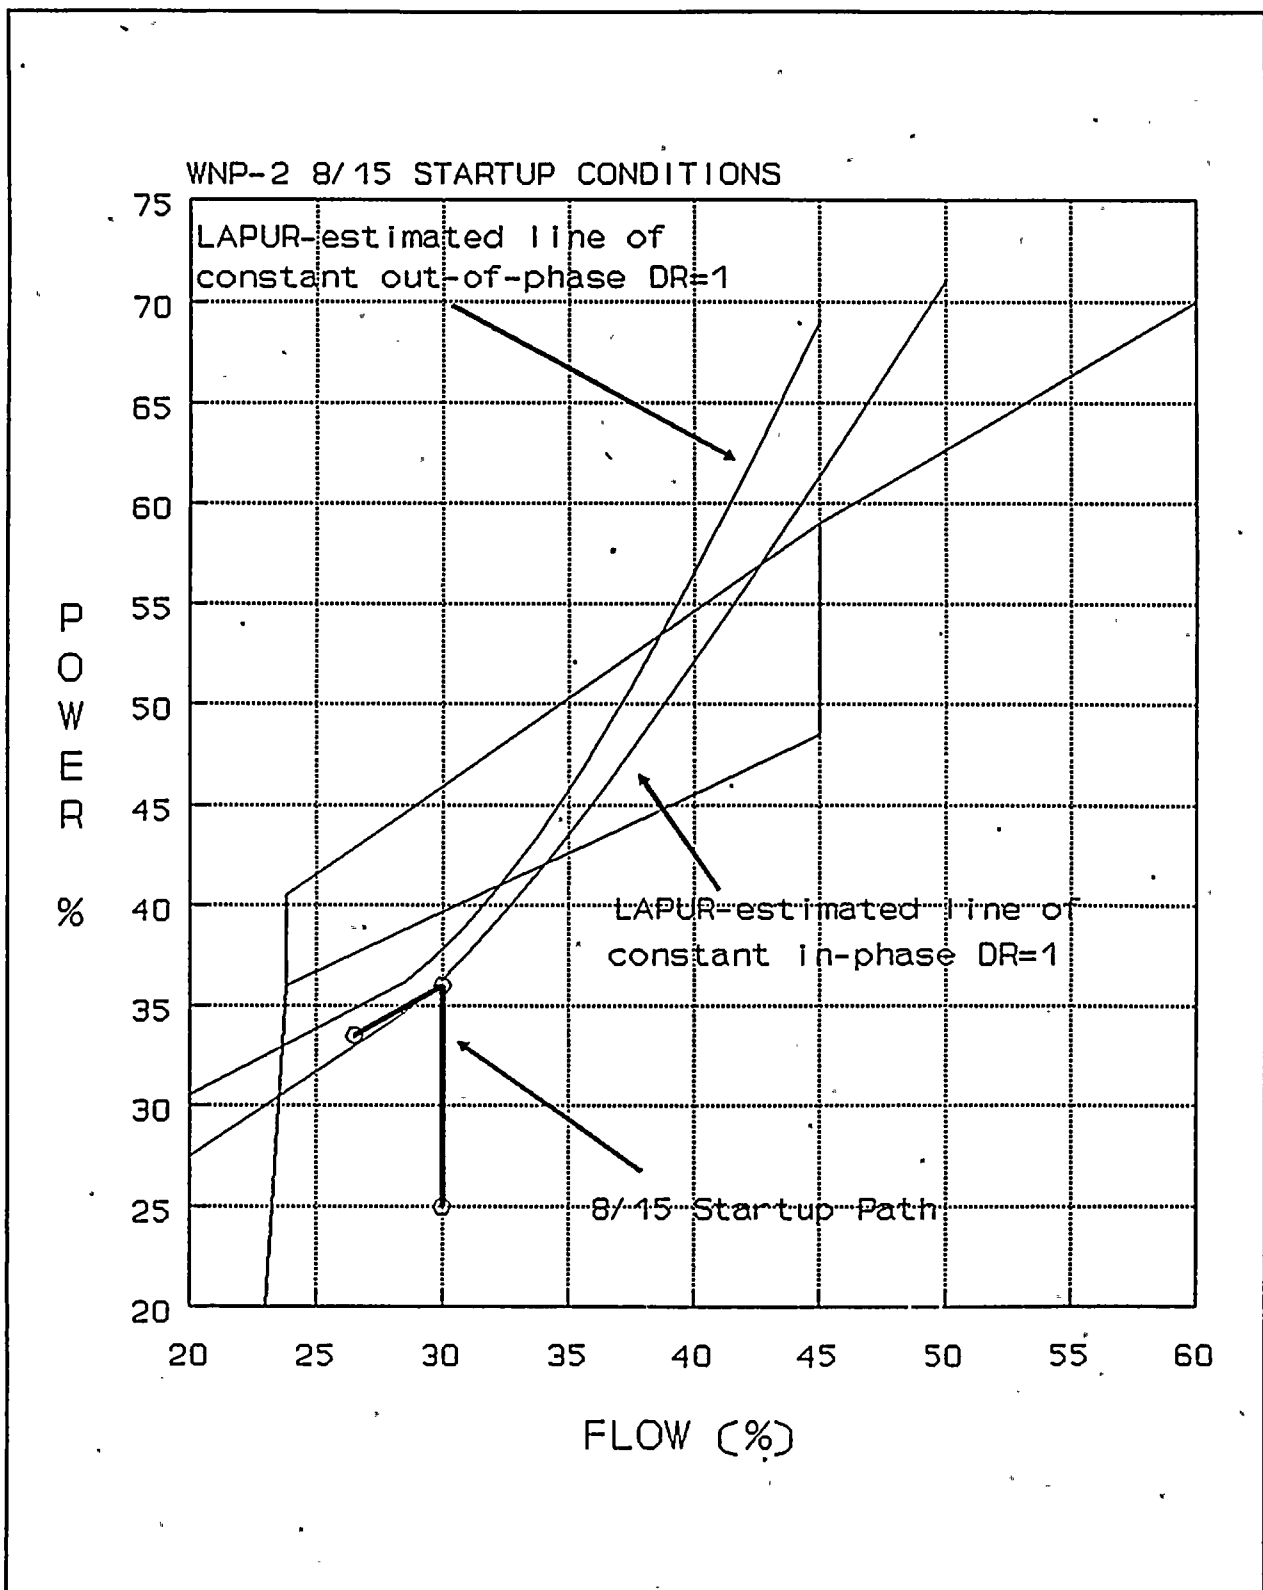
Figure C.1 Best-estimate lines of constant decay ratio=1.0 for actual conditions of 8/15 event, assuming constant power distribution

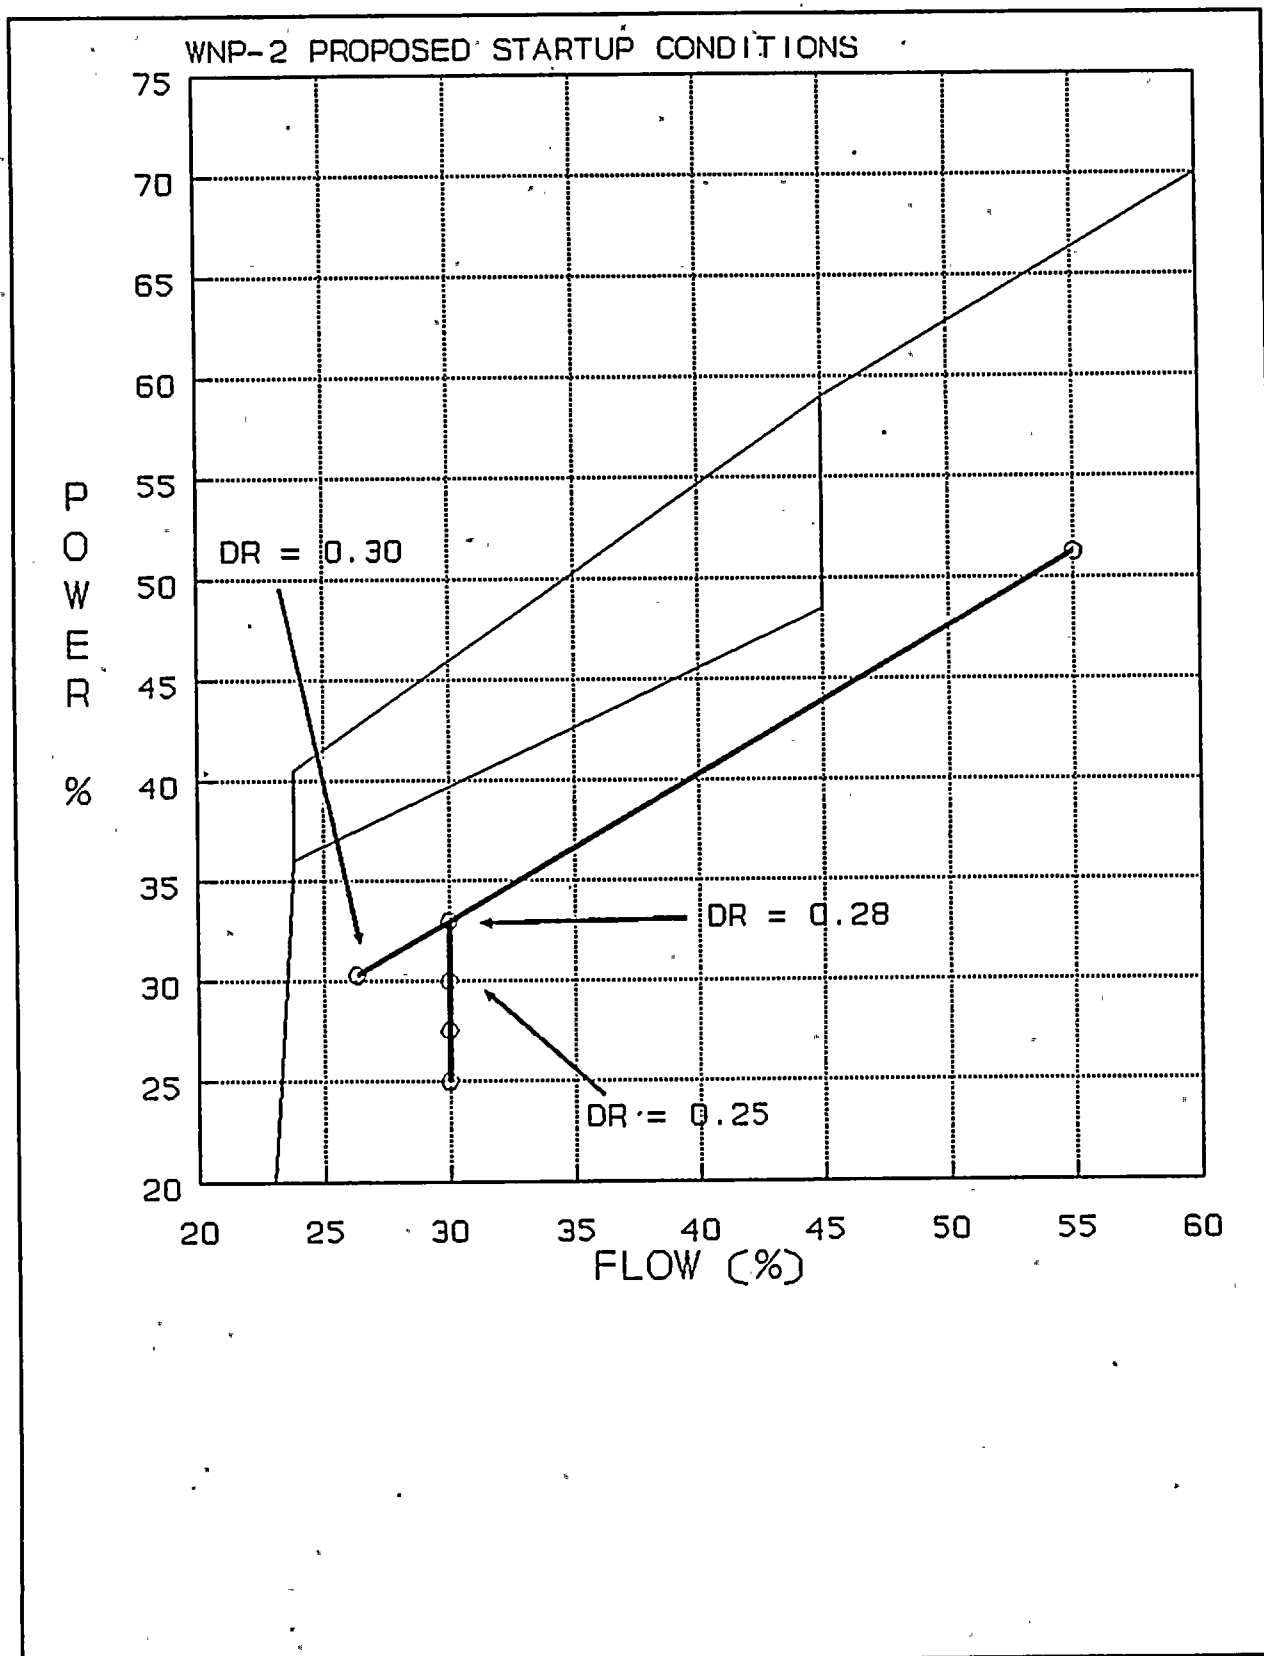
Figure D.2 LAPUR calculated decay ratio for proposed startup path

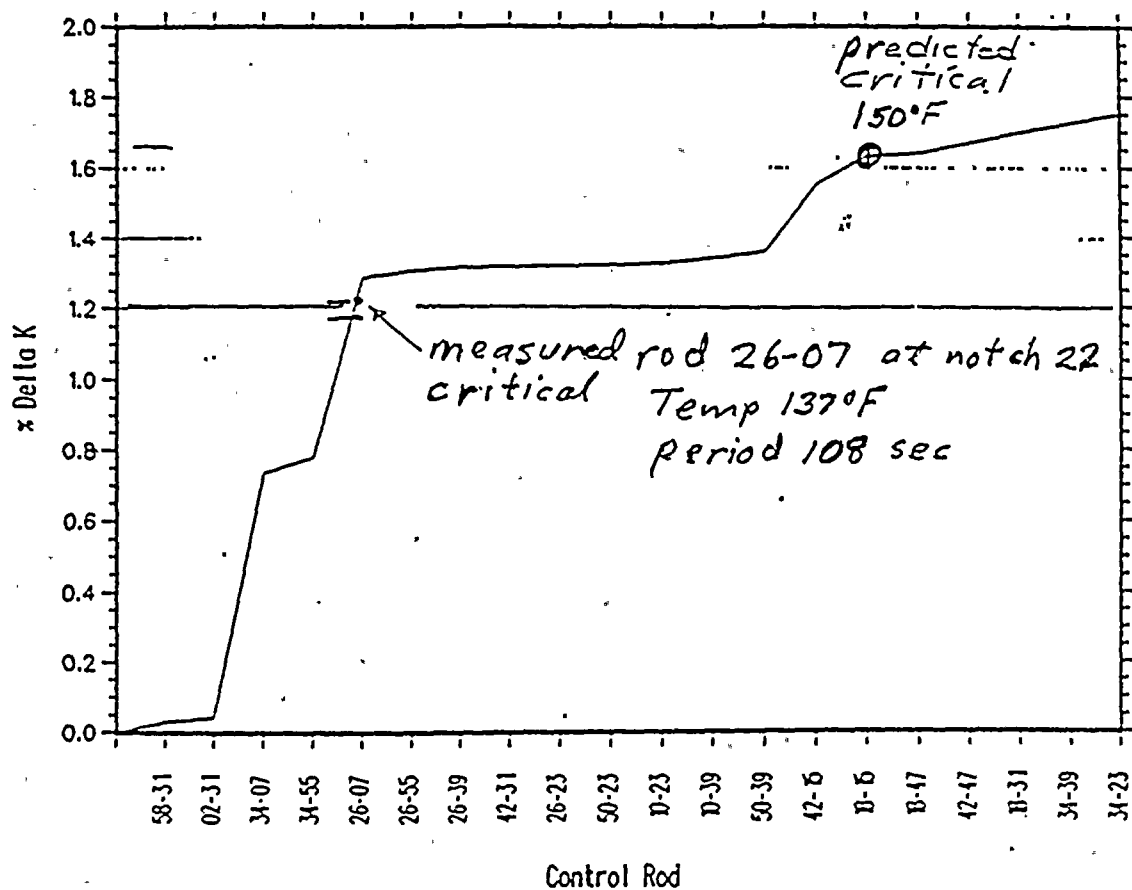
The AIT was concerned, however, with the licensee's position that early criticalities, even with high worth rods, were to be expected. The focus of the PER-provided solution was on the flux tilt, and not on the early criticality. Furthermore, rather than direct that the shift staff stop and ensure a reactivity anomaly is well understood, the Reactor Engineering Department provided a means to get around flux anomalies by pulling banked rods. How this would correct for the early criticality was not explained.

Fig. F.1. Control rod worths for the selected startup withdrawal sequence. Criticality was predicted for rod 18-15, but was reached at rod 26-07, a 0.5% $\Delta K/K$ error.

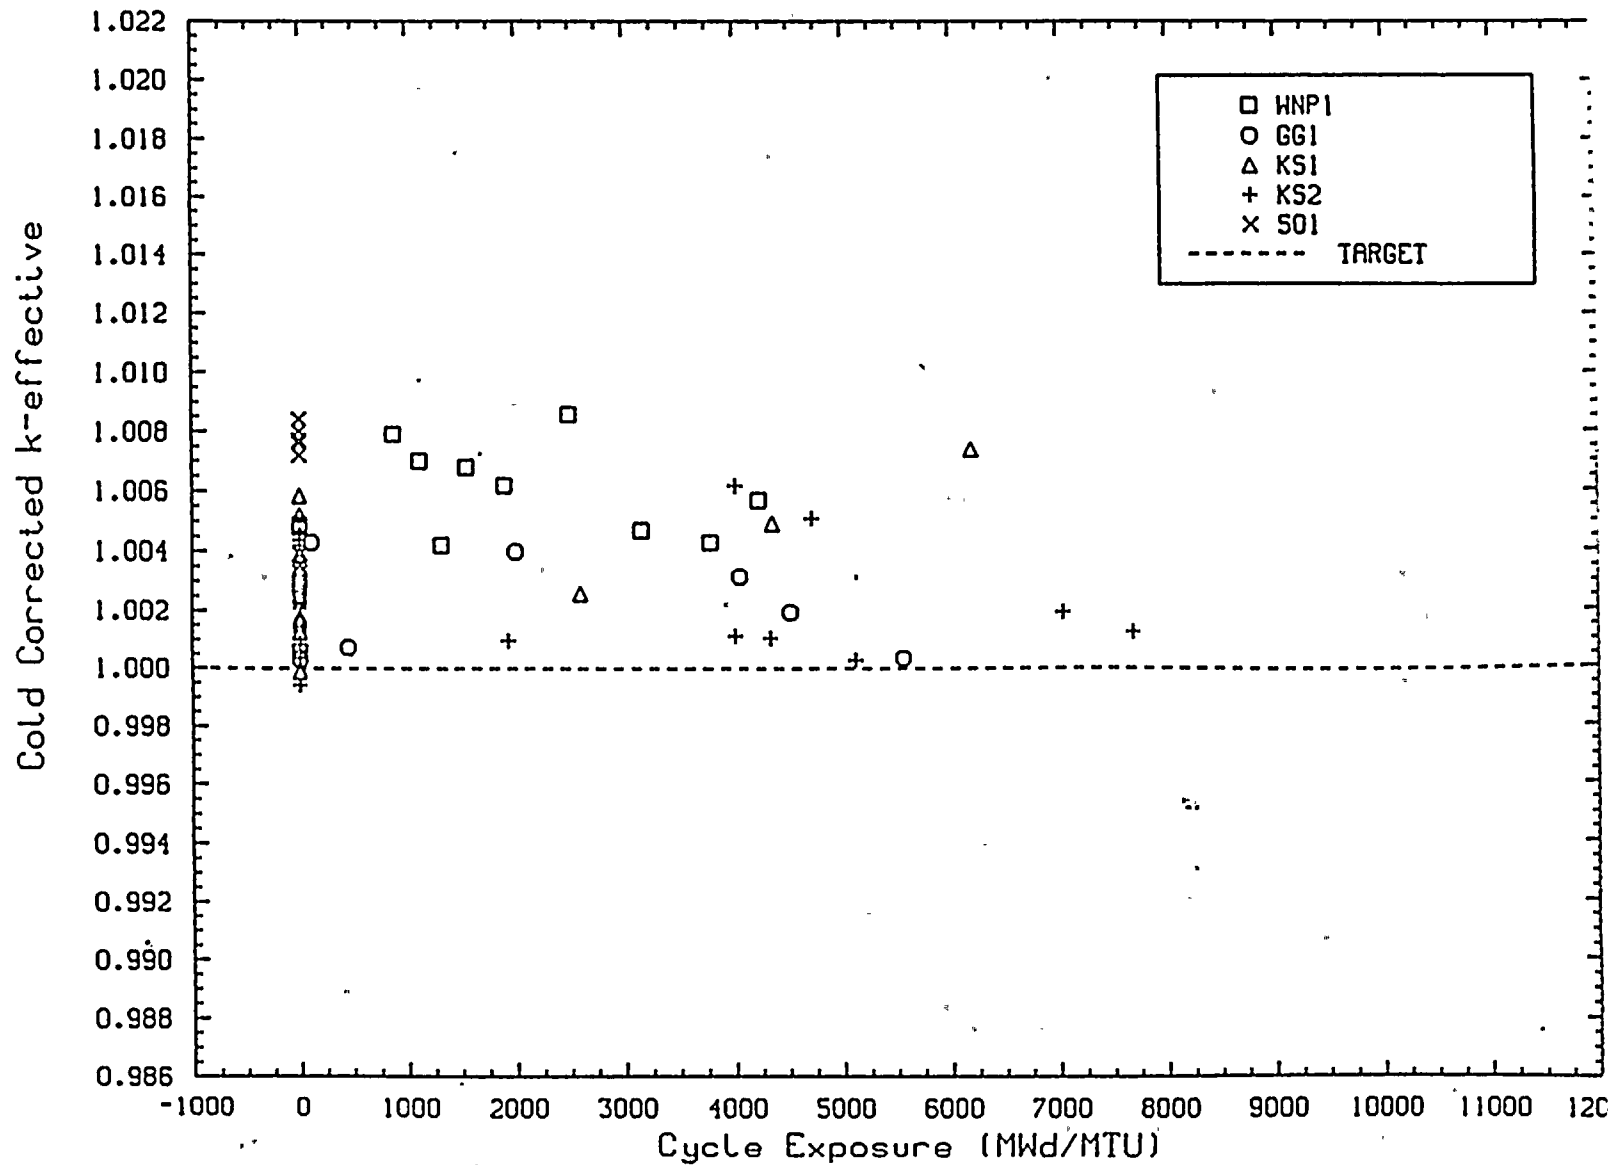
Fig. F.2. Historical cold-corrected k -effective values predicted by SNF, showing a 10% $\Delta K/K$ bounding error band.
